**ARK626 -
Architectural
Transformation and
Environmental care**

Damage report

The following report documents Orust Återbruk buildings damages that can be detected by superficial studies as of October 202. Large parts of the building were inacssable and thus the building most likely has more damages and a comprehensive study should be performed. The document is arranged by rooms and illustrated with examplatory images.

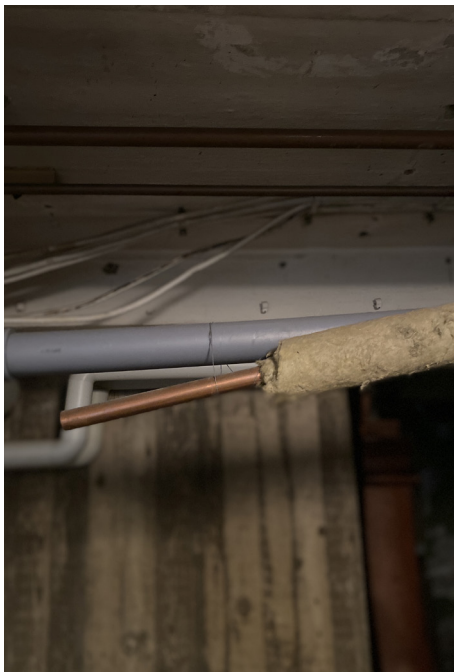
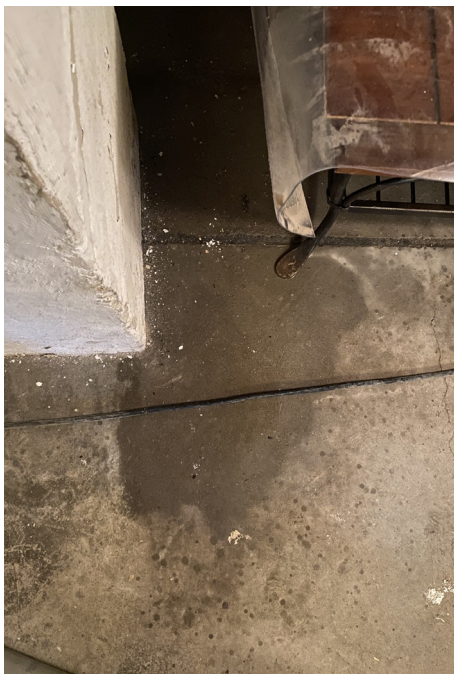
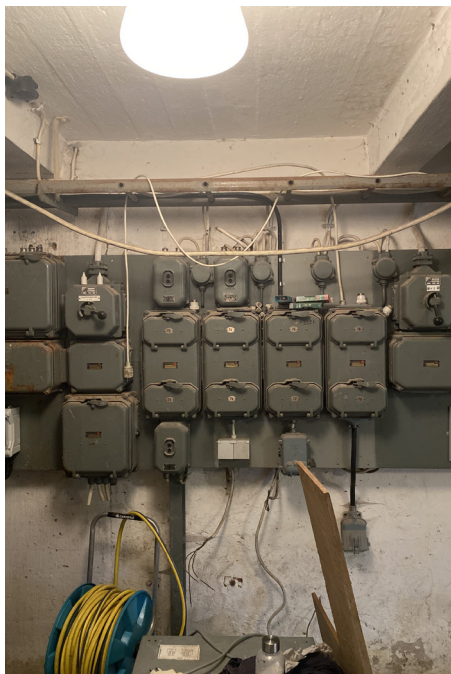
Room 01-03

Damages: Major: Leaking pipes, glass missing on window, smell, sewage pipe running over the floor is in the way, concrete fundamentals on the floor, walls are flaking, mold

Reperations: Sewage pipe that is running over the floor needs to be moved, walls needs to be fixed (add moisture barrier), leaking piped needs to be repaired, dehumidification

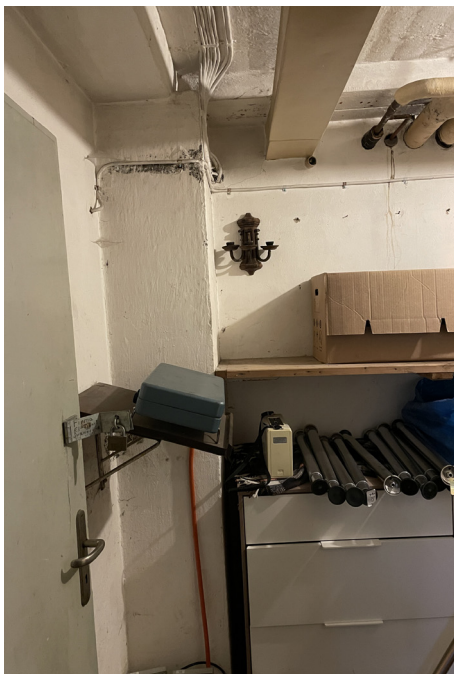
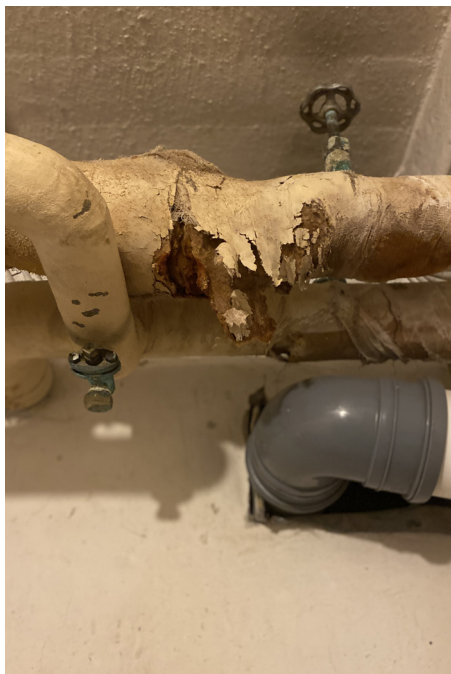
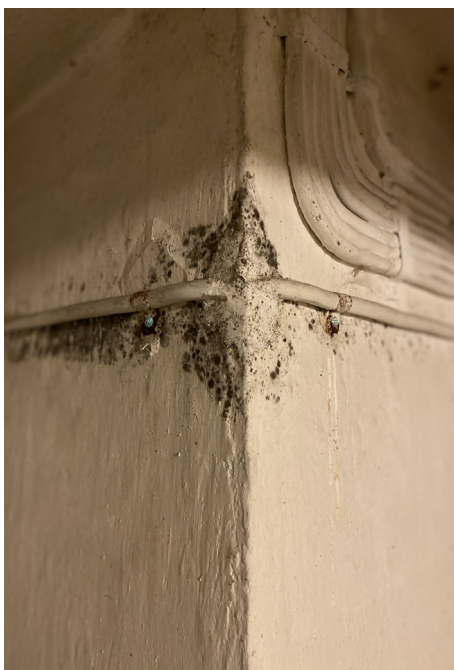
Room 01-04

Damages: Major: mold on pillar, leakage, pipe is blocking the door

Reperations: new surface layers (walls, ceilings and floor) dehumidification, move pipe that is blocking the door

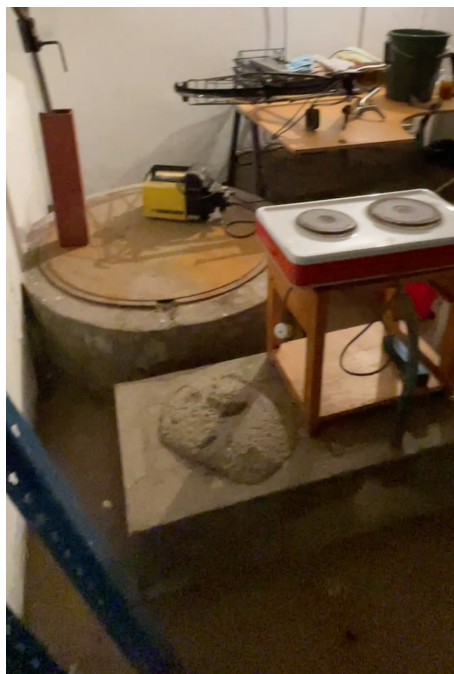
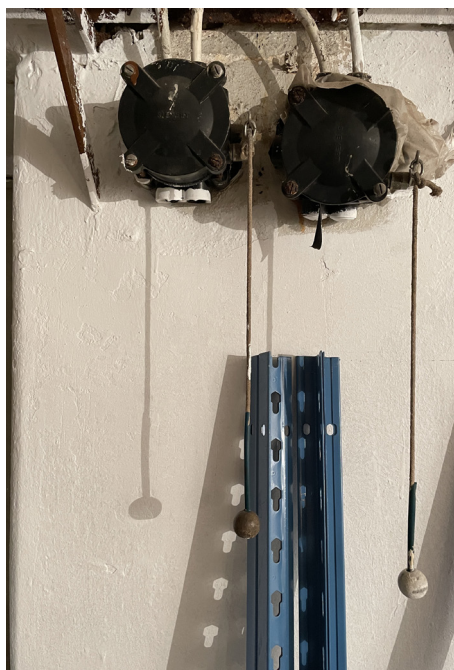
Room 01-11

Damages: Moderate: sewage smell, pipe is hanging down, hole for sewage close to stairs, concrete fundamentals on the floor that can be in the way, high humidity, pipes leaking

Reperations: New surface layers, pipe on floor close to the stairs has to be moved, dehumidification

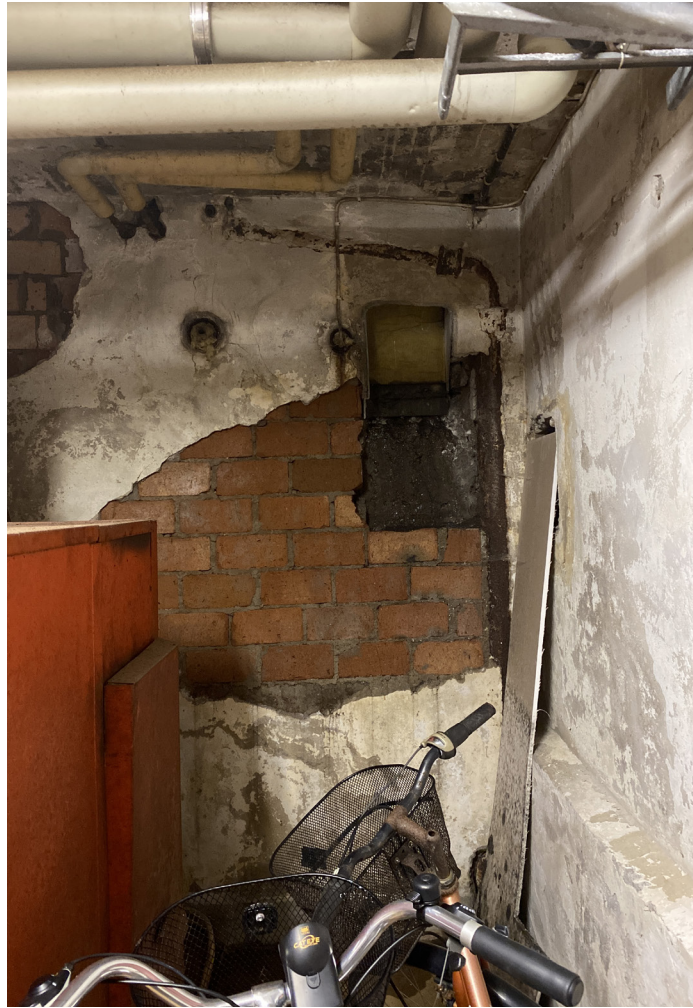
Room 01-12

Damages: Moderate: unfinished wall, but if you want to change the room's purpose a lot of installations have to be moved

Reperations: rust on door, new surface layers,

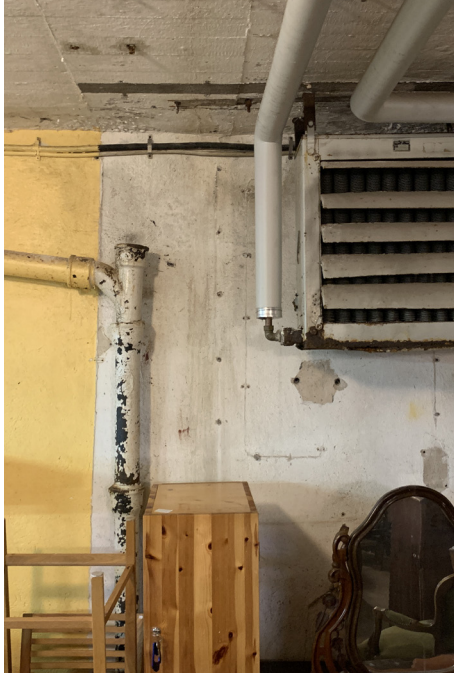
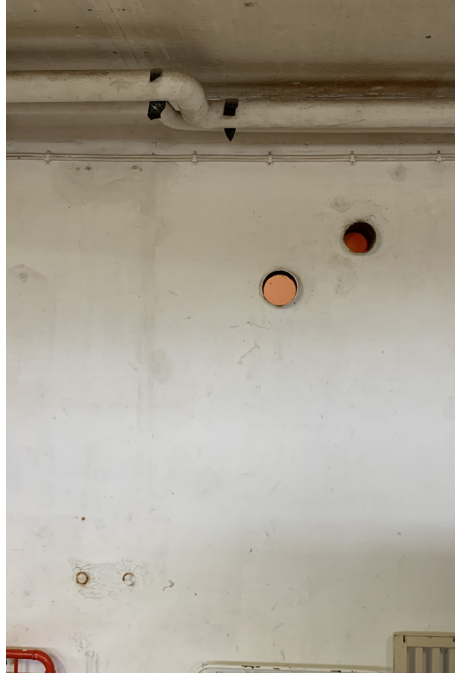
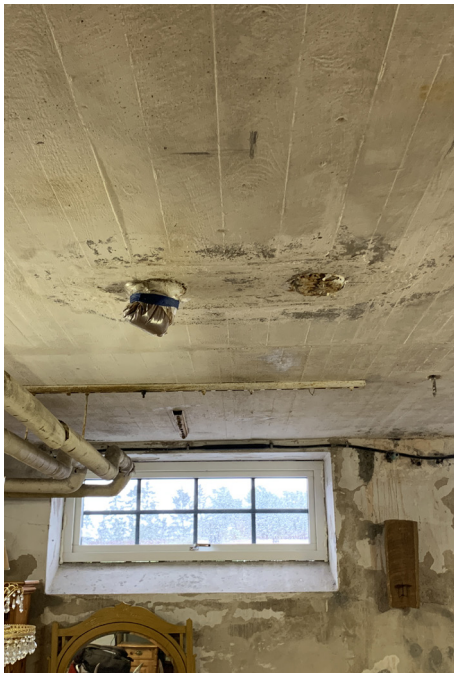
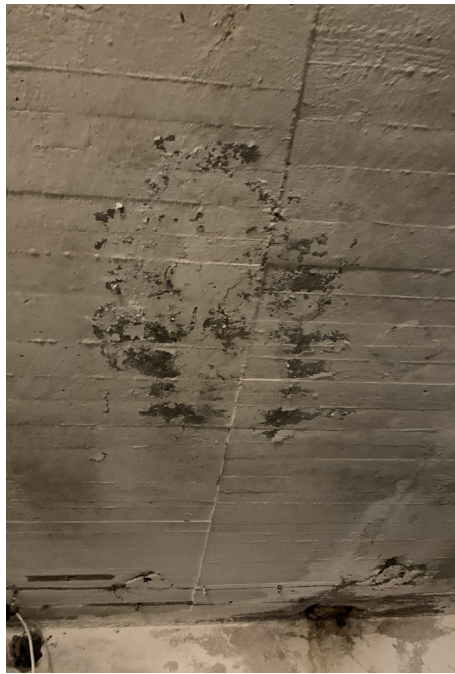
Room 2-01

minor: damaged plaster - on walls and ceiling; pipe system damage

moderate: holes in the walls and ceiling from the pipes, missing small amount of concrete layer on the ceiling

Reperations: Walls and ceiling plaster, parts of celing concrete layer, pipe system replacement + holes in the walls from the pipes, dehumidification, poorly installed new windows

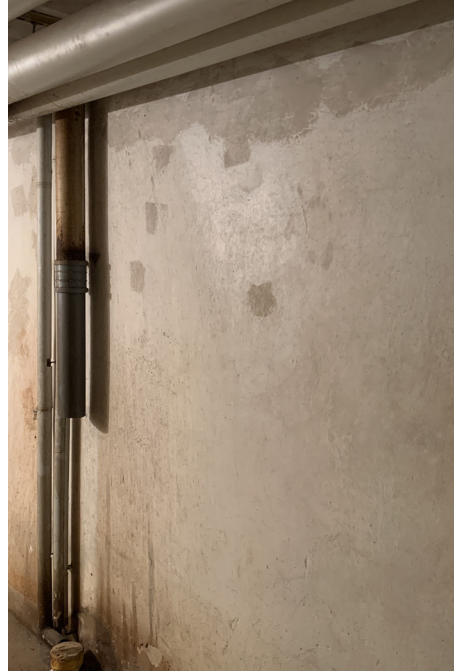
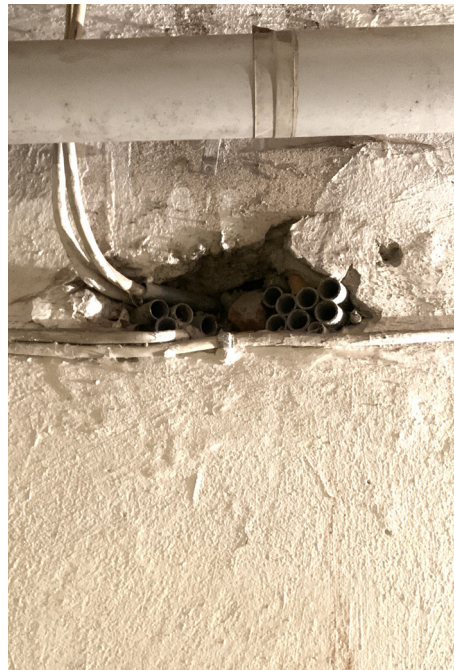
Room 2-02

minor. damaged plaster, wall colour, pipe insulation, water marks on the wall and door

moderate: holes in the walls from the pipes

Reperations: Walls and ceiling plaster, pipe system replacement + holes in the walls from the pipes, door frame, partition wall clading, fireproof door replacement

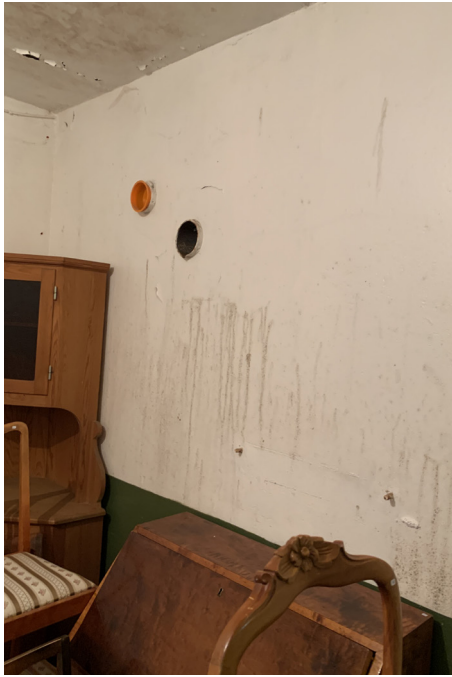
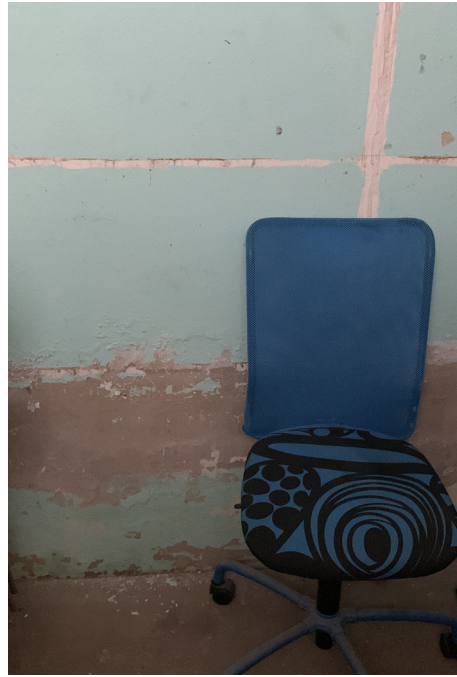
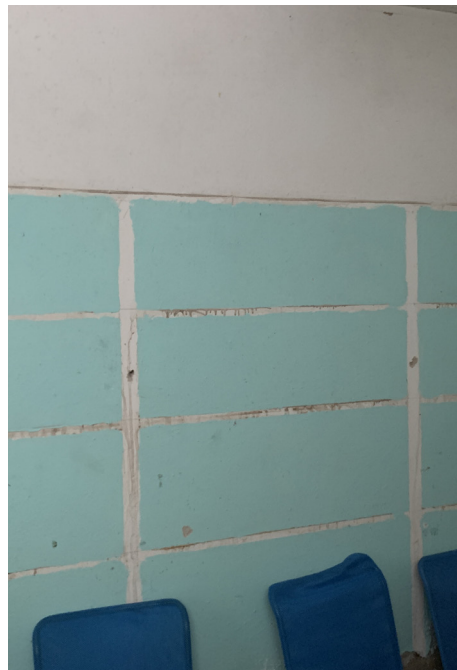
Room 2-03

minor: plaster on the walls, water marks; moderate: broken glass (window)

Reperations: window, plaster (surfaces)

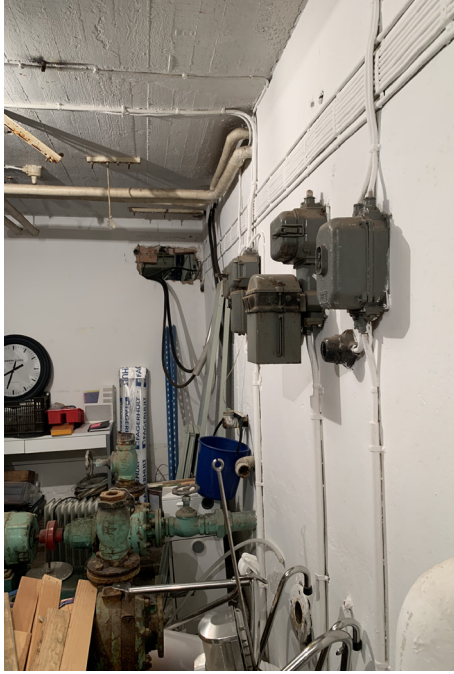
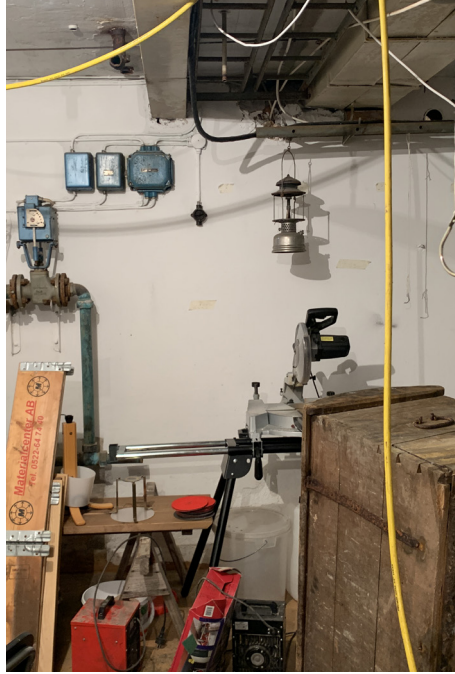
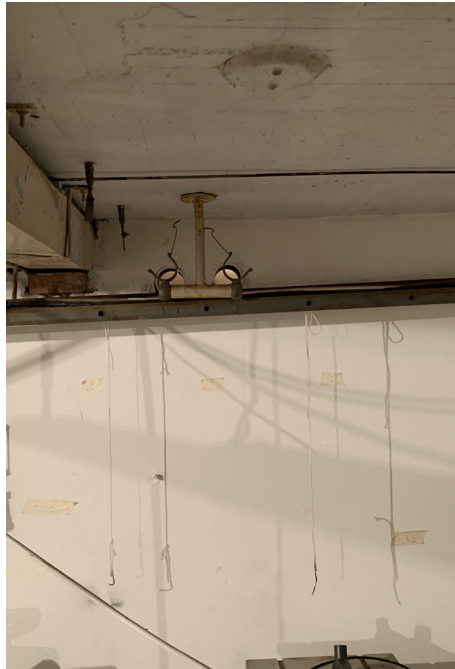
Room 2-05

minor: ceiling plaster, leaking sewage pipes, rusty pipe grid on the ceiling;

moderate: holes in the walls from the pipes

major: hole in the wall - missing bricks

Reperations: new surfaces, new pipe system, holes in the walls and rebuild part of the wall

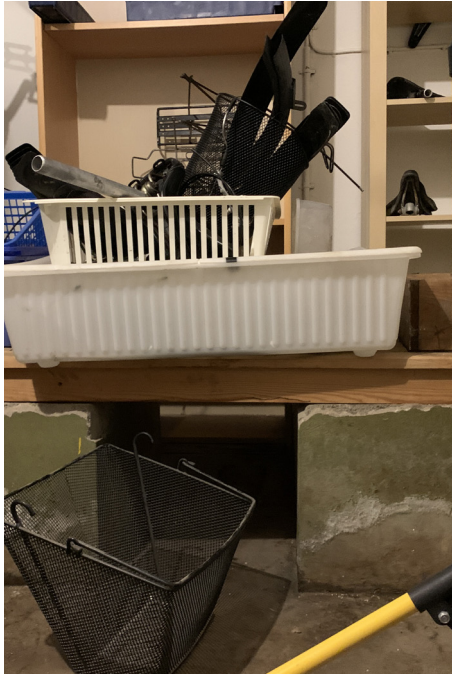
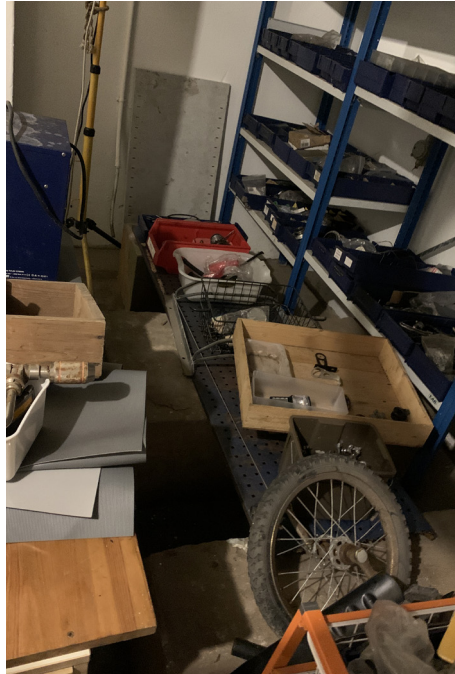
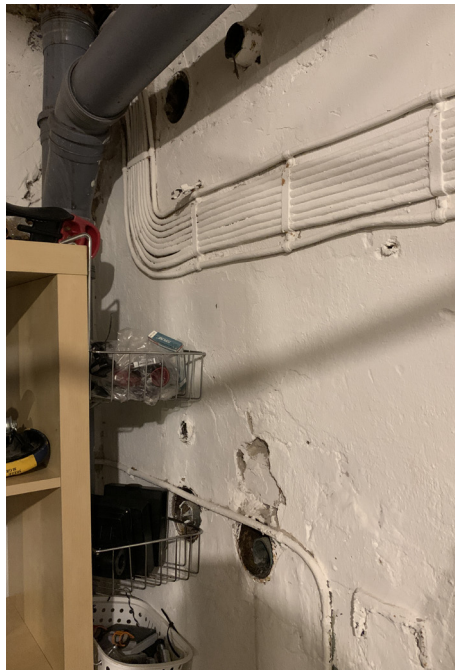
Room 2-06

minor: ceiling plaster, rusty pipe grid on the ceiling, concrete blocks fall apart, damaged door

moderate: holes in the walls from the pipes

major: hole in the wall - missing bricks

Reperations: new door, new surfaces, new pipe system, holes in the walls and rebuild part of the wall, repair/remove concrete blocks

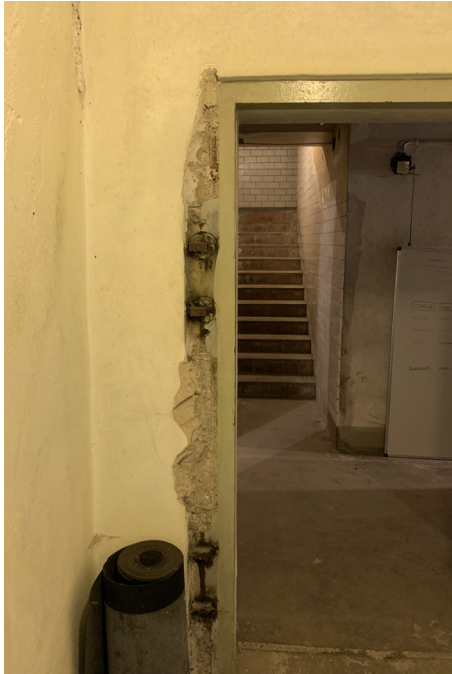
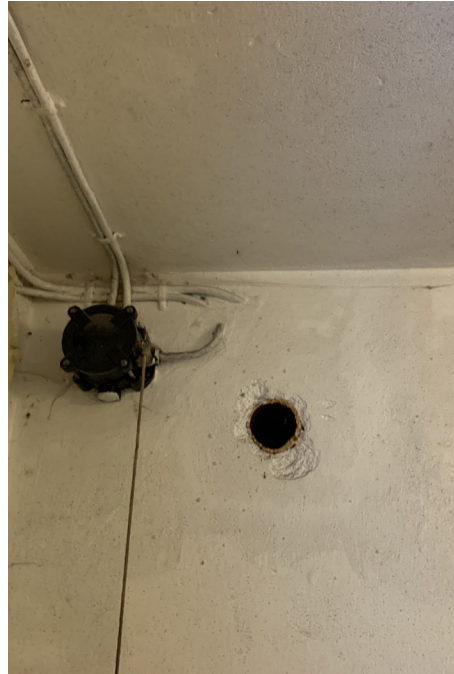
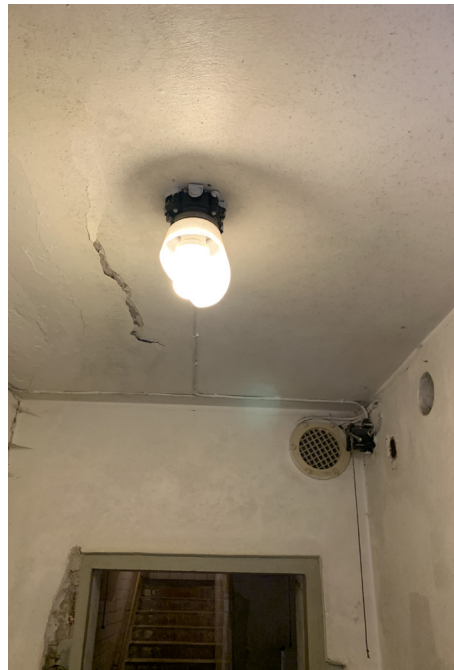
Room 2-08

minor: wall around the door

moderate: damaged ceiling, wall (water damage) - mold

Reperations: dehumidification, new surfaces, repairing the ceiling and the door frame

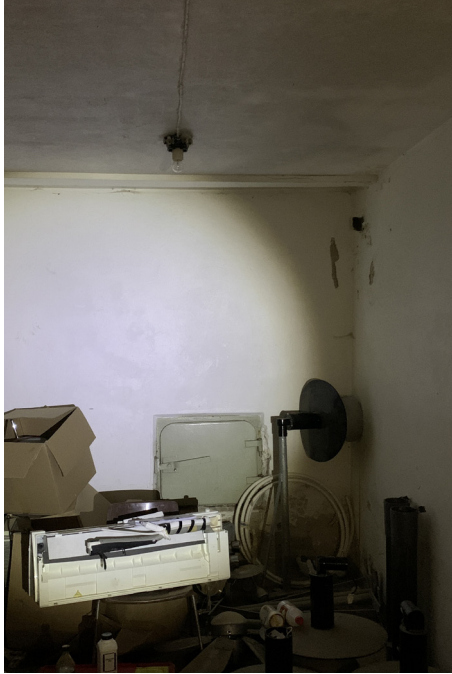
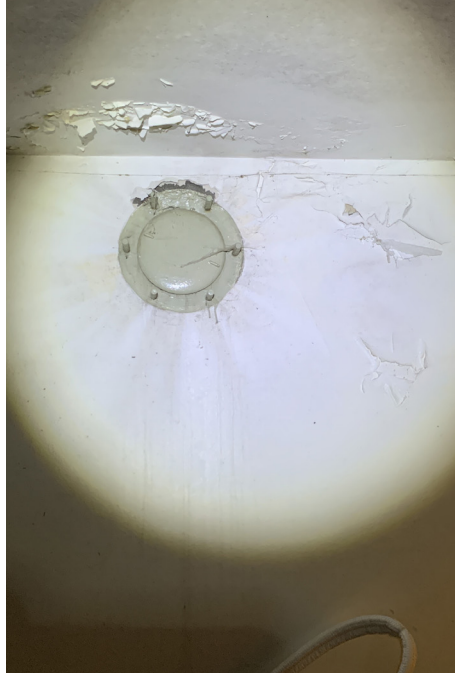
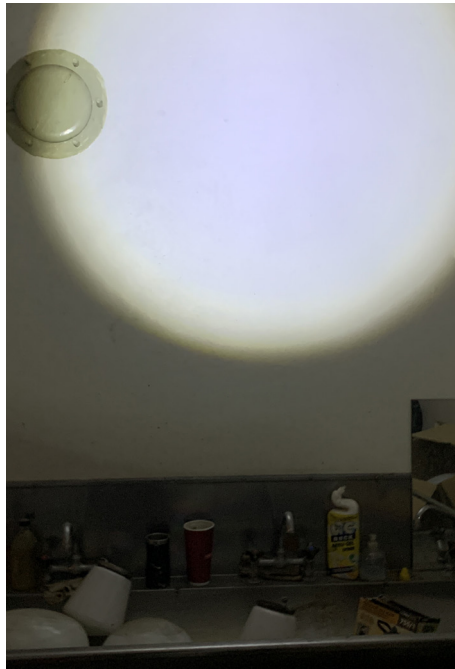
Room 2-09

minor: colour on the walls and the floor

moderate: water damage

Reperations: dehumidification, new surfaces

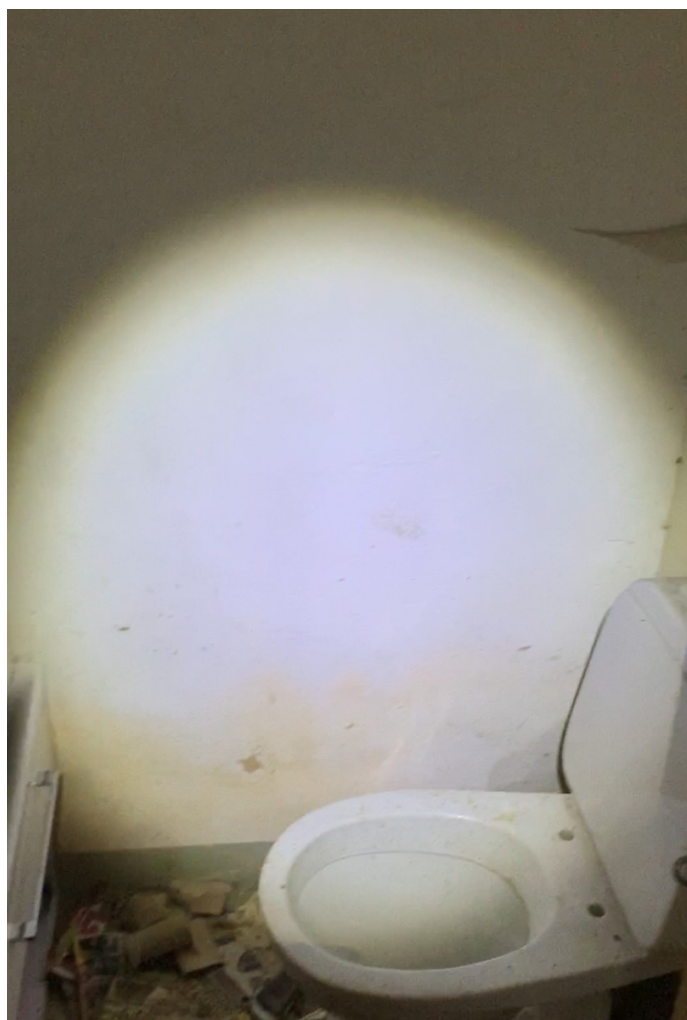
Room 2-10

minor: colour on the walls and the floor

moderate: water damage

Reperations: dehumidification, new surfaces

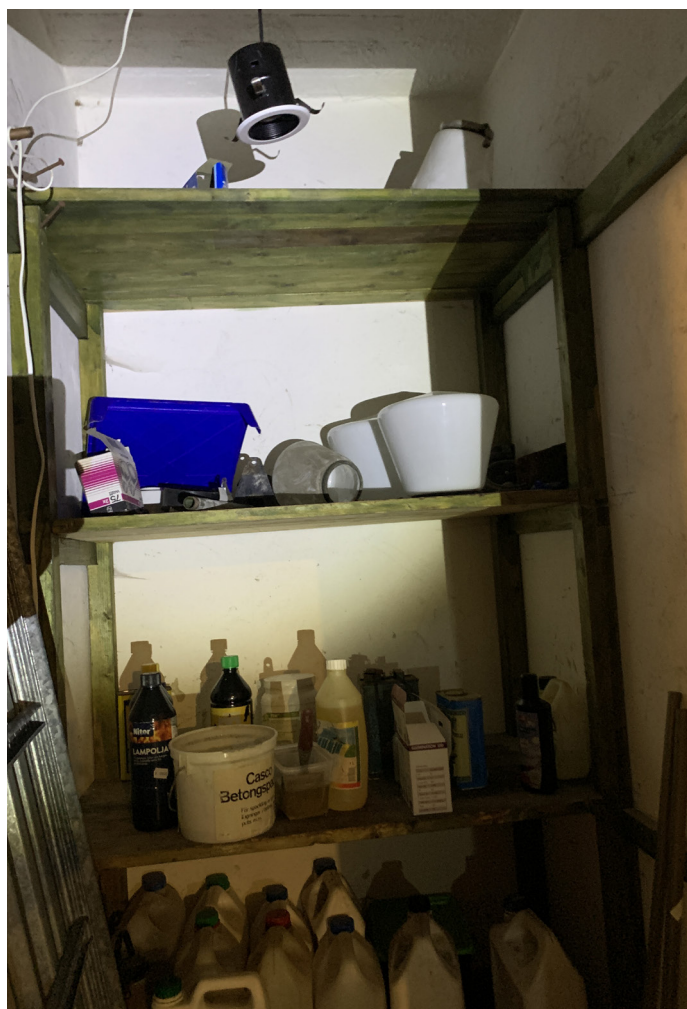
Room 2-11

minor: colour on the walls and the floor

moderate: water damage

Reperations: dehumidification, new surfaces

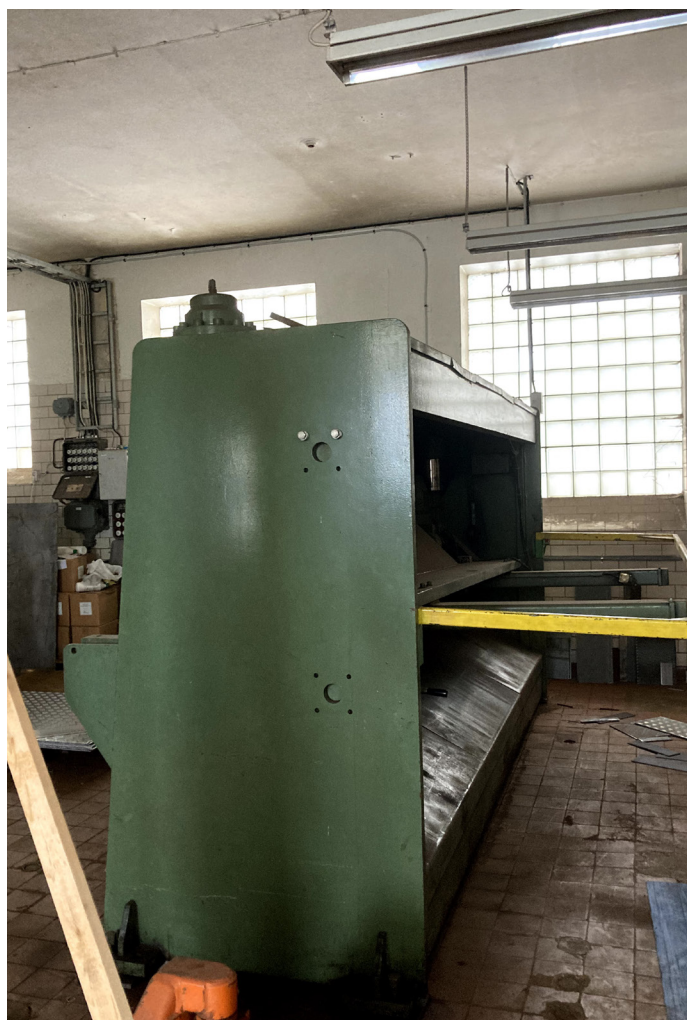
Room 03-01

Major : Discoloured with a yellow tone

Minor: Discoloured joints in some areas

Minor: Cracked tiles in some areas

Reperations: Some tiles has to be replaced. The joints has to be washed/painted. The discolor is perhaps difficult to fix.

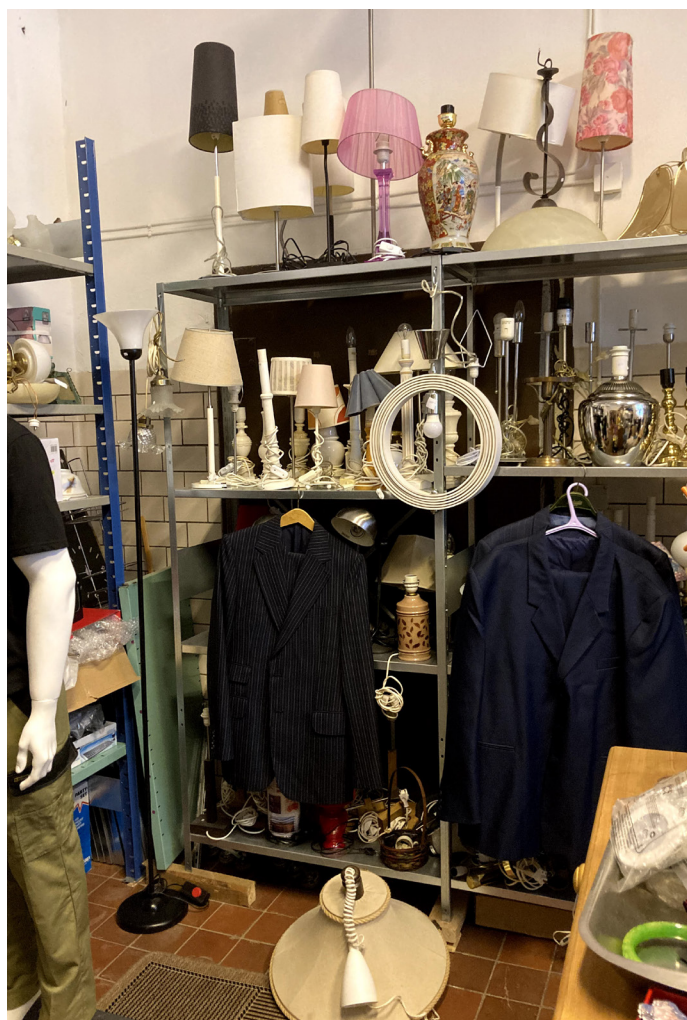
Room 03-03

Major : discoloured tiles, drilled holes, cracked bricks, water damage on roof and walls

Moderate: Different bricks

Minor: Discoloured joints, cracked tiles, plaster damage, dirt,

Reperations: Some tiles has to be replaced. The joints has to be washed/painted. The discolour is perhaps difficult to fix. Fill the plumbing holes and spackle the plaster. Replace some tiles or fill in with concrete. Clean windows, decide wether to change the difference in bricks, replace damaged or missing bricks. Open up to the boarded up window. Remove damaged parts, replace material and check underneath for further issues

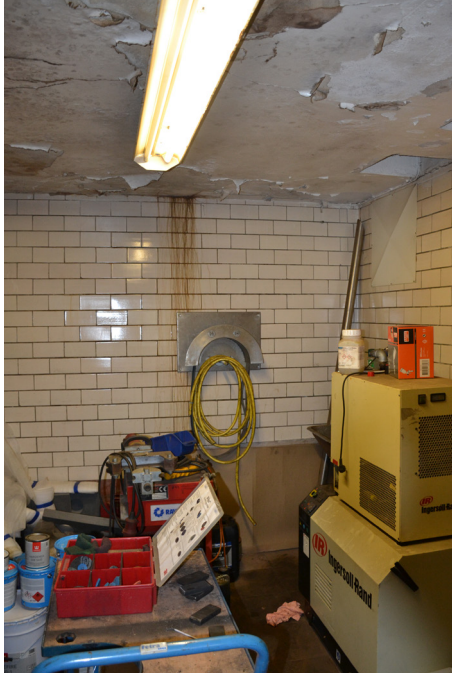
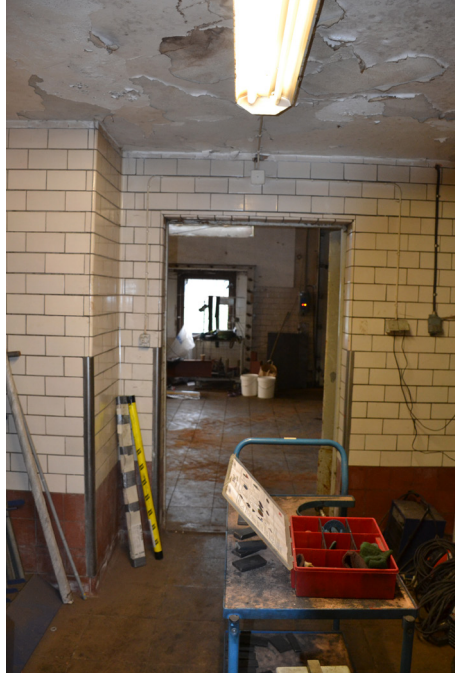
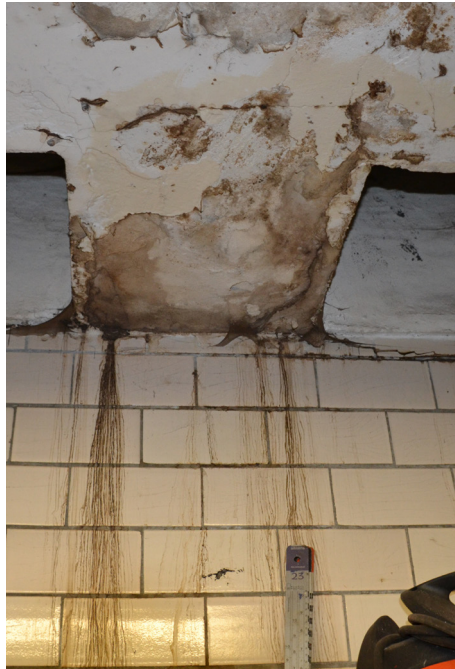
Room 04-02

Moderate: Waterdamage from the ceiling down on the wall

Minor: Rusty door, rust and dents in the floor tiles

Reperations: Ceiling

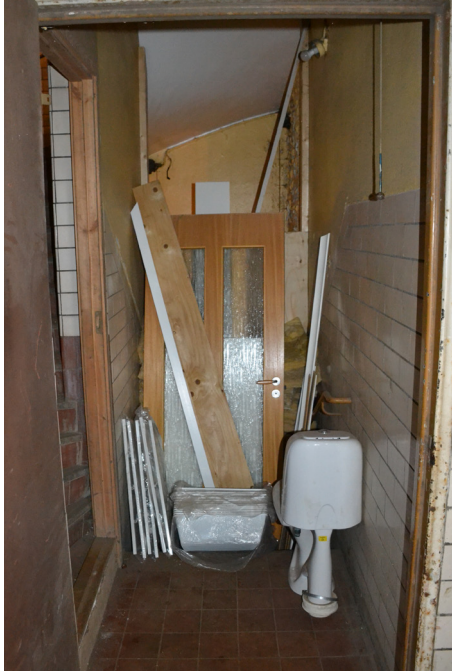
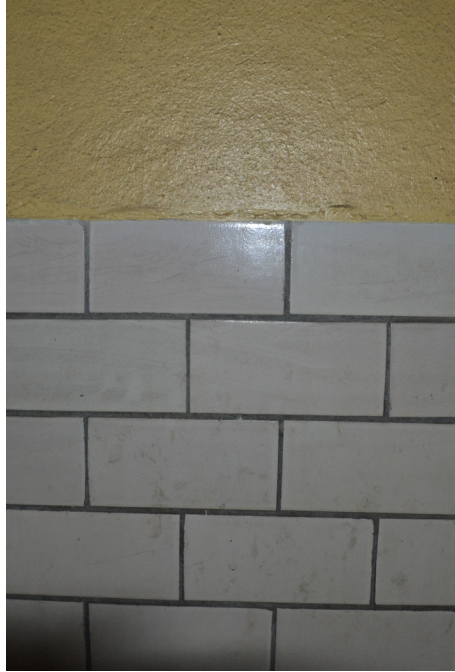
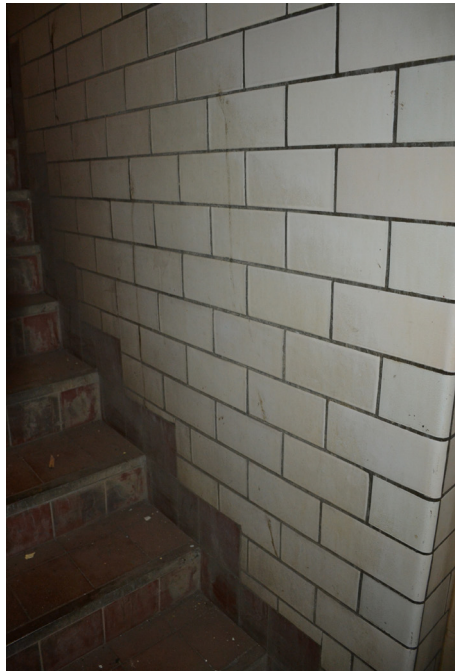
Room 04-03

Moderate: Holes in wall

Minor: Worn off plaster, tiles and floor tiles

Reperations: Walls

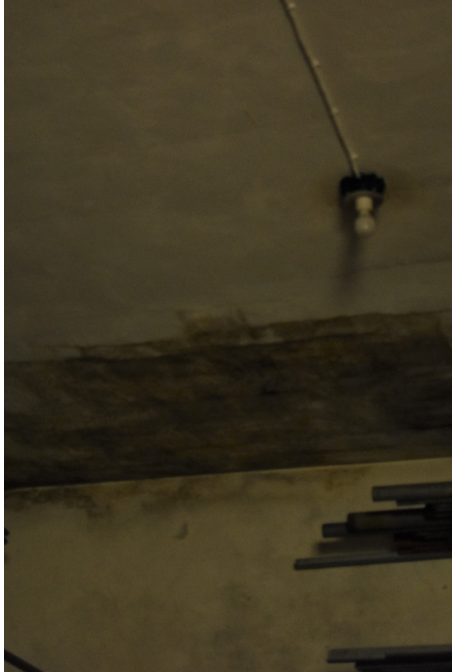
Room 05-01

Major: Water damage in ceiling, non accessible. Crack in concrete following all way around the room (floor, wall, ceiling)

Minor: Possible door to exterior fire exit, non accessible. All walls include markings in varying levels

Reperations: Water damage needs futher investigation. Large crack needs further investigation to determine the severity of the damage. New finishes on surfaces depending on future use

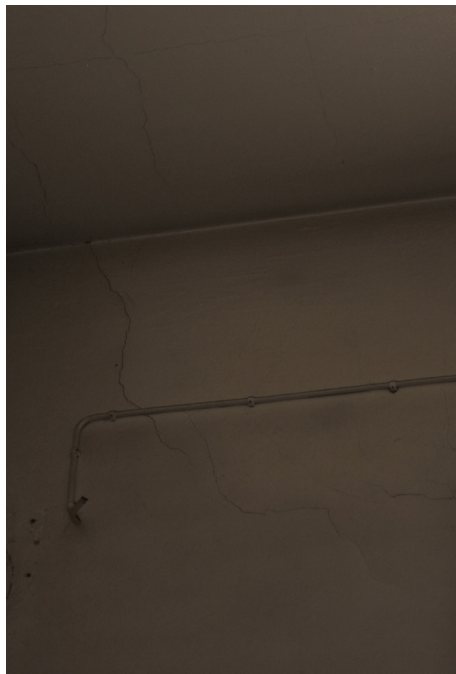
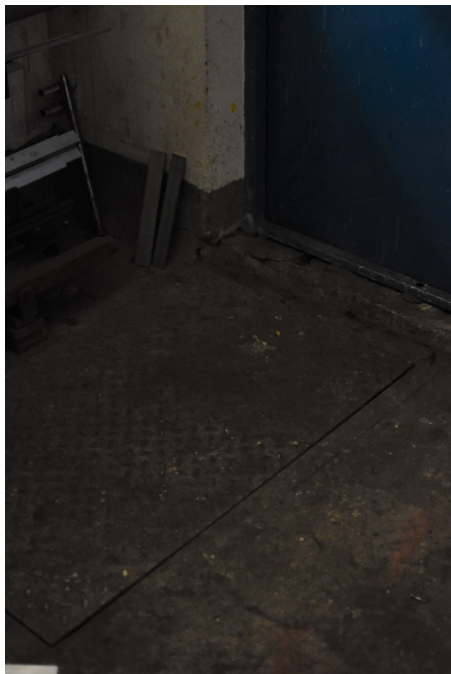
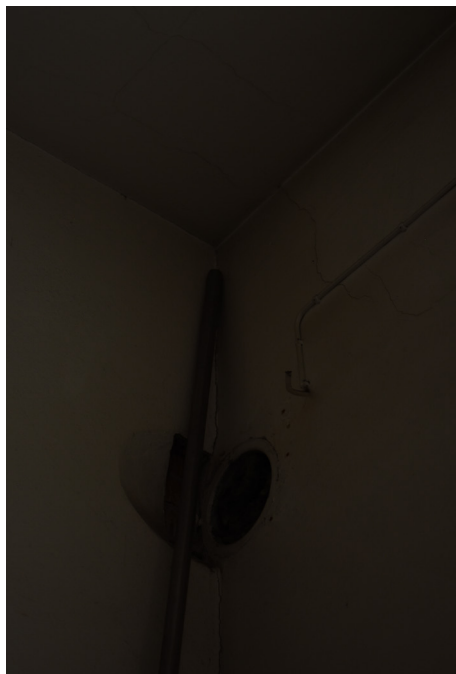
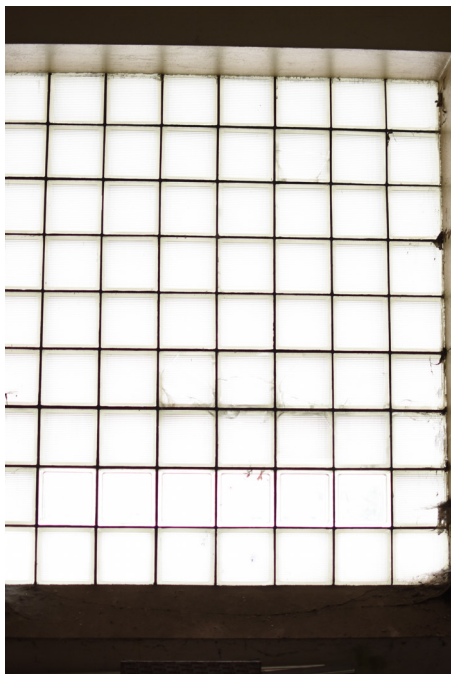
Room 05-02

Major: broken window bricks.

Moderate: ventilation cared into a wall, disturbs airflow. Water damage in the roof, no access to inspect if an ongoing issue. Crack starting from window leading to the ceiling

Reperations: Windows need to be changed, water damage and reason for the crack need inspection

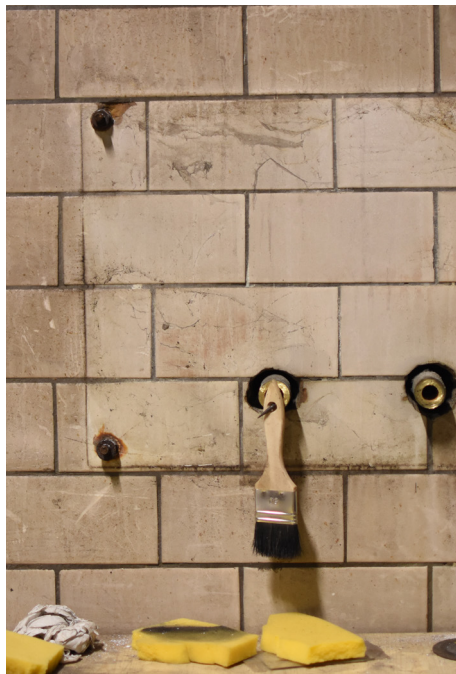
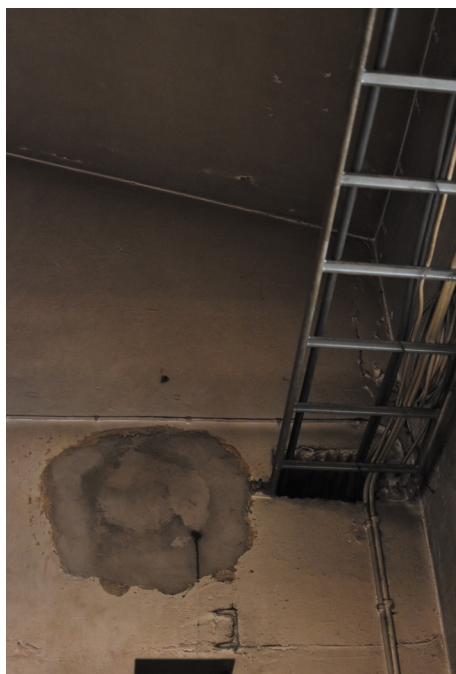
Room 05-04

Major: Broken window bricks. Hole in exterior wall for temporary (?) ventilation. Large hole in surface of wall from installation. Potential water damage in exterior walls (mainly around exterior door). Hole in wall to adjacent room for cable ladder. Moderate: Walls pierced by numbers of pipes and rods, damaging concrete and wall tiles. Hole in wall to adjacent room, patched up with concrete. Concrete beam cut to fit heavy duty crane (needs inspection to determine severity of impact on structure). Wall tiles broken. Minor: Floor tiles missing (concrete infill). Surface finish missing in places on all walls. Scrapings in ceiling from exterior door. I beams cut off over opening to adjacent room. Unused pipes in several areas. Construction of concrete foundation from adjacent room damaged wall tiles.

Reparations: Windows need to be changed, water damage and cut-off beam need inspection. Surface reparations depend on future use. Holes in walls need reparation. Broken tiles need to be replaced.

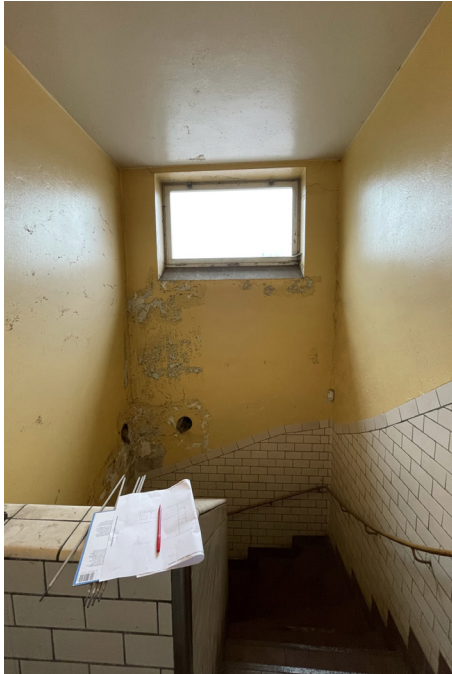
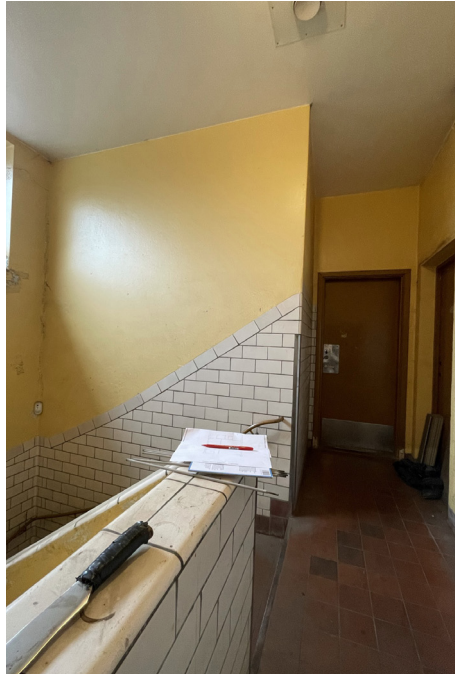
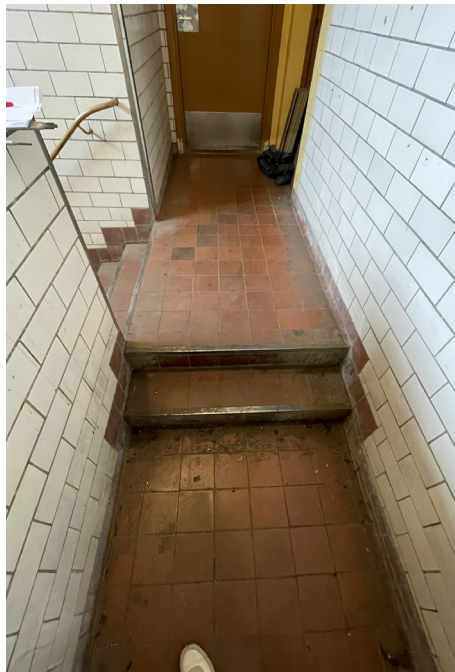
Room 06-01

Major: holes in the exterior wall (in the stairs), broken wall plaster, minor: cracked paint, damaged window

Reperations: Walls, window

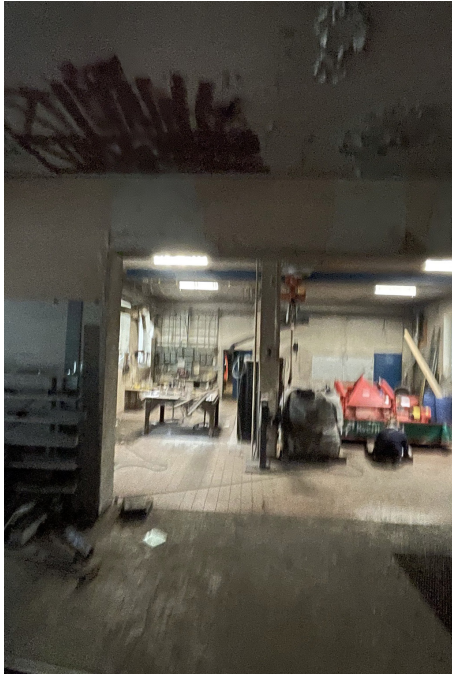
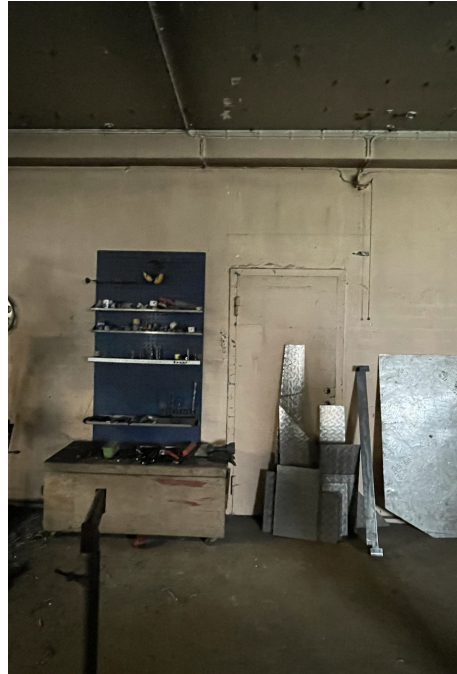
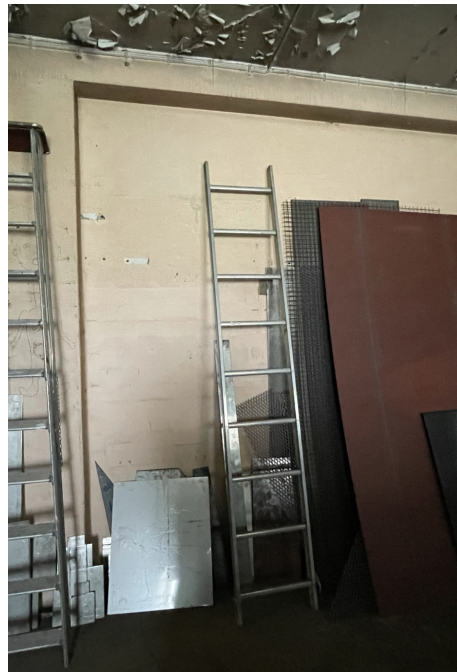
Room 06-02

Broken windows, metal residue on ceiling, broken wall plaster, cracked paint

Reperations: Walls, ceiling, windows

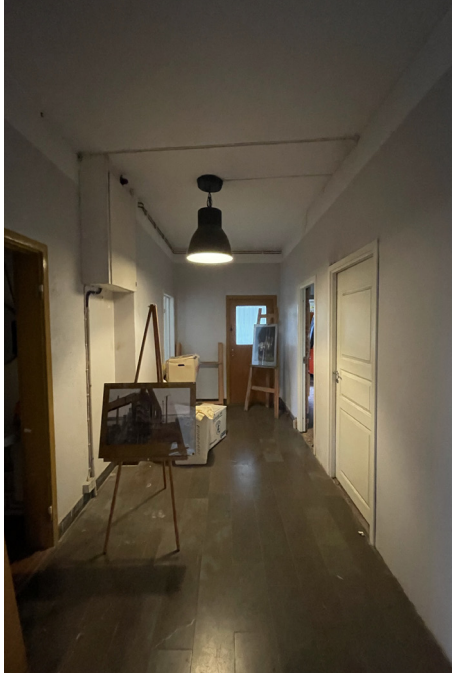
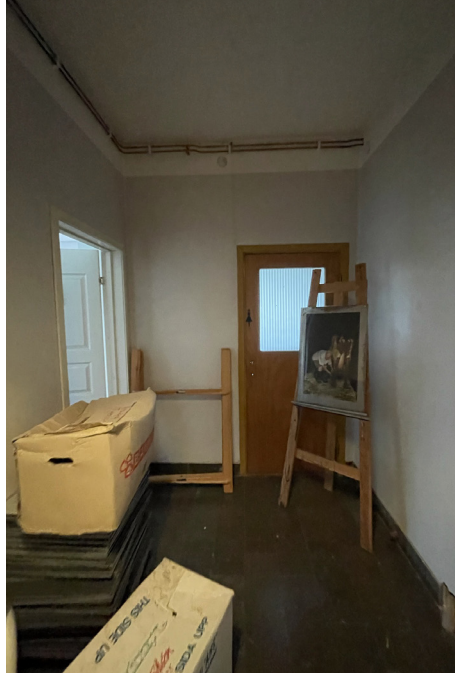
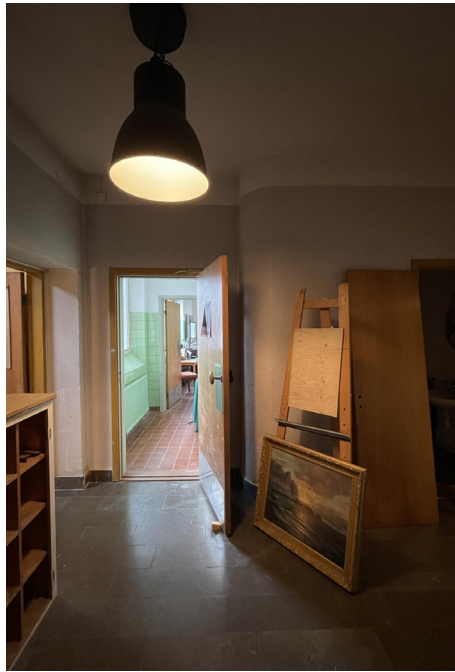
Room 06-04

Minor: Broken bases, doors

Reperations: Bases, doors, repaint

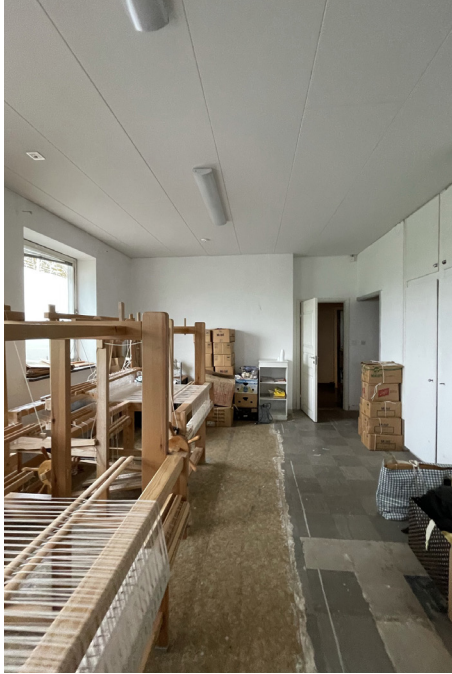
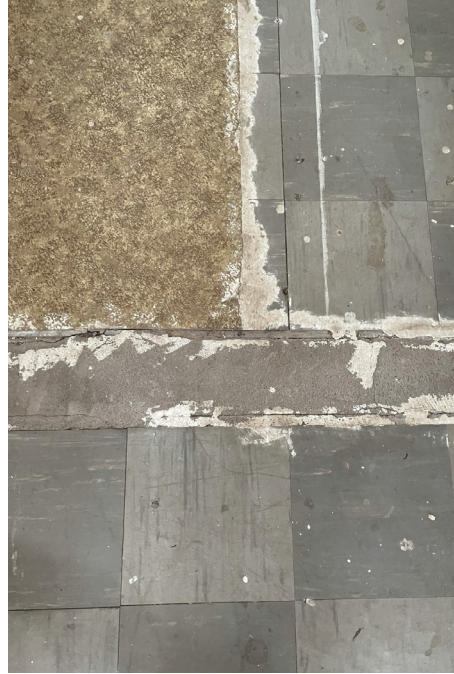
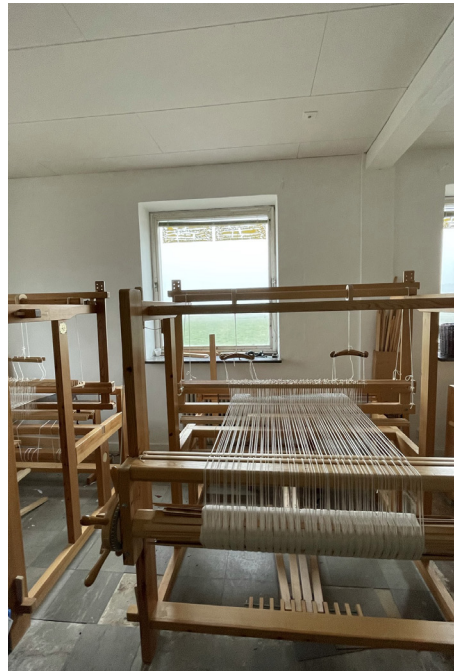
Room 06-12

Minor: exposed concrete between different floor surfaces (where there's previously been walls) Damaged windows

Reperations: Change or repair floor surface, change windows

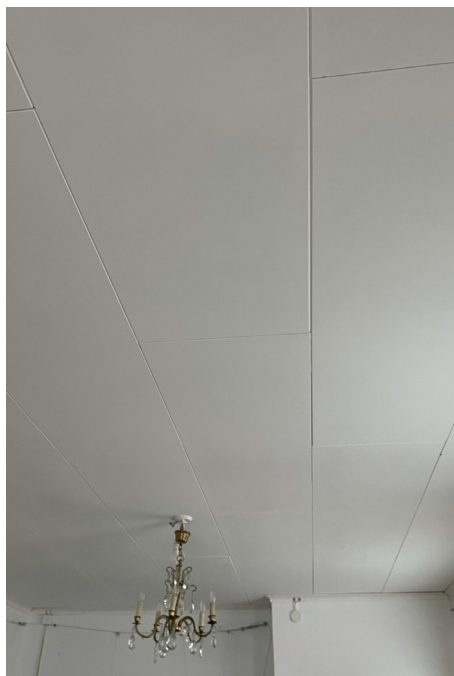
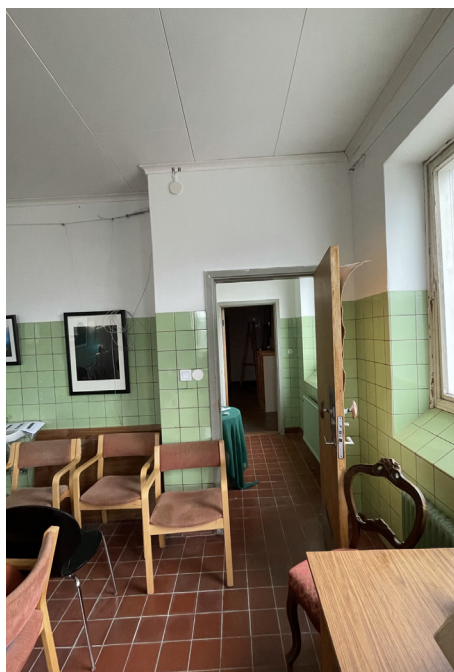
Room 06-14

Minor: damaged windows, damaged door, hole in the wall (ventilation?)

Reperations: Change or repair windows, change door
