**ARK626 -
Architectural
Transformation and
Environmental care**

Damage report

The following report documents Orust Återbruk buildings damages that can be detected by superficial studies as of October 202. Large parts of the building were inacssable and thus the building most likely has more damages and a comprehensive study should be performed. The document is arranged by rooms and illustrated with examplatory images.

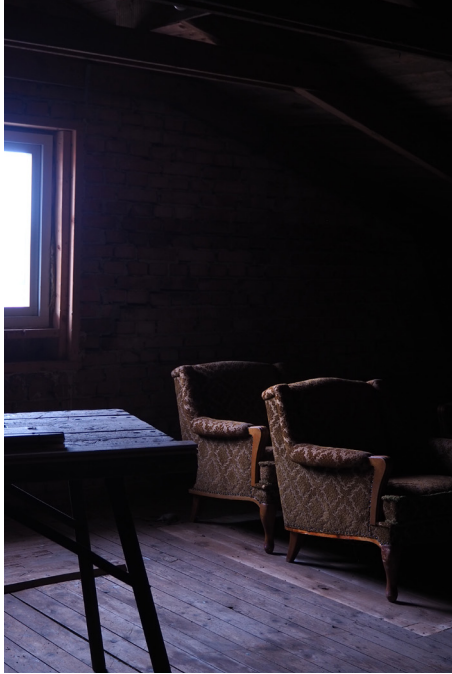
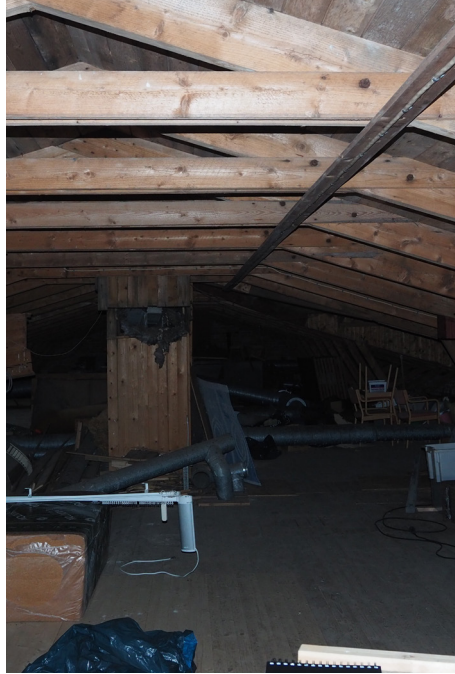
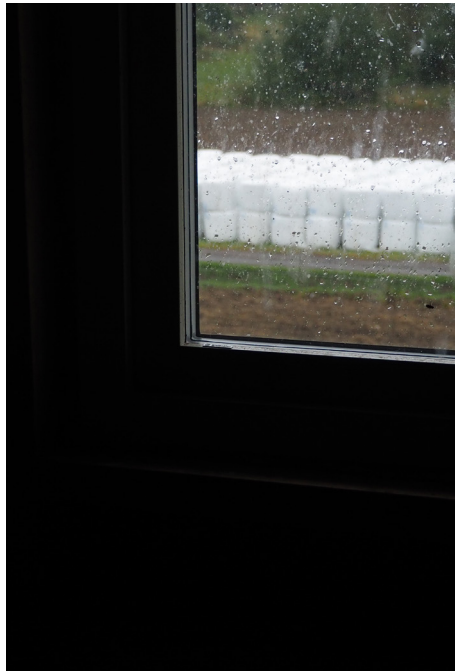
Room 07-01

Minor : cracked paint and dirty space

Reperations: - windows need to be painted and wood to be treated

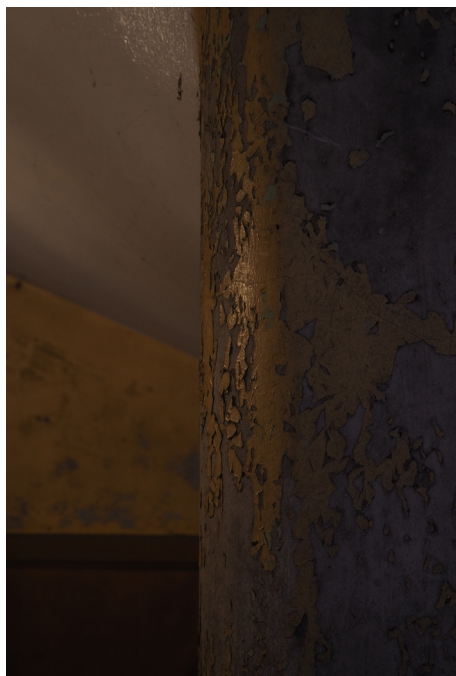
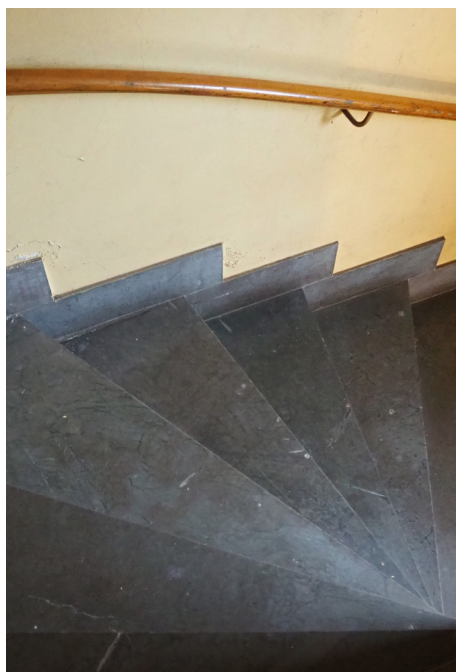
Room 07-02

Major : - huge crack along the gable next to the window (the upper part of the wall is attached to the truss and the lower part is getting pulled down because of the sinking building)
- important water leakage through the roof

Moderate : - missing beams under a part of the floor

Minor : - bare walls, dirty space

Reperations: strengthen the floor
fix the leak

short term actions for the wall/gable : - add mortar to the crack

long term actions for the wall/gable : - stabilise foundations

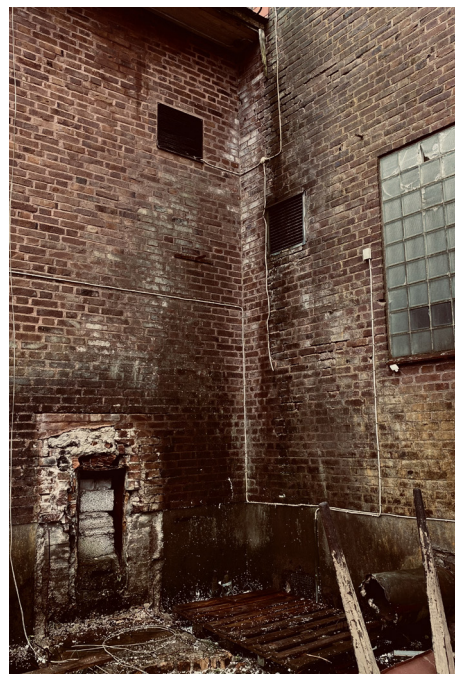
Room 08-03

major: ventilation is partly gone - needs replacement, floor - tiles broken, big holes in floor, very uneven > replace tiles, fill holes, pipes are broken > new pipes

Reperations: new surface layers (walls, ceiling and floor) - new paint, new tiles, floor needs to get replaced > new, replace pipes
long term actions : replace windows/door, new insulation
