CONCERN TO CONSERVE

*Investigating how the transformation of the manager's house at Lyckholms
brewery can provide adaptive reuse and cultural value to its context.*

Christina Dimitriadou

Concern to Conserve
Gothenburg, 2023

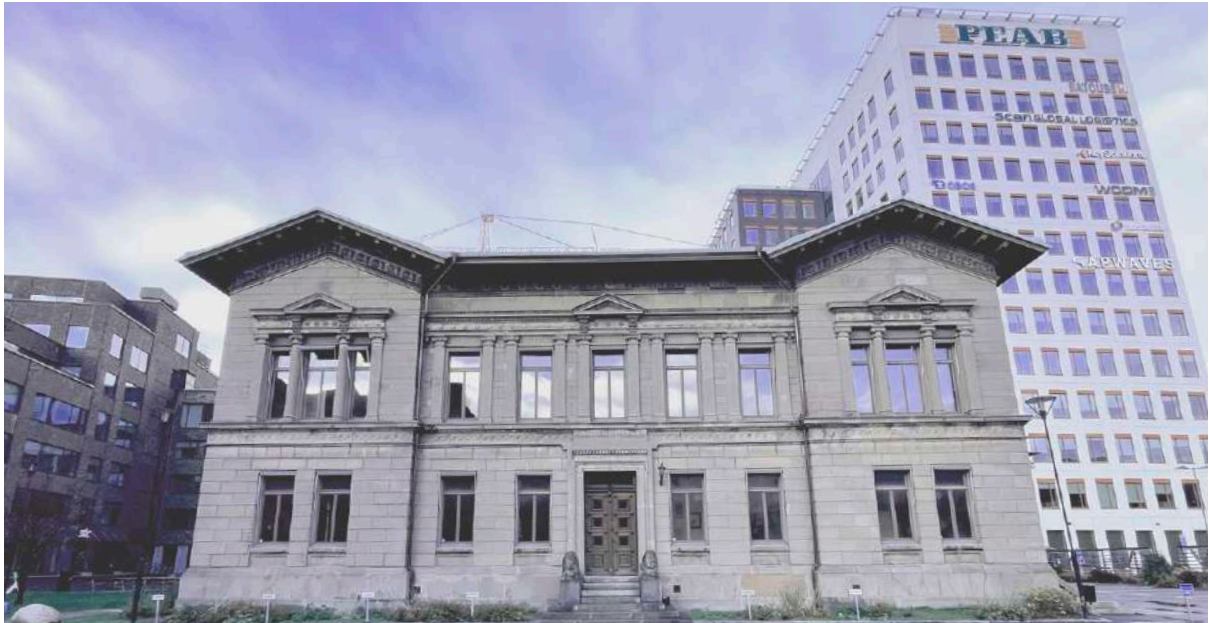
Image 20. South facade with the centered main entrance.

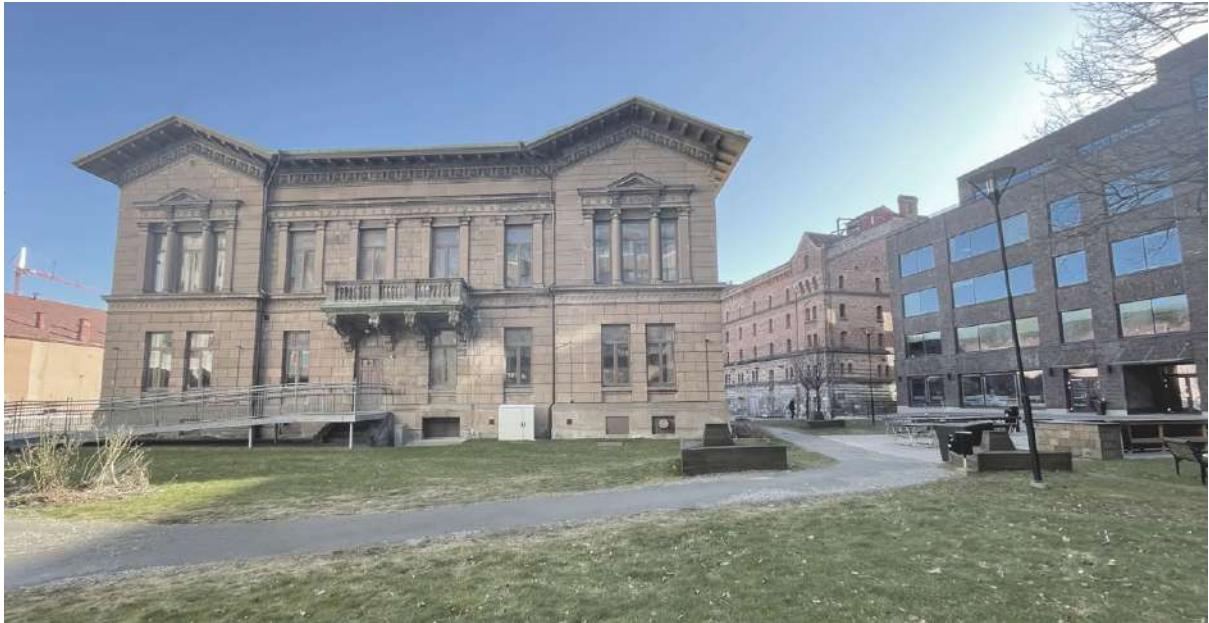
Image 23. North facade with the added ramp.

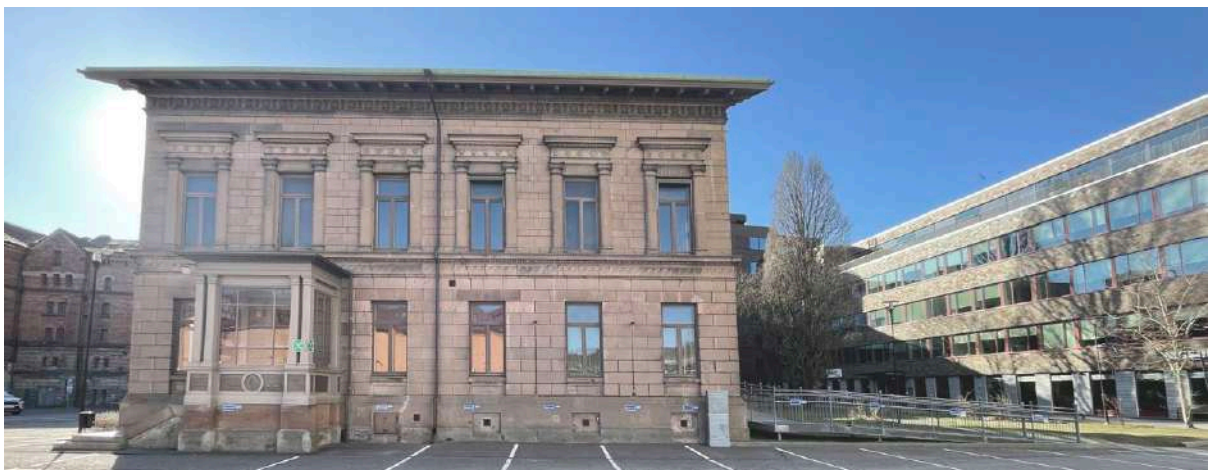
Image 24. East facade with the added ramp.

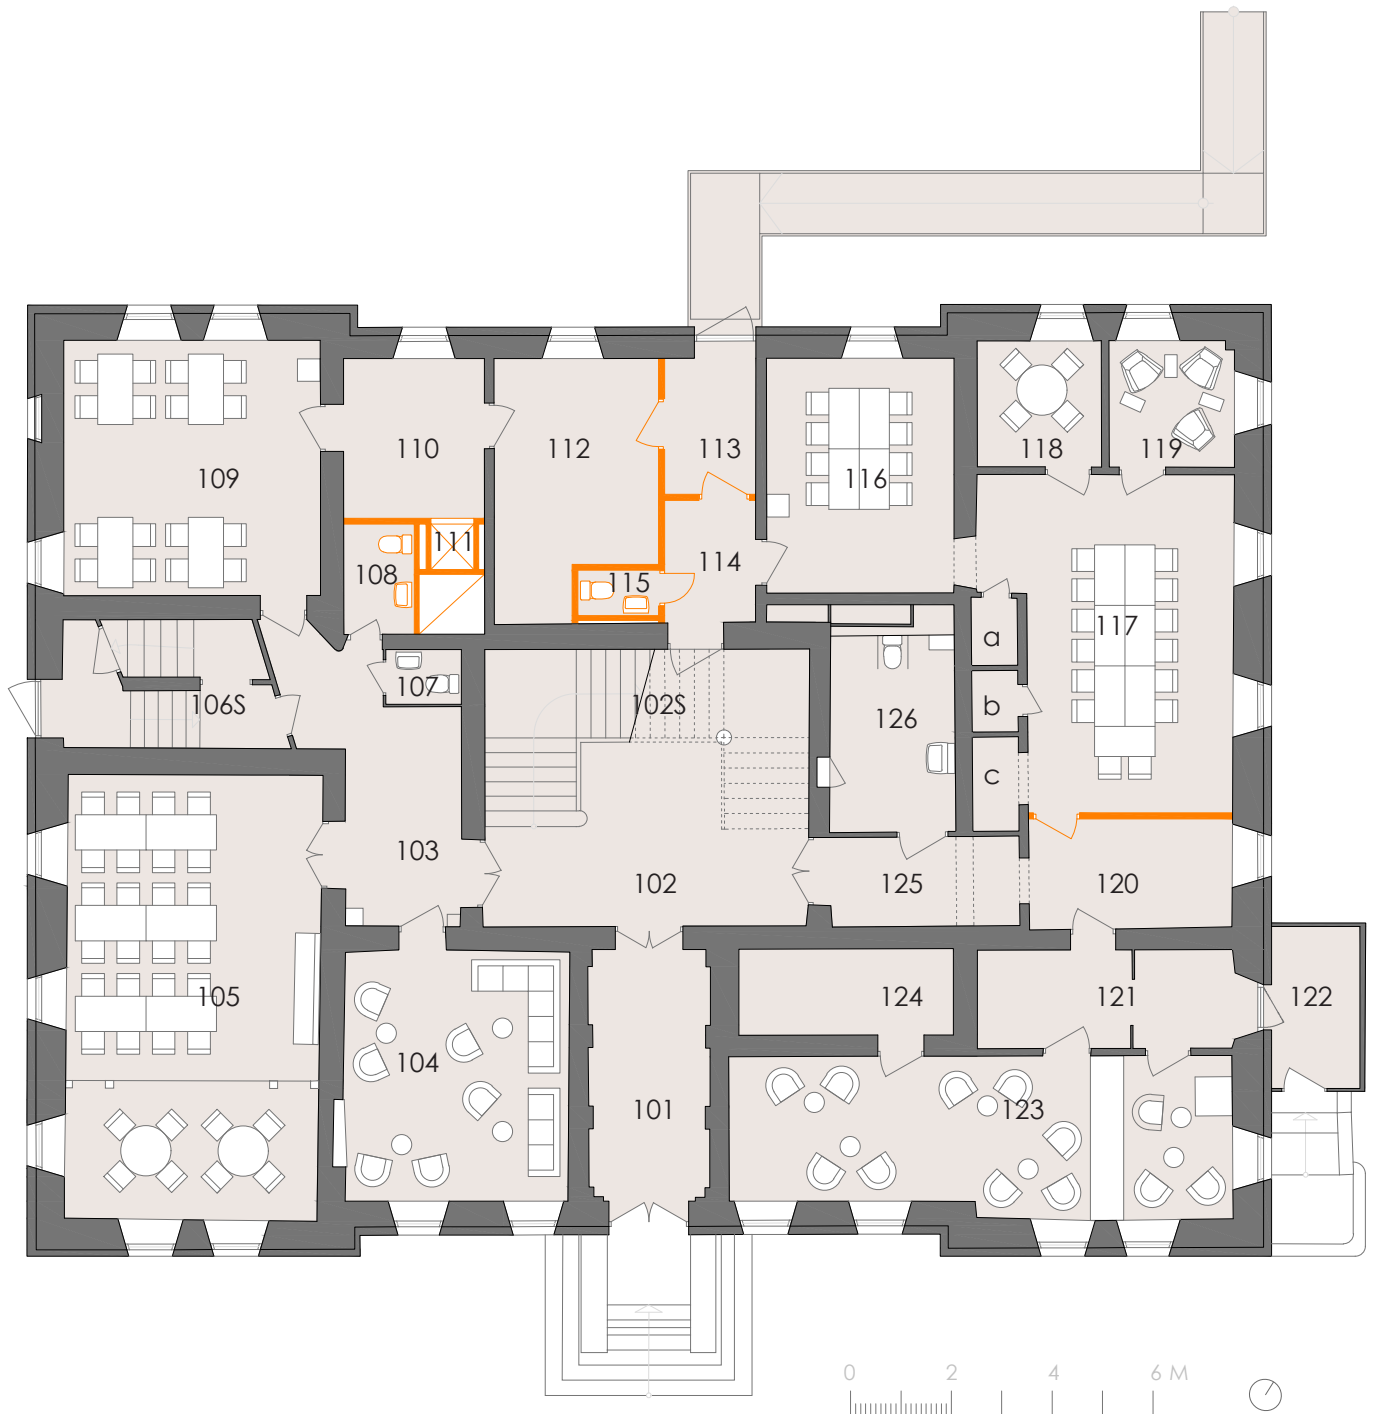
First floor, scale 1:150

Room numbers included by the author, same as in the room description later in this paper.

- Adjustments in 2015
- 101, 113, 122 Entrance
- 102S, 106S Staircase
- 102, 103, 114, 121, 125 Hall
- 104 Lobby
- 105, 109 Dining room
- 107, 108, 114 3 WC
- 111 Food lift

- 110, 112 Preparation room
- 116, 118, 119 Group room
- 117 (a, b, c) Meeting room
- 117a, 117b, 117c Storage
- 120 Passage
- 123 Lobby
- 124 Storage
- 126 RWC

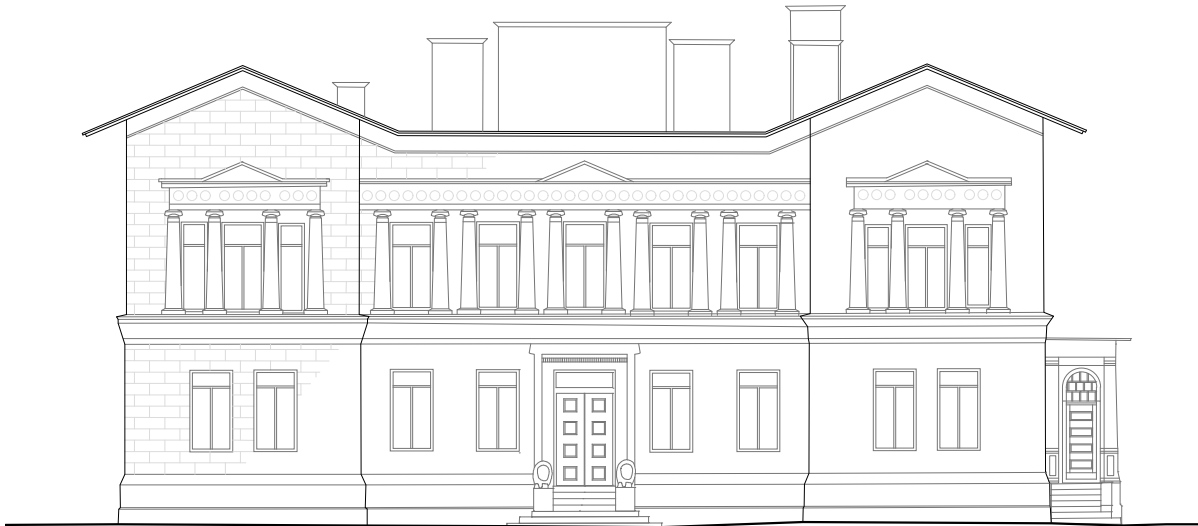
South facade, scale 1:200.

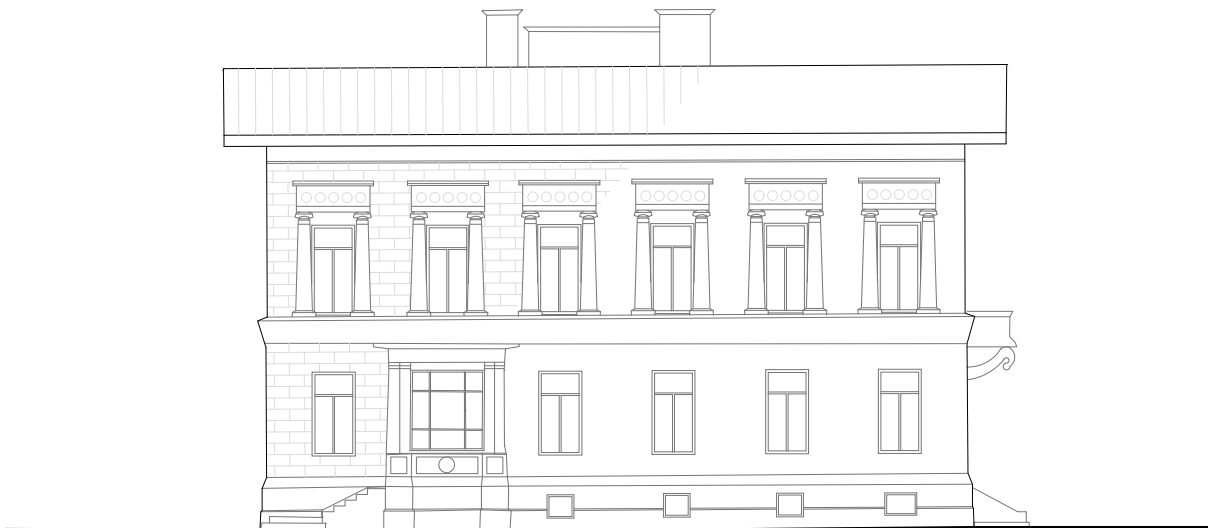
East facade, scale 1:200.

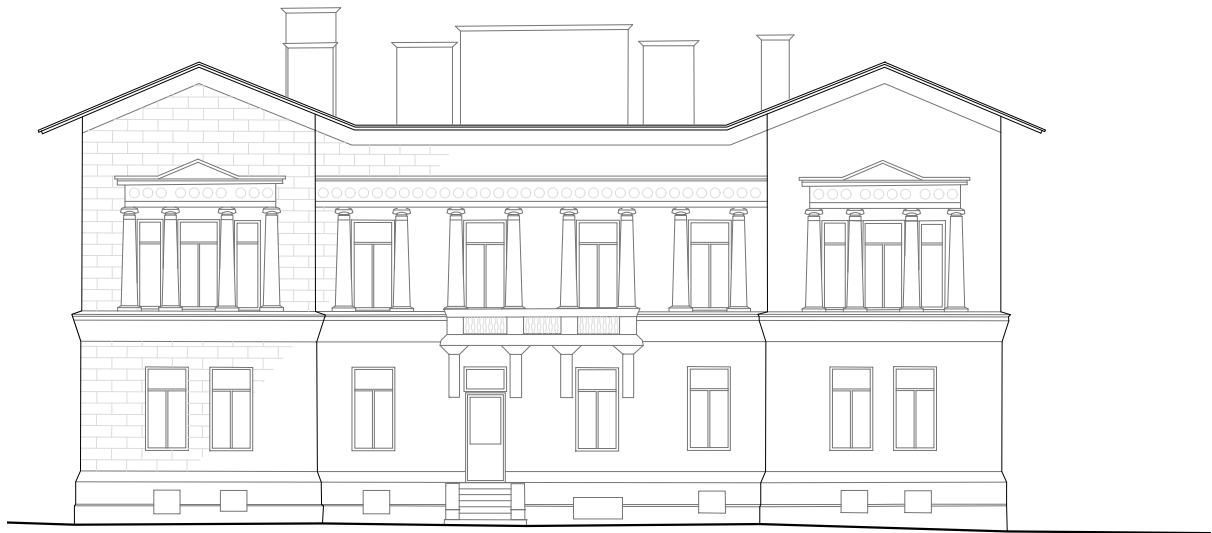
North facade, scale 1:200.

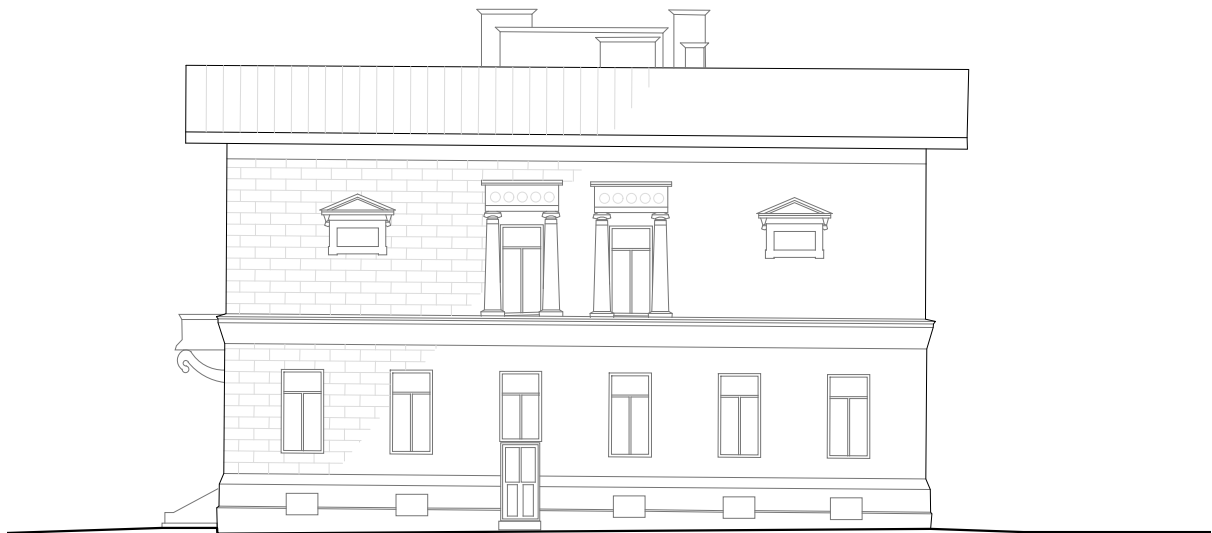
West facade, scale 1:200.

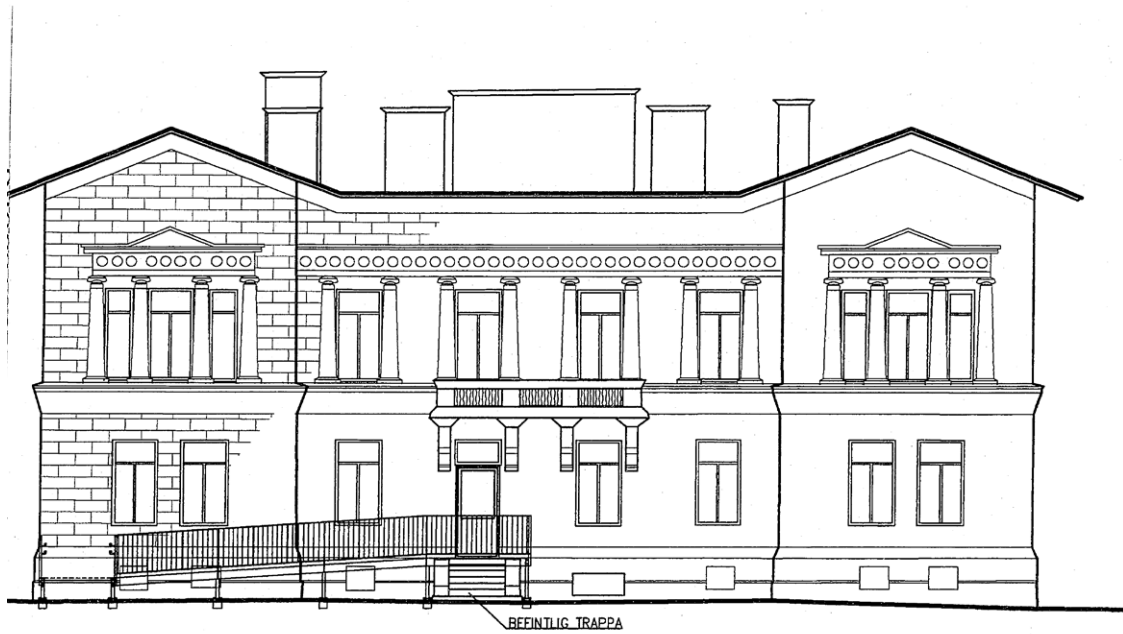
Figure 26. North facade with the addition of the ramp in 2015. (City of Gothenborg, 2023. Retrieved with permission.)

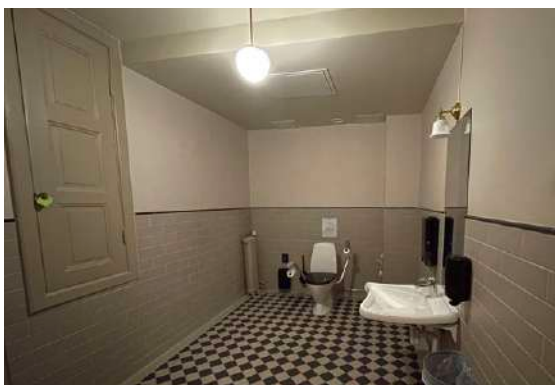
Image 34. The addition of an RWC after the renovation in 2015.

The former use of the room was as kitchenette, and after the intervention it has been transformed into a lavatory for people with disabilities and cleaning storage space. (Antiquum AB, 2015)

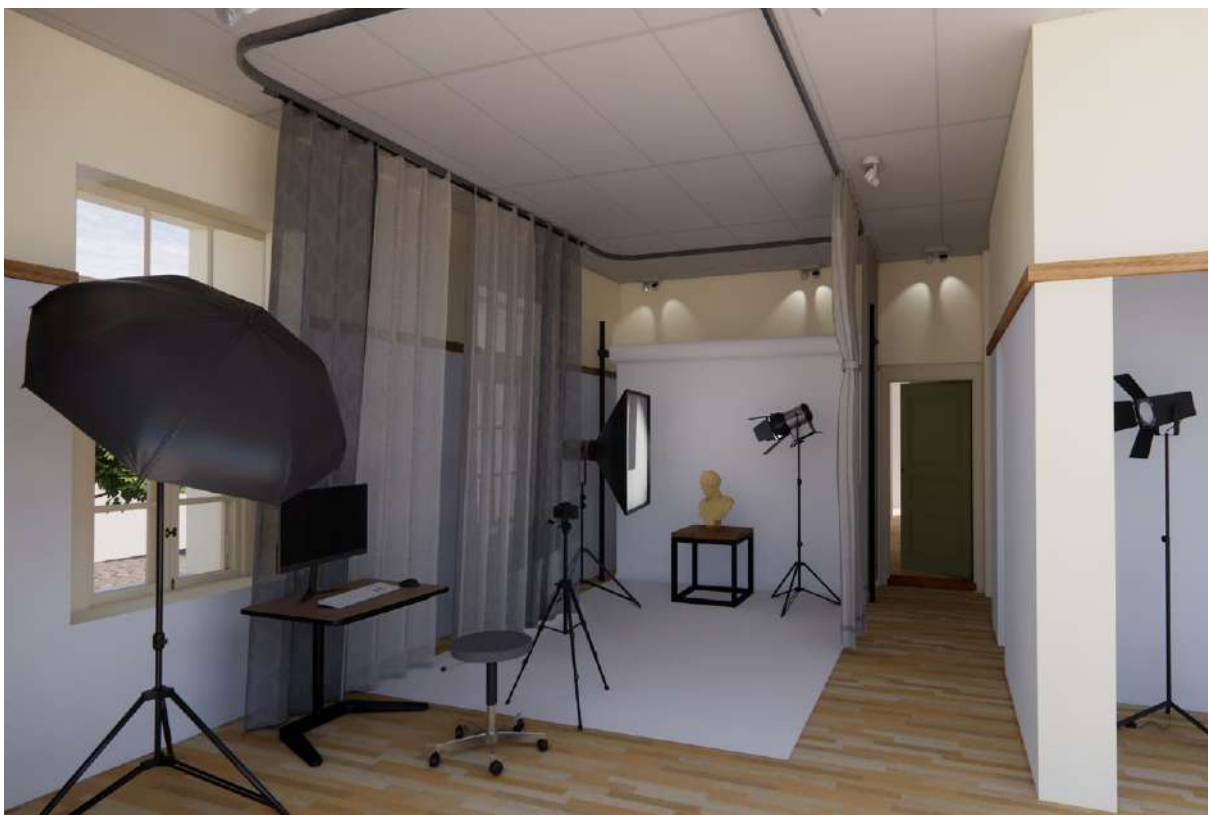
Image 39. Perspective: The photography studio where a curtain rail attached to the ceiling and can be arranged according to the light conditions.

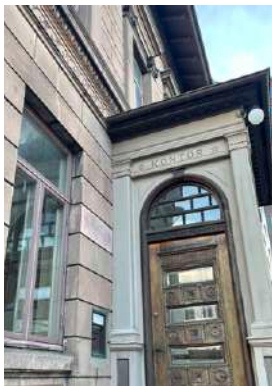
Image 40. The added entrance in the east in 1924.

The addition of this volume on the east side was made due to the transformation of the building into an office when a separate entrance was needed. It is of high cultural-historical value due to the fact that many parts of the addition such

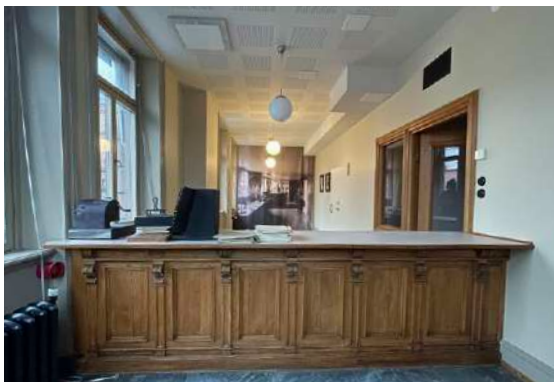
Image 42. The accounting cashier's office.

The accounting cashier's office was rebuilt in the 1920s to facilitate the expansion of the factory. Of a cultural-historical value due to the maintained initial layout, interior oak doors with carved decor and glass, original coffered vaults, the cast iron radia-

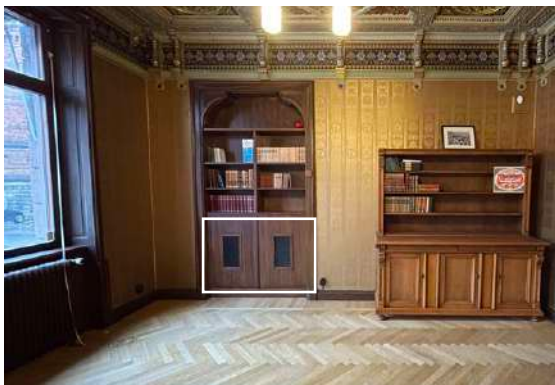
Image 44. West wall, with the hidden ventilation in the built-in wooden bookshelves. (white rectangle).

The renovation carried out in 2014-15, was very innovative as they installed hidden ventilation in the existing built-in bookshelves. This method has affected the room in a positive sense and has improved its potential. Nevertheless, it is imperative to avoid drilling holes in the floor joists.

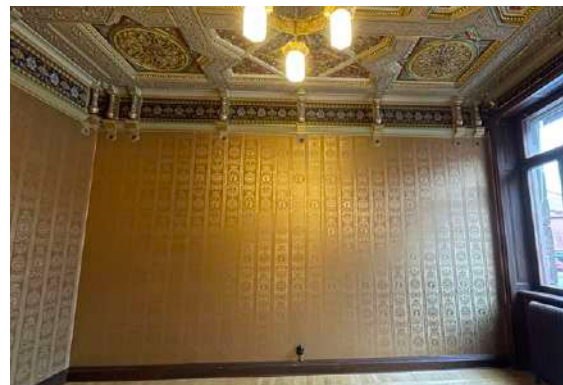
Image 45. East wall, illustrating the gold en wallpaper, and the ceiling with decoration.

There is gold-patterned wallpaper around the room with this element imparting a majestic atmosphere. There were found some remnants of wallpaper rolls in the attic, proving it is not the original paper but a later intervention.

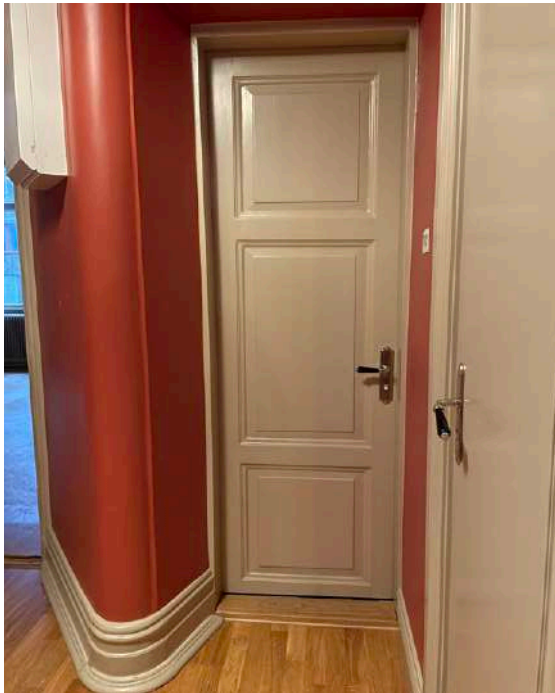
Image 49. The hall on the west side, a perspective outside the washing room with the repaired original doors.

The hall's function is to connect the staircase, billiards room, parlor, work-space, and wash room. The floor has been repaired, and a new Pompeian red color has been applied to the walls.

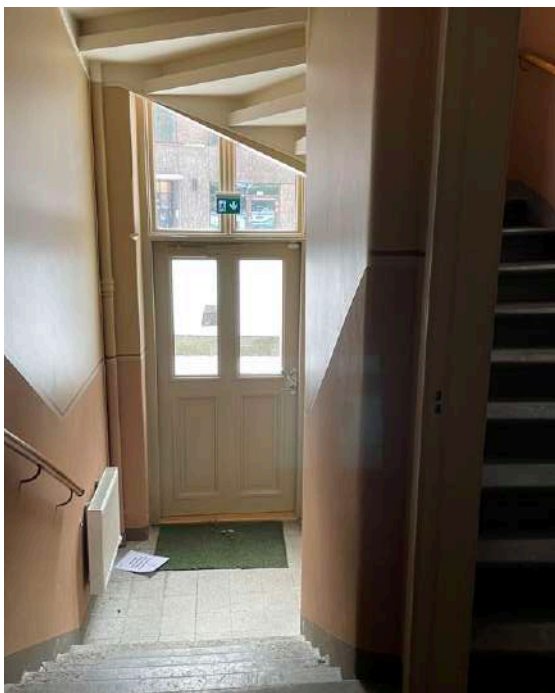
Number: 106S

Image 50. The west entrance connects the cellar, 1st floor, 2nd floor, and attic.

Type: Kitchen staircase
Proposal: Stairs with auxiliary use.

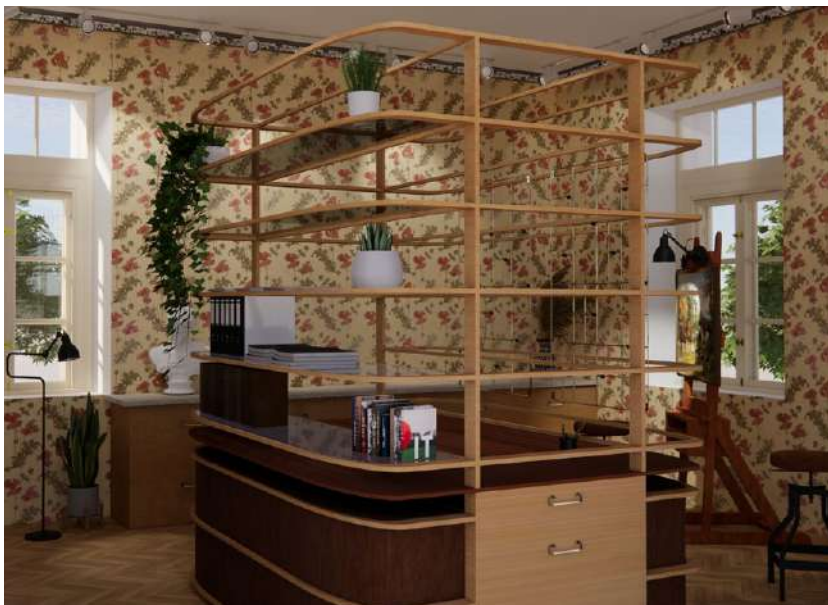
Image 52. Perspective: Room 109, with the addition of multifunctional furniture, that can be used for storage, bookshelves, working space for one conservator, and hanging grid for notes. The furniture has been placed in the center to achieve circulation in the room and preserve the walls in their current condition.

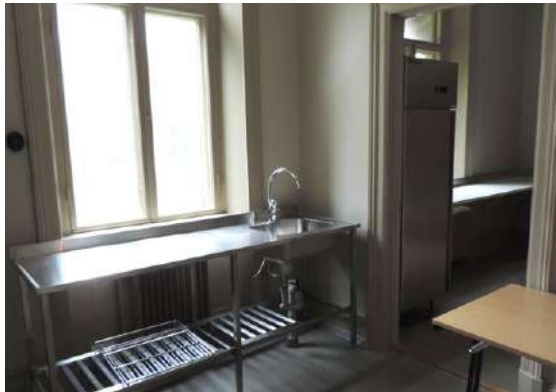
The kitchen is of lesser cultural-historical value in comparison with the other rooms. For the new use of the building as a conference venue, a dining room was needed with a food lift, this was the space that

could accommodate technical installations. Furthermore, two extra restrooms were added, one at the west entrance and the other at the north entrance.

Image 53. The kitchen and the preparation room.

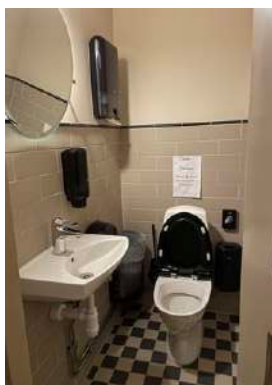
The entrance to the north has lower cultural-historical value and for this reason a pantry and an extra lavatory were created with walls added. The whole space has been remodeled and the hall is narrower than before the renovation in 2014-15.

Image 54. The extra restroom.

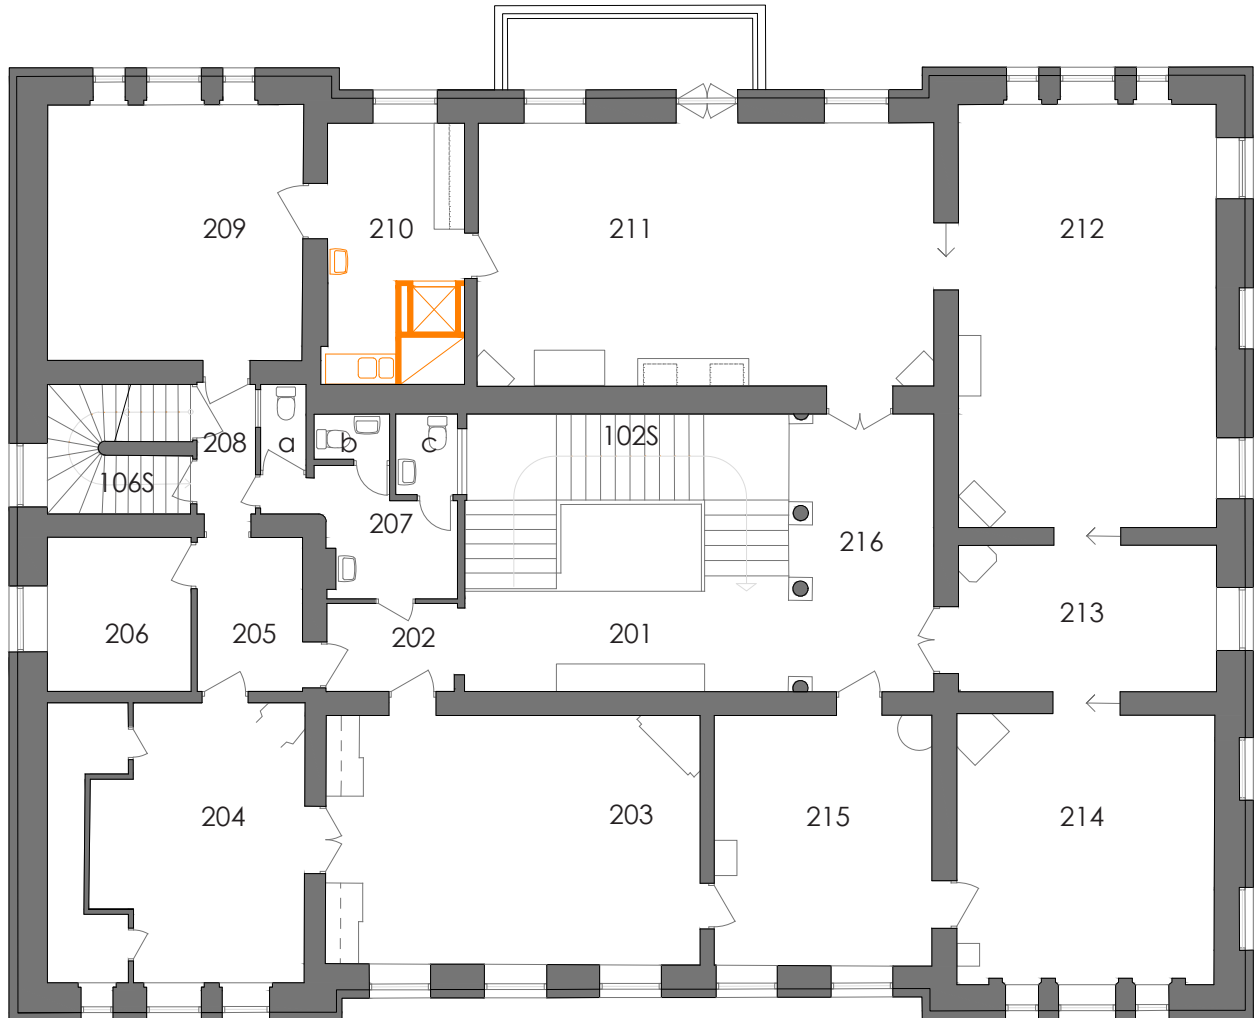
Second floor, Scale 1:150

Room numbers included by the author, same as in the room description later in this paper.

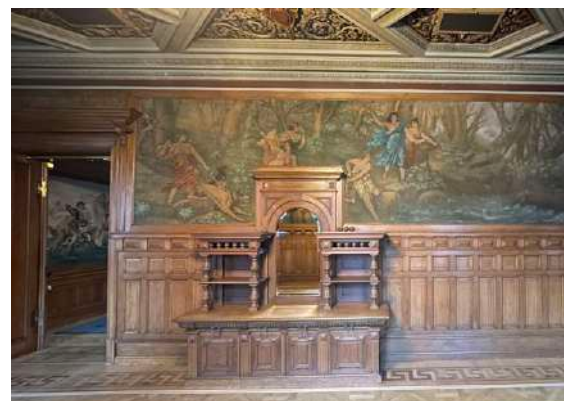
Image 59. The joinery, oak wall panels, and an original piece of furniture.

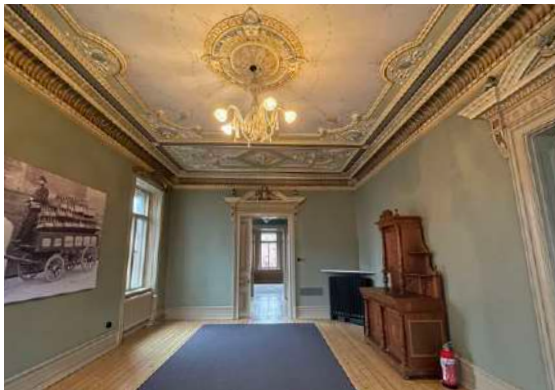
Floor: 2 Number: 212
Size: 43 sqm

The drawing room is defined as a room in which guests can be received and entertained. The room is very well preserved and has a high cultural-historical value featuring painted pediments and a decoratively painted ceiling.

It features an oak wood floor and ventilation as installed in the other rooms, in the existing furniture.

Image 60. The drawing room.

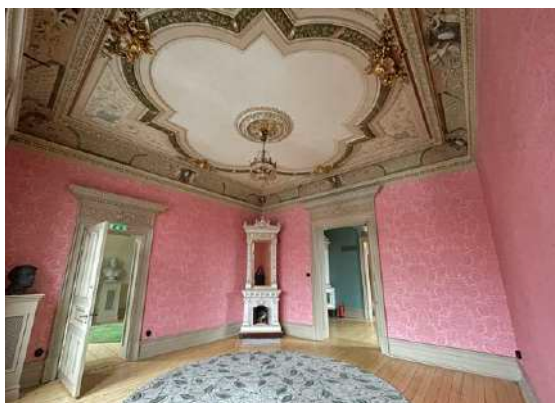
The living room is well preserved of very high cultural-historical value. It also features a new wooden floor, a conserved decoratively painted ceiling, and a white

tiled fireplace. The pink wallpaper is not original but a latter modification to the room.

Image 61. The living room with the fireplace and the pink wallpaper.

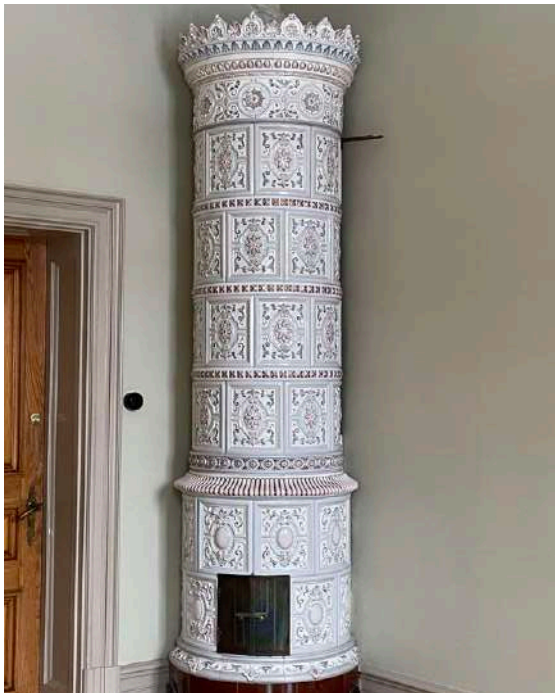
The living room is well preserved and of high cultural-historical value. This room features the only round tiled fireplace.

Image 62. The round tiled fireplace.

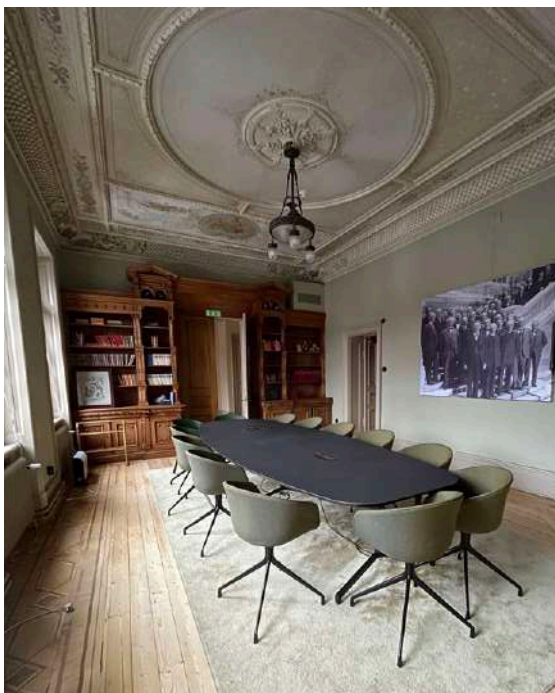
This library is a room with high cultural-historical value as the wooden bookshelves in oak are original and well-preserved. The wooden floor and the painted ceiling with decorations have been conserved during the renovation.

Image 63. The library.

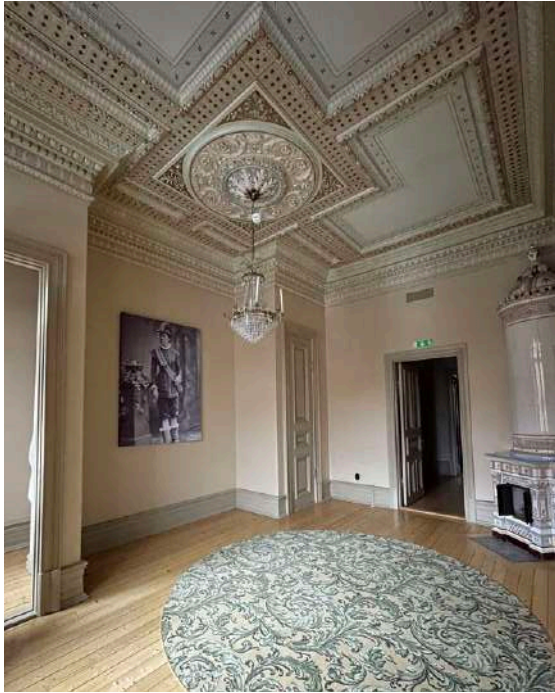
Floor: 2 Number: 204
Size: bedroom + wardrobe =
21,18 + 6,52 = 28 sqm

Image 64. The bedroom with a fireplace and the two ways round garderobe.

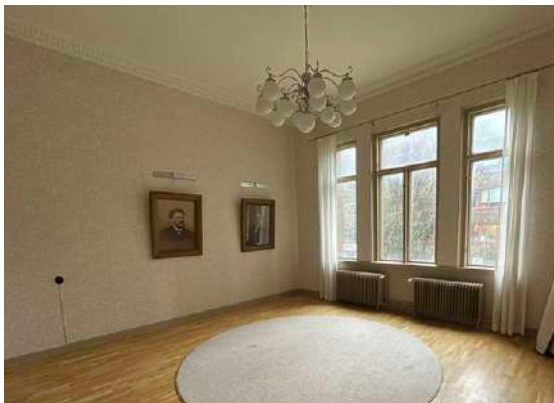
Previously a kitchen this room had an auxiliary purpose in the operation of the building following reconstruction. It is of medium cultural-historical value and this increases its potential for use reiteration in line with the needs of any new function.

Image 65. Corner room.

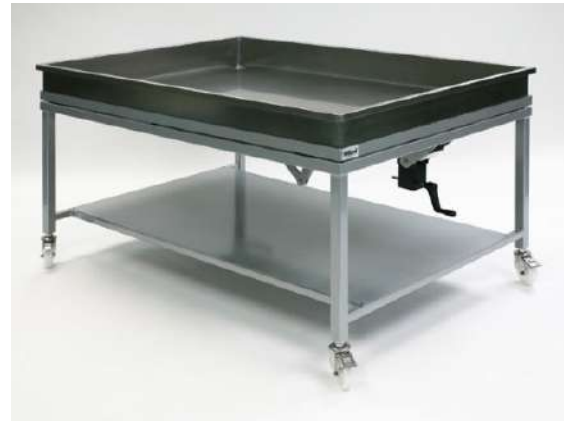
Image 67. Laboratory sink with height adjustment mechanism.

The conservation lab space demands space larger than that of an ordinary office since the workspace hosts artworks of high cultural value and various sizes, particular tools and equipment and the users are required to adhere to the safety requirements.

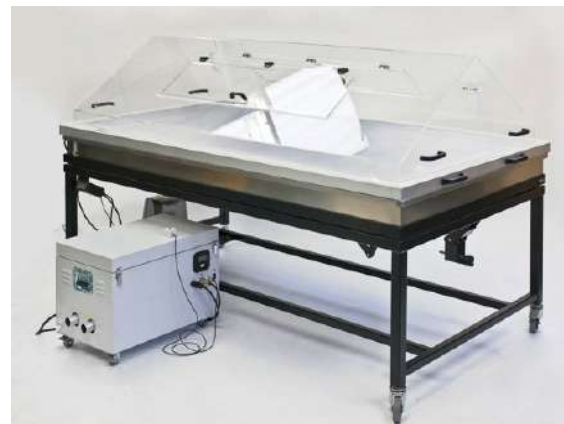
Image 68. Paper conservation vacuum table.

- Image 68. Willard. (2017). Retrieved from <https://www.willard.co.uk/post/conservation-washing-equipment-laboratory-sinks-suction-cleaning-more>

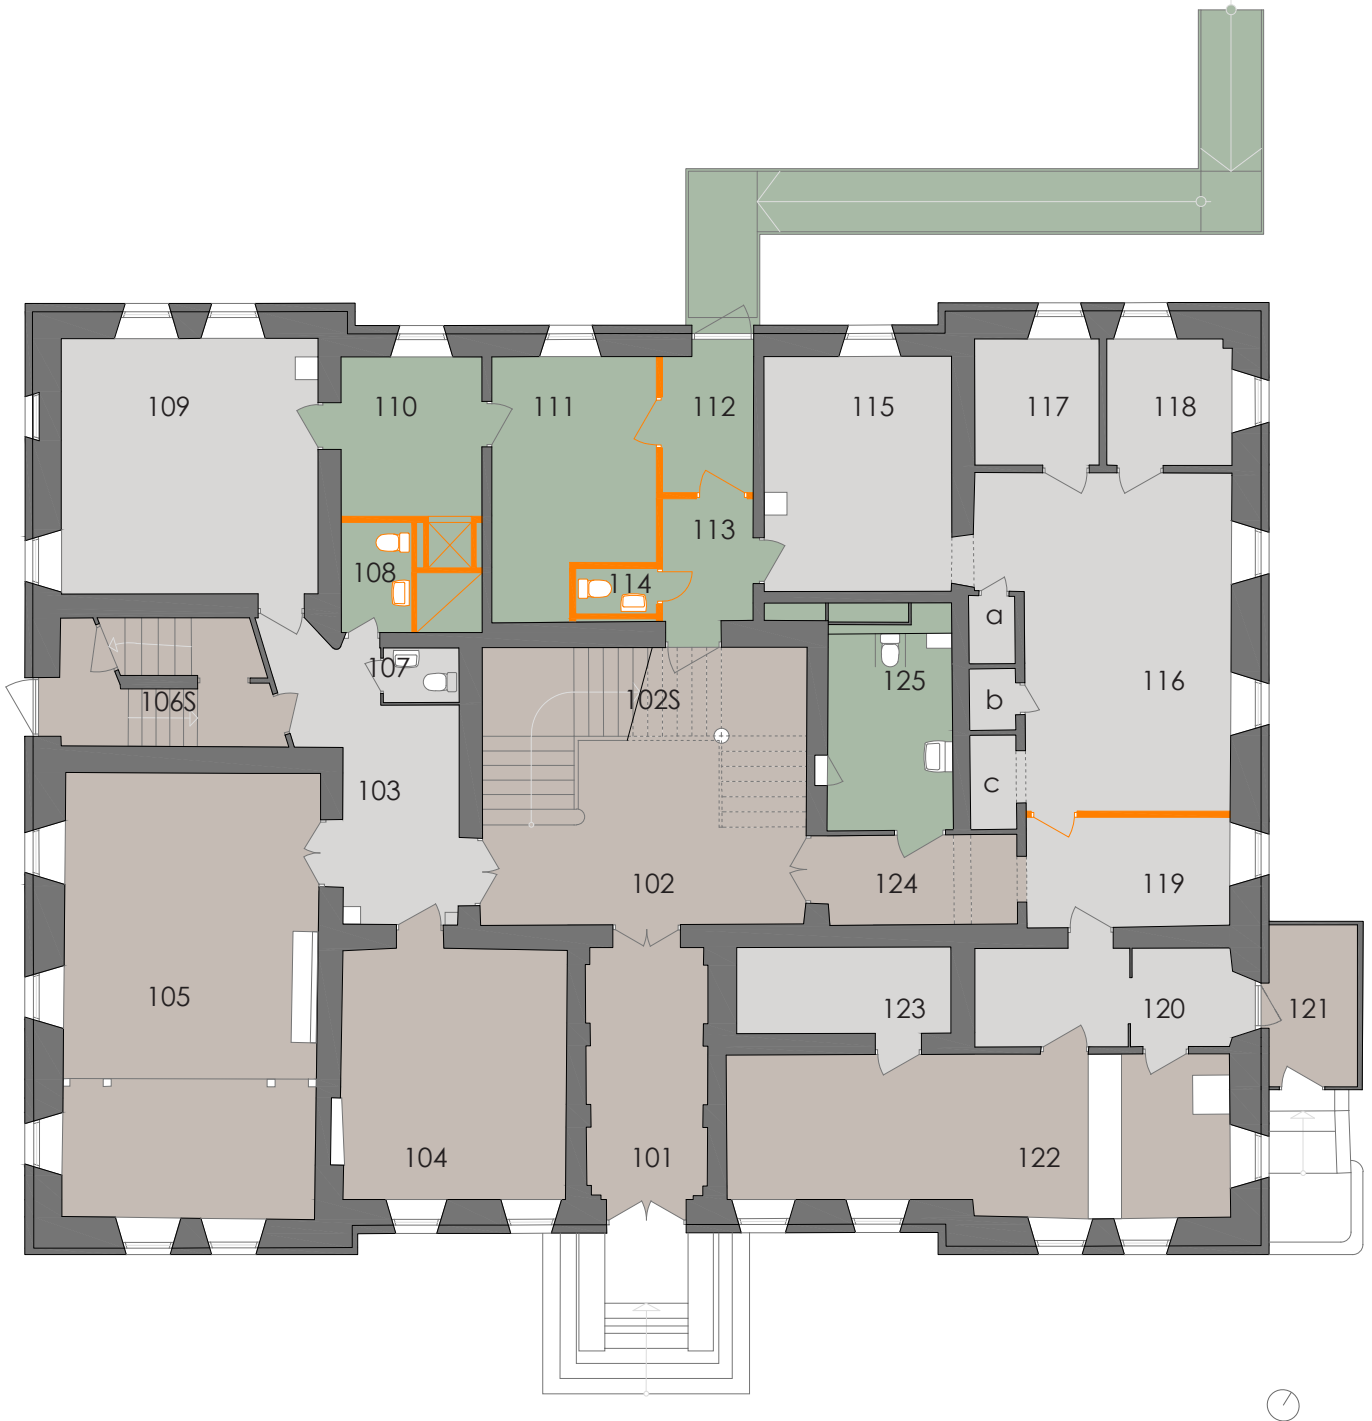
First floor, Scale 1:150

- Added wall 2015
- Untouchable/Original room
- Room that have been changed
- New rooms that have been created

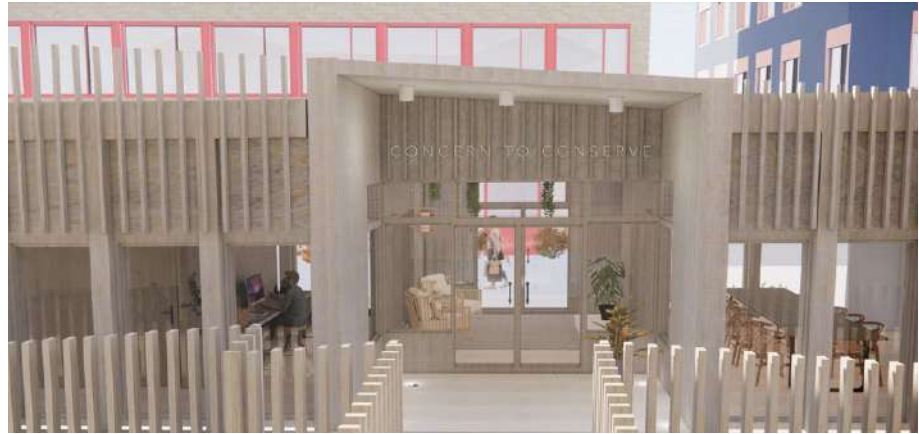
Image 80. Perspective: Scene from the ramp that connects the existing building with the "Concern to conserve studio".

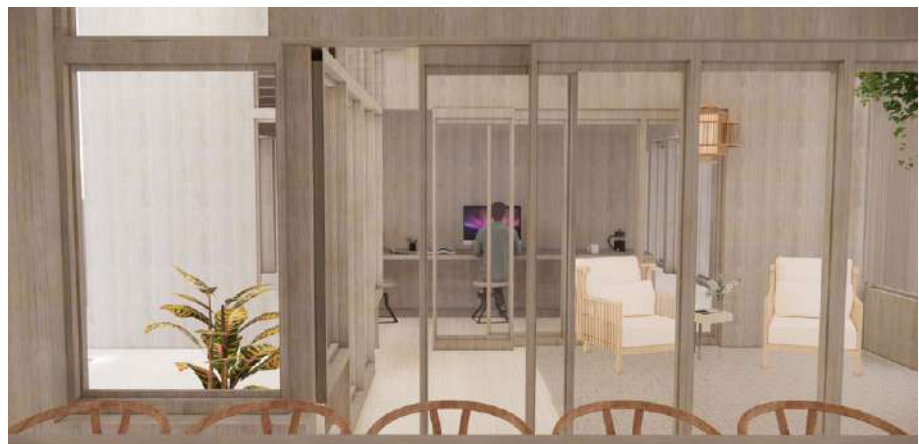
Image 81. Perspective: Scene from the studio's kitchen to the entrance foyer. In the background, there is the reading corner.

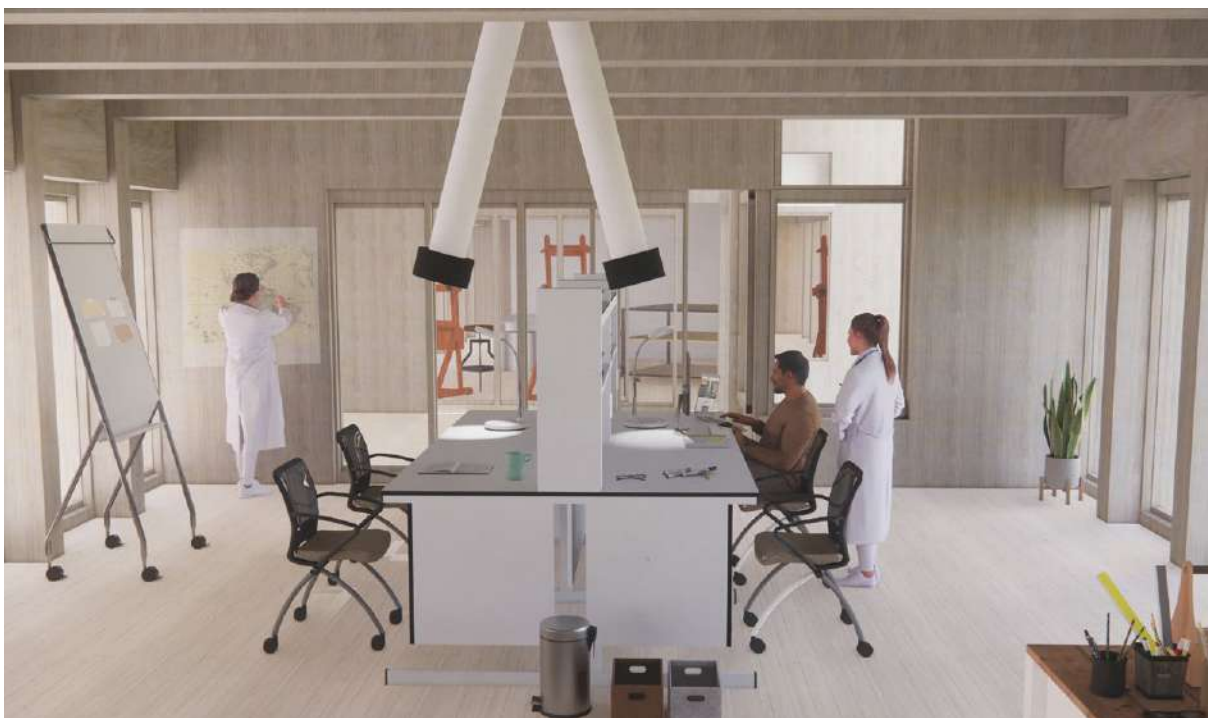
Image 82. Perspective: Scene from the section of the paper conservation where the fume extractors are placed in the inner ceiling.

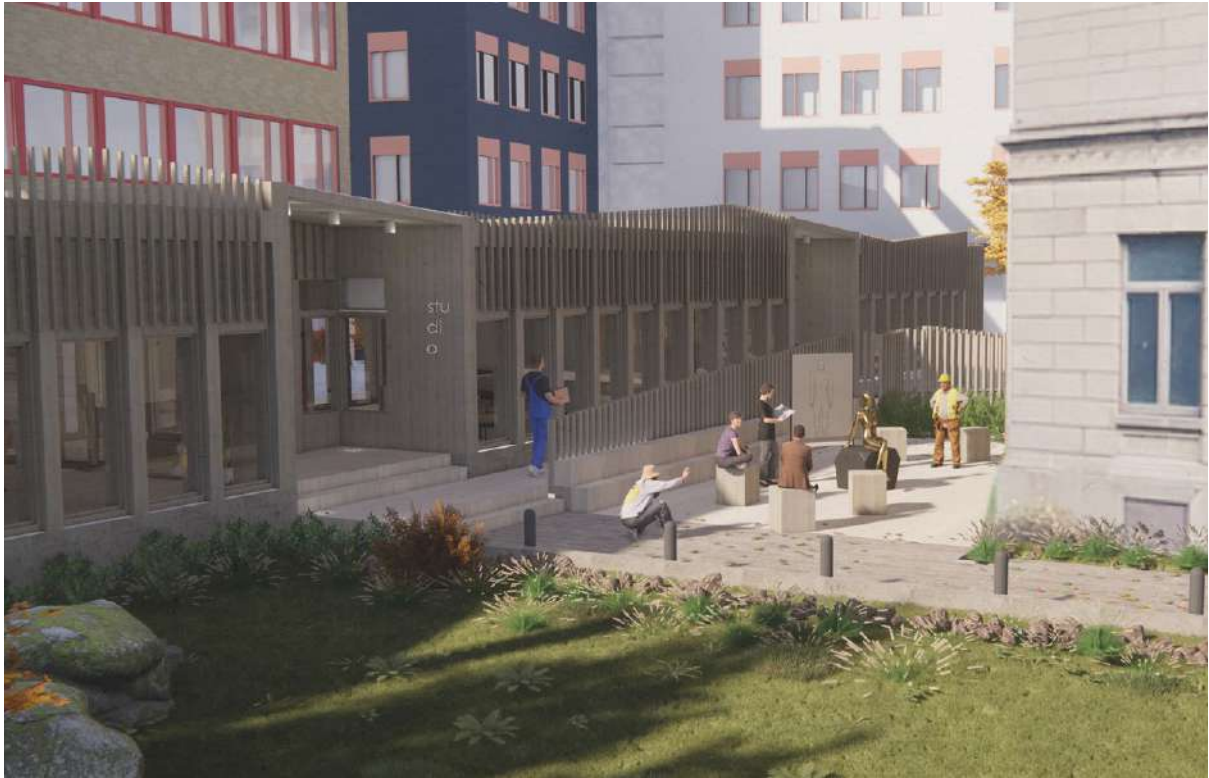
Image 83. Perspective: Outdoor space where there is the path where leads to the section of the paper conservation and to the main entrance from the west side.

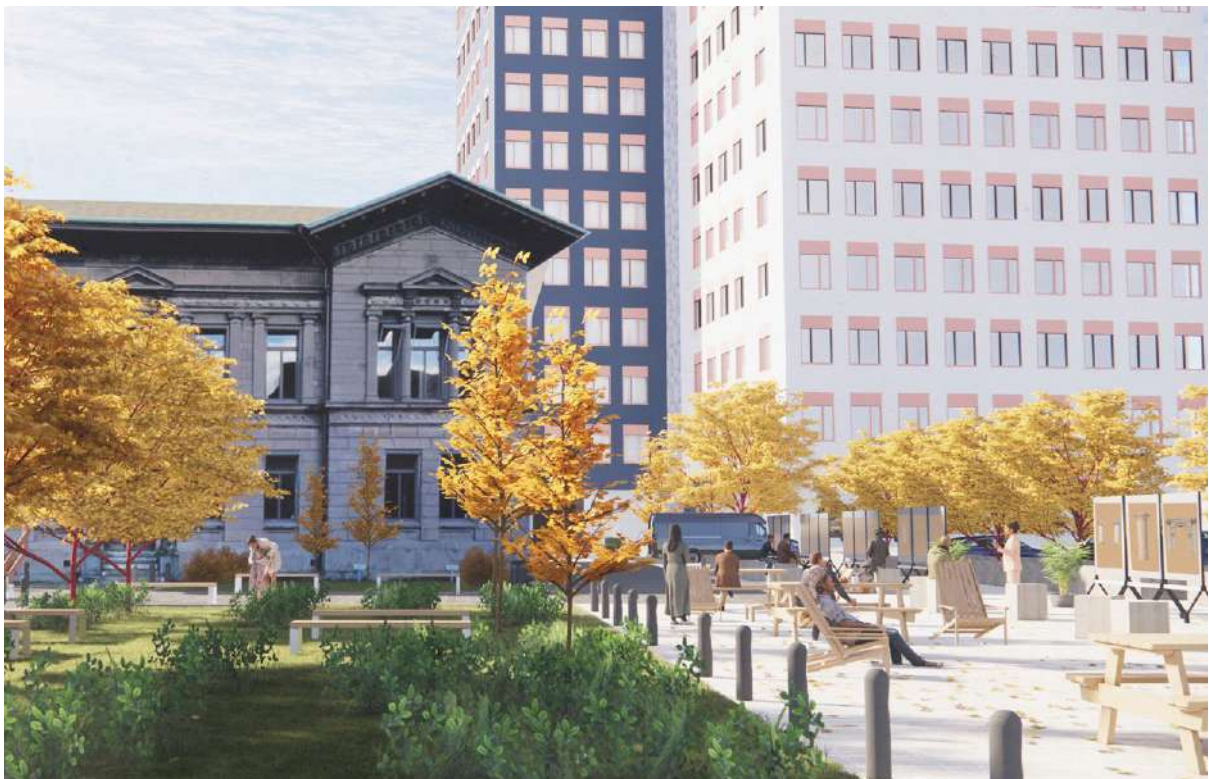
Image 84. Perspective: The scene depicts the new outdoor space and the exhibition space.
