# TRANSFORMATION AS A REFLECTION OF TIME

A study of building transformations in Bräcke småstugeområde

Master's Thesis

Chalmers University of Technology

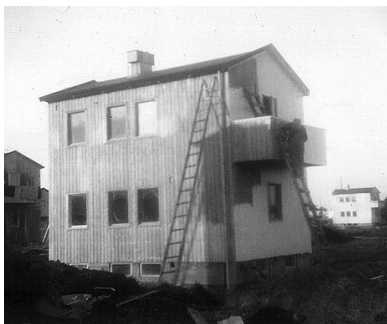
Figure 2.12  
Facade of building type A  
(Bräcke småstugeförening, 1934)

Bräcke had three different types of homes. Costs were kept low by mass production. The Type I house was the most basic, having just one floor and a basement. At first, the standard was straightforward. The toilet and bathtub were both located in the basement’s laundry room. The various house types were based on various family sizes. (Brink & Mayer, 2022)

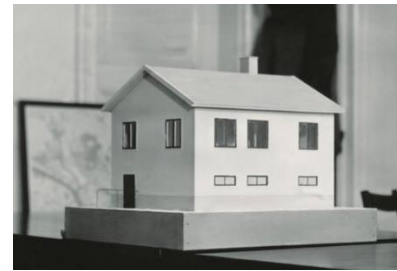
The prefabricated house components were delivered and put together quickly. They were built, and because of their functionalist modern architecture and all-white exteriors, they were called “sugar boxes.” Everything designed to be functional. The kitchen had to be small; nothing else was to be done in this space other than prepare food.

Figure 2.13  
The physical model of sugar boxes  
(© Egnahemsbolaget, 1934)

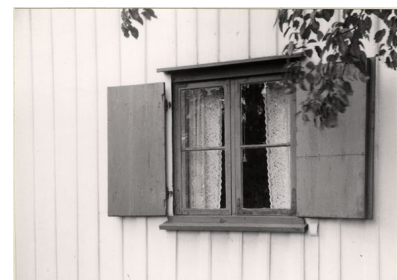
Figure 2.14  
The windows shape  
(© GhmD\_16984, 1940)

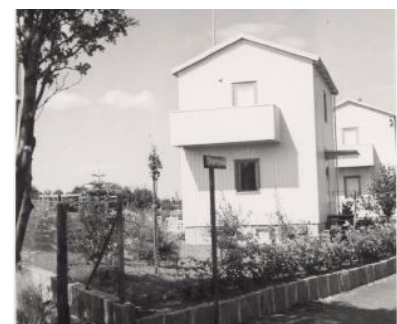
Figure 2.16  
Type A buildings  
(© GMA:9980:33. 1934)

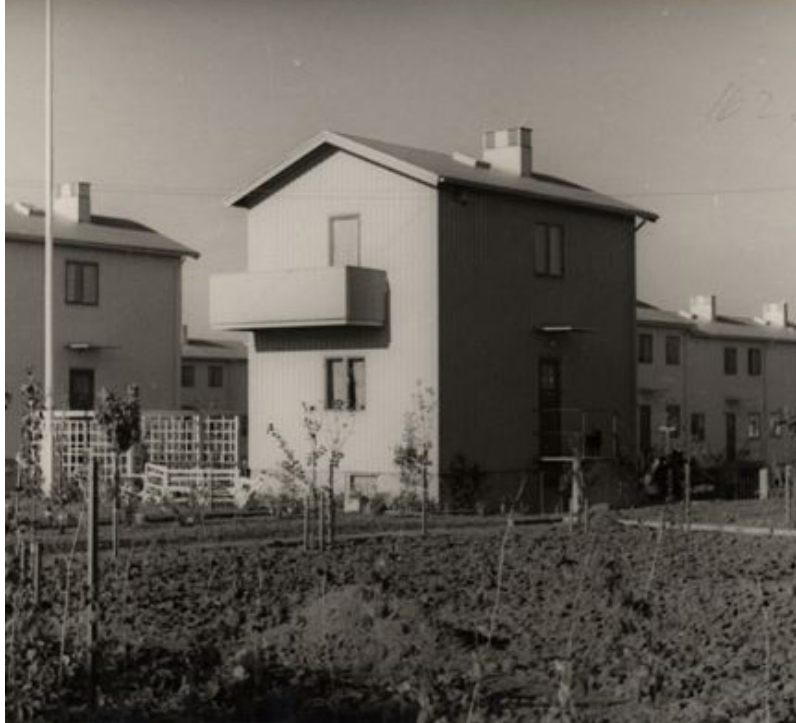
Figure 2.18 Type A building  
(© Thulin, O. 1937)

It was assumed during the planning phase that type A houses would have a minimum of three rooms and a kitchen, with a housing cost not exceeding SEK 65 to 70 per month. The original design included a bathtub, laundry room and WC located in the basement, no hot water, no refrigerator. The total construction cost was approximately SEK 11,280, with land cost at SEK 3,000. (Tengberg, 2020)

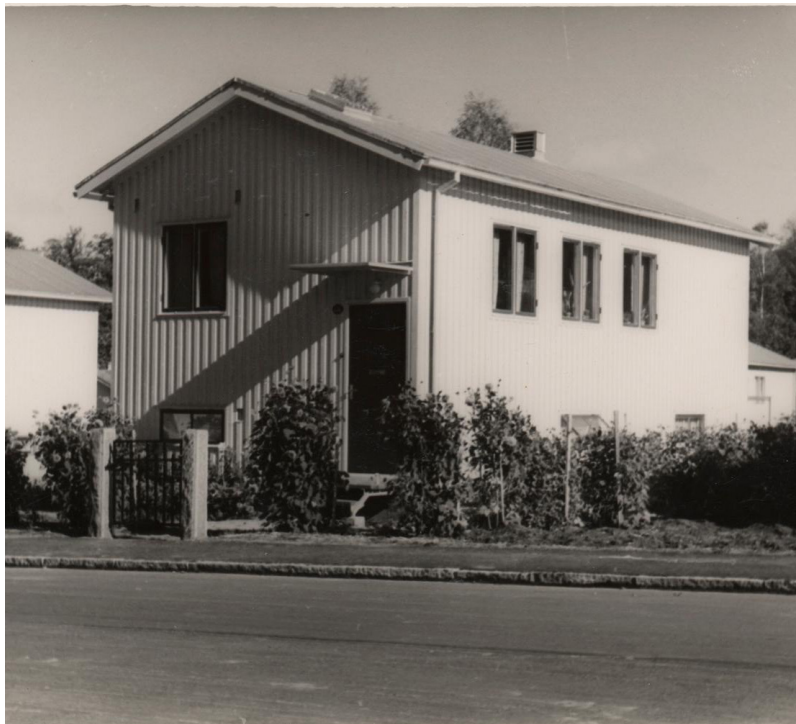
Figure 2.19 Type B building  
(© Thulin, O. 1937)

The construction cost was around 9.560sek and the land cost was 3,000sek. (Tengberg, 2020)

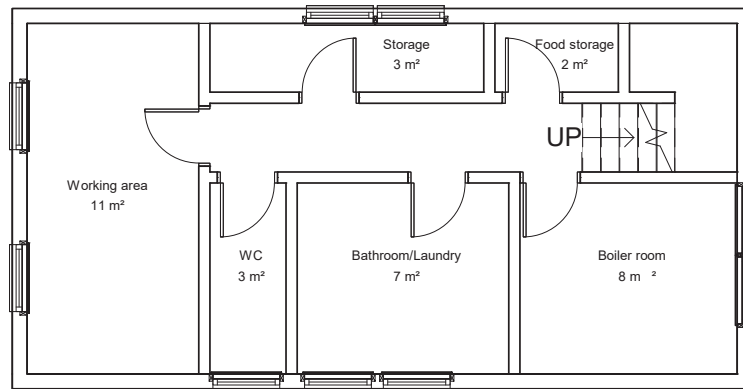
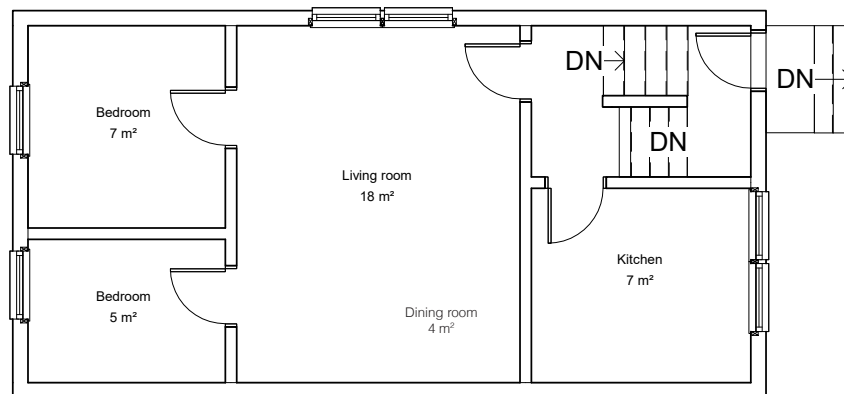
TYPE B FLOOR PLAN

The floor area of a building of type B is 46 m<sup>2</sup>, and it has two floors without a basement. It doesn't have a balcony. The ground floor is where the storage area, laundry room, and drying room are located and the first level serves as the kitchen, living room, and two bedrooms. (Informationsmaterial Stadsbyggnadskontoret, 2021)

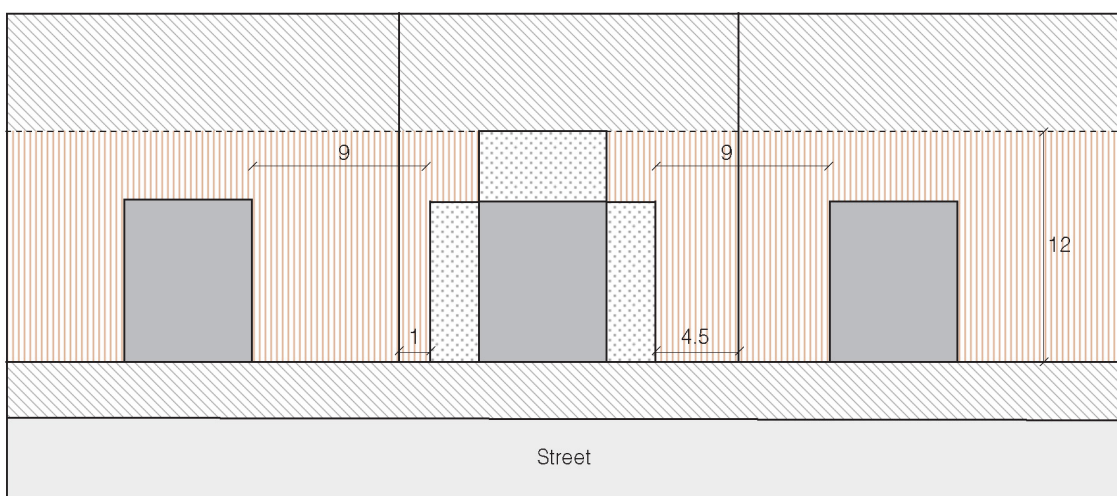
Figure 2.20 Detail plan of the neighbourhood of Bräcke  
( © Bräcke, Sävenäs och Utby, 2021)

- The Permitted building height is 7 m.
- Maximum number of floors is 2.
- Windows for living rooms may not be built on facade less than 4.5 meters from the border with neighboring property.
- In case of the extension the minimum distance between the building and the neighbours should always remain 9 meters.
- Depends on the position of the original buildings, there should always be a distance to the side borders of the site. (Informationsmaterial Stadsbyggnadskontoret, 2021)

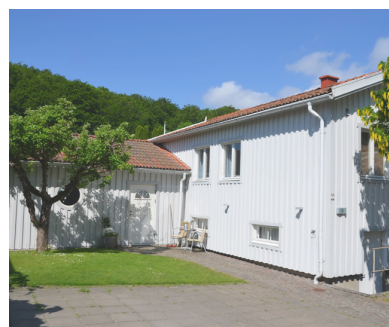
Extensions should be added towards the garden and not with facade which is facing the street to maintain the character of the street.

Figure 2.22  
Extension from the sides  
(© Bräcke, Sävenäs och Utby, 2021)

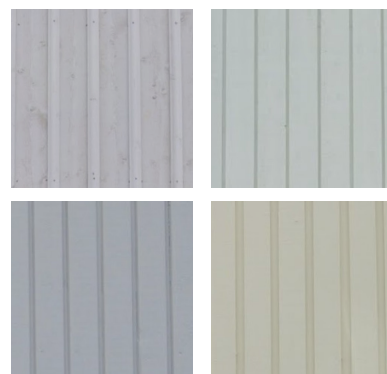
The choice of facade material, color, and roof design must be coordinated with the design of the area and the whole neighbourhood. The overall impression depends on the coloring, which should keep the same saturation level, or brightness level, as the original house. Light gray and light yellow are suitable hues, while a dark color like black severely violates the area's character. (Informationsmaterial Stadsbyggnadskontoret, 2021)

Figure 2.23  
Allowed colours and materials  
(© Bräcke, Sävenäs och Utby, 2021)

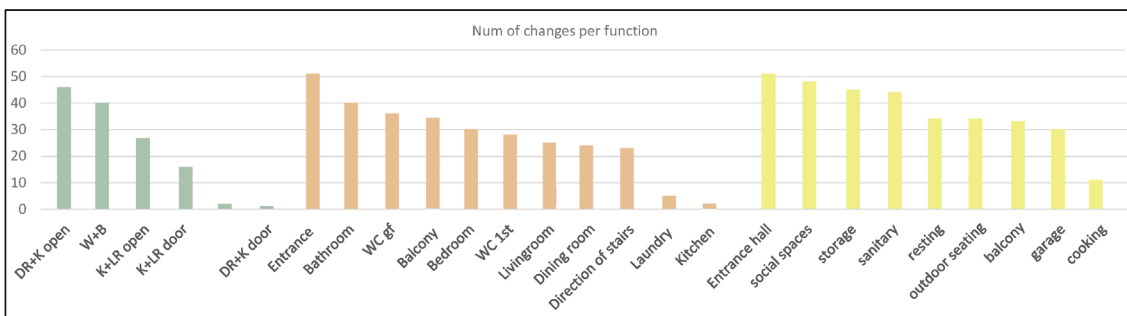
Merging two rooms into one					Moving functions										Enlargement									
W+B	DR+K		K+LR		Kitchen	Livingroom	Bedroom	Balcony	WC		Bathroom	Laundry	Entrance	Direction of stairs	Dining room	Living room	bedroom	outdoor		kitchen	garage	WC/bathroom	storage	Entrance hall
	door	no wall	door	no wall					gf	1st								balcony	seating					
40	1	46	18	27	2	25	30	35	36	28	40	5	51	23	24	48	34	33	34	11	30	44	45	51

The analysis shows that residents of these buildings were actively involved in adapting their homes to meet their evolving needs and preferences over the time.

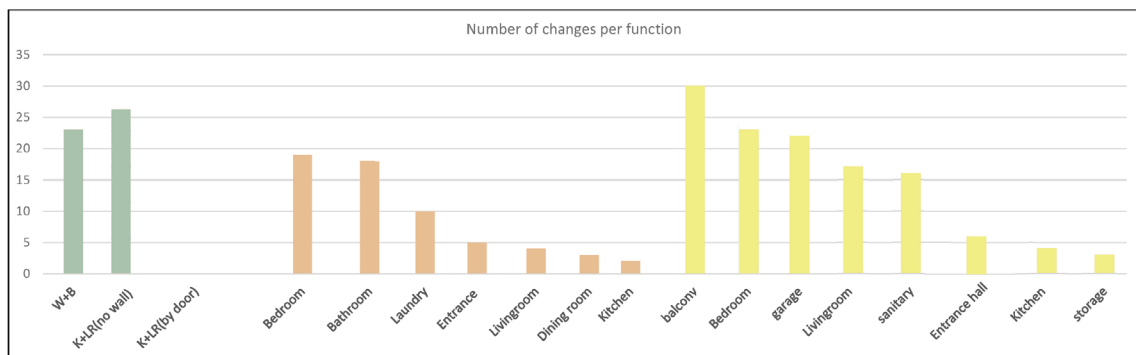
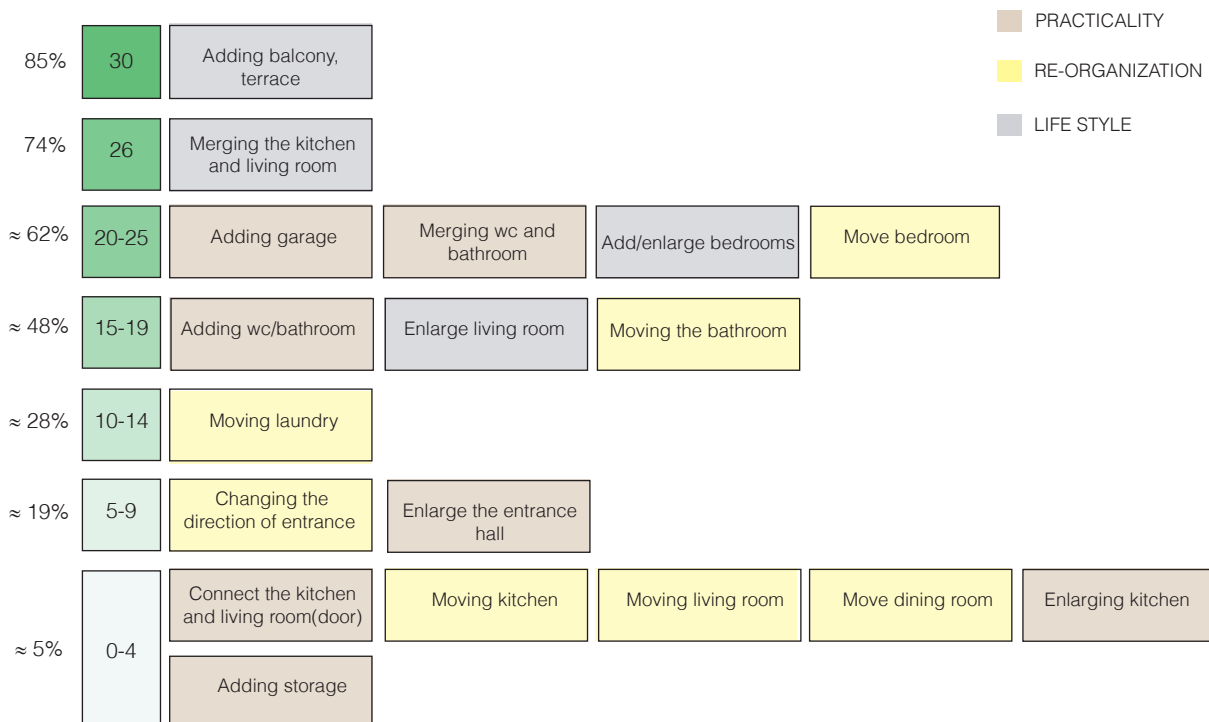
Merging two rooms into one			Moving functions							Enlargement							
W+B	K+LR (by door)	K+LR (no wall)	Kitchen	Livingroom	Bedroom	Bathroom	Laundry	Entrance	Dining room	living room	bedroom	balcony	kitchen	garage	wc/ bathroom	storage	Entrance hall
23	0	26	2	4	22	18	10	5	3	17	23	30	4	22	16	3	7

After analysing the data, it became clear that adding a balcony or a terrace was the most common change made (85%). This finding indicates that residents highly valued having an outdoor space as the original design did not include a balcony.

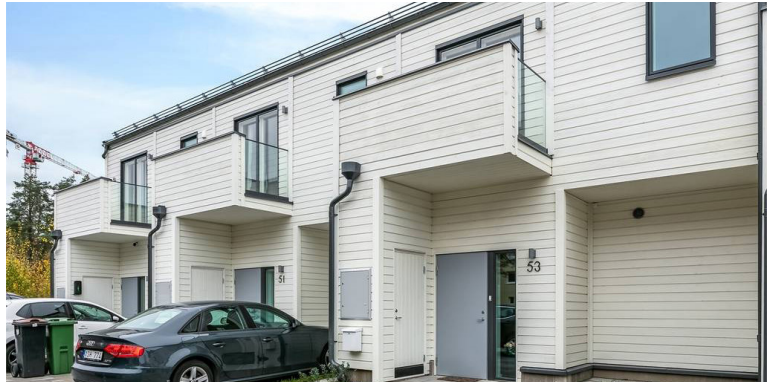
Snapphanevägen 53  
 Jakobsberg, Järfälla municipality  
 Housing type: Terraced house  
 Rooms: 4 rooms  
 Year of construction: 2021  
 Living area: 80 m<sup>2</sup>

Figure 6.1 Snapphanevägen 53 (© Hemnet AB, 2023)

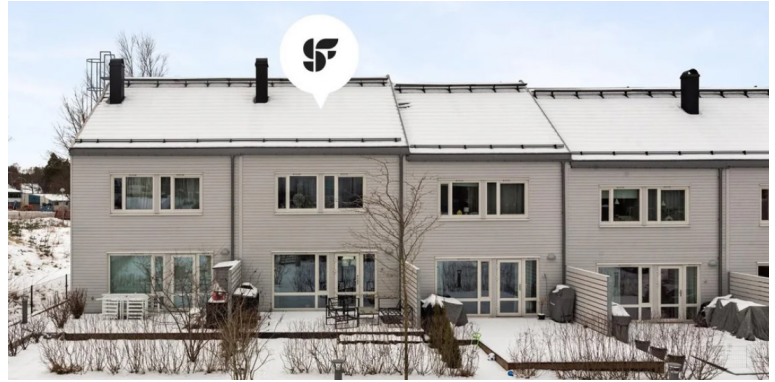
Year of construction: 2018

Living area: 105 m<sup>2</sup>

Figure 6.2 Ingaredsgatan 39B (© Hemnet AB, 2023)
