A Transformation of Thordéns Ladugård

Year of Publication:	2025
Title:	A Transformation of Thordéns Ladugård
Author:	Hugo Bergman
Institution:	Chalmers School of Architecture + Department of Architecture and Civil Engineering
Examiner:	Mikael Ekegren
Supervisor:	Isabella Eriksson
Master's program:	Architecture and Urban Design

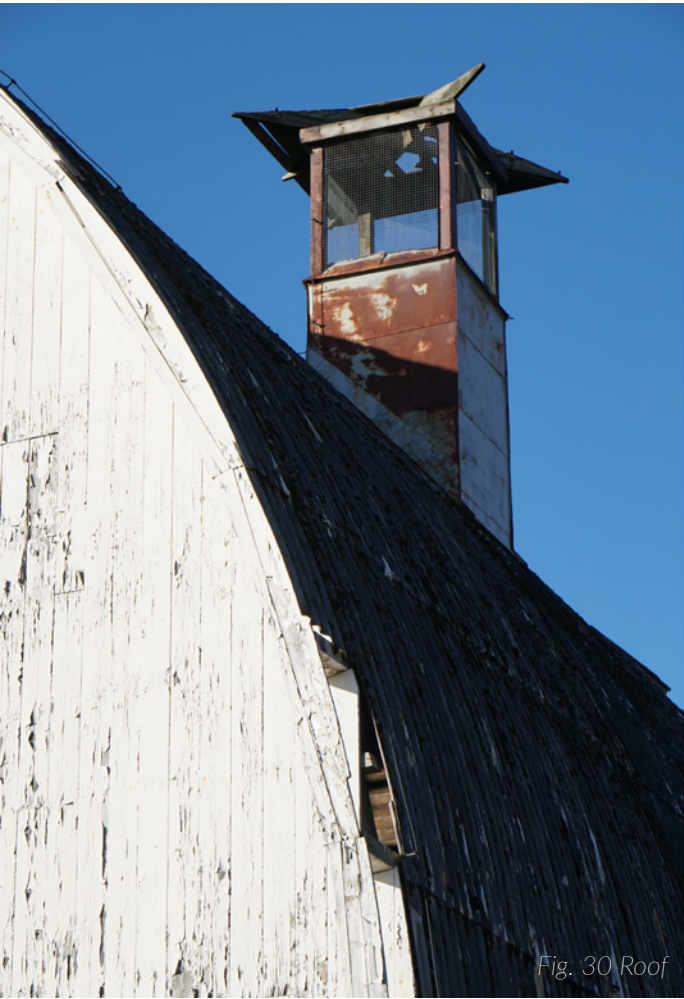
Fig. 30 Roof

Many of the facade materials are original and have gained a natural patina, some more gracefully than others. Most concerning is the roof on the eastern side, with large amounts of moss buildup which has lead to frost shattering damages.

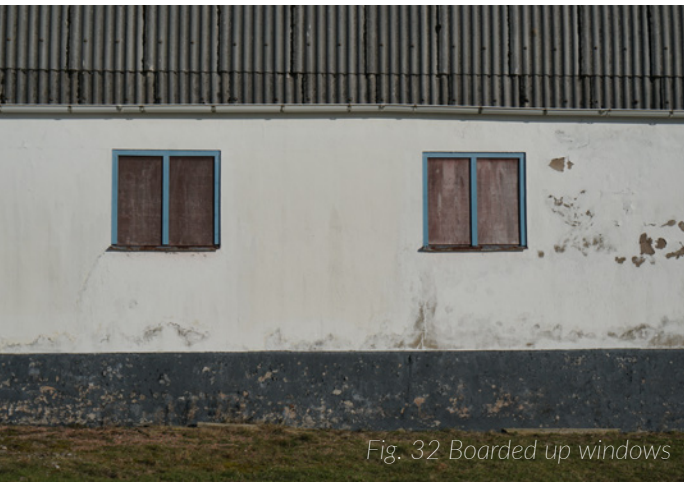
Fig. 32 Boarded up windows

Multiple windows on the ground floor have been either boarded up or replaced. Those that are still original are visibly worn with wooden frames.

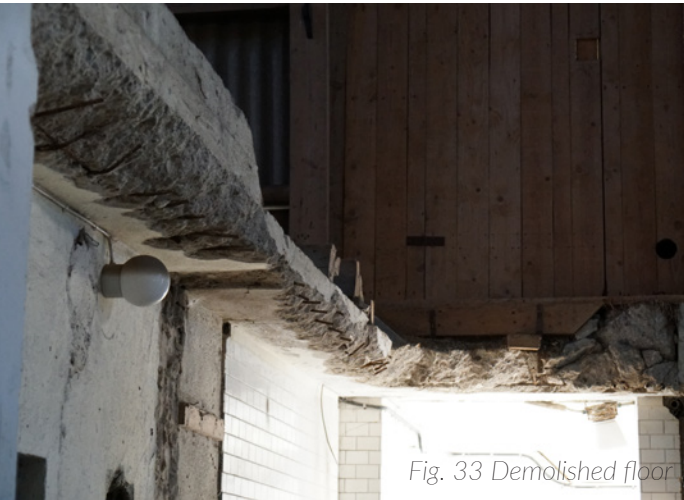
Fig. 33 Demolished floor

To be able to fit even larger machines, one of the laminated wood beams was relieved to make room for a larger gate. The cow stable used to extend a bit into the machine hall, but the extension has since been demolished.

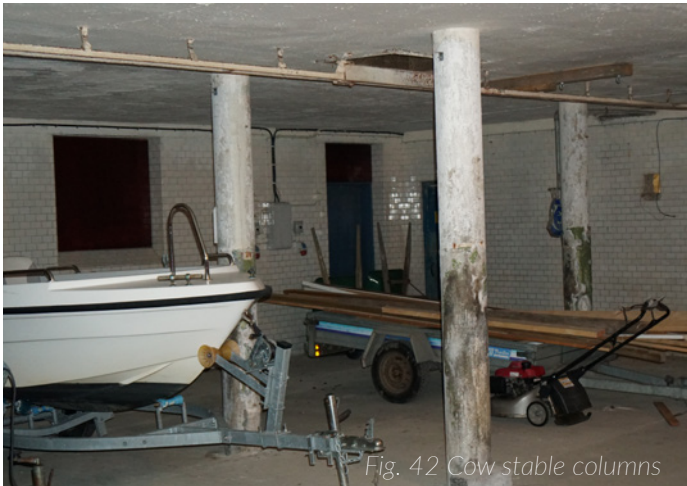
Fig. 42 Cow stable columns

The three rows of columns divide the room into sections, with a suspended rail running across the ceiling. This rail was once used to distribute grain to the cows' feeding baskets.

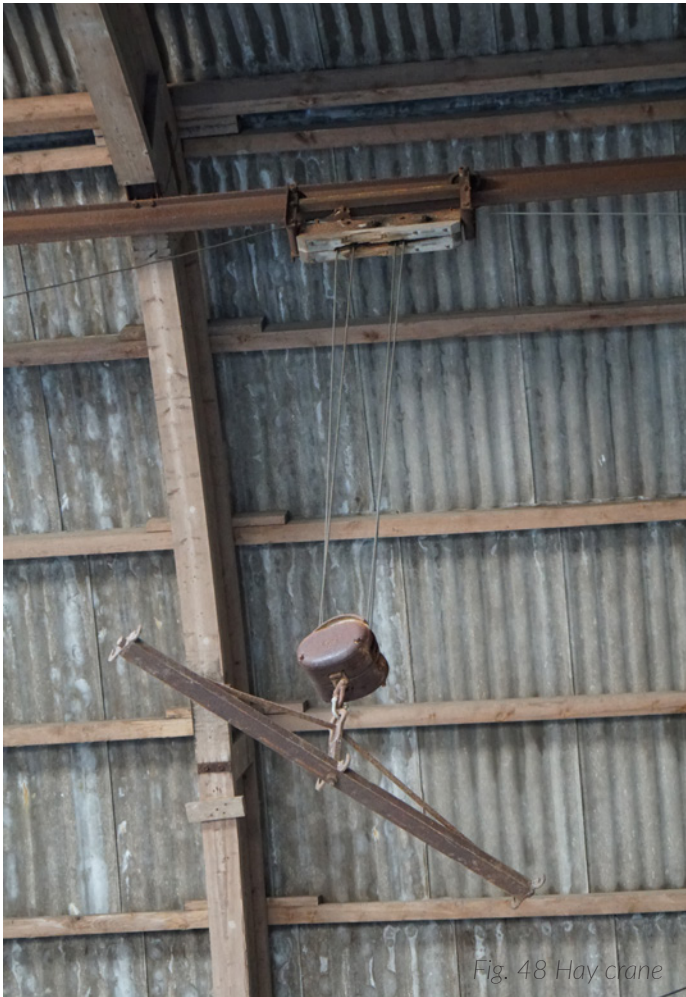
Fig. 48 Hay crane

From the southern hayloft you have access to the mezzanine on top of the silo(s), from which you could control a crane mounted to the ridge. This crane could hoist several tonnes of hay, and is the cause for the large dimensions of the laminated wood roof beams.

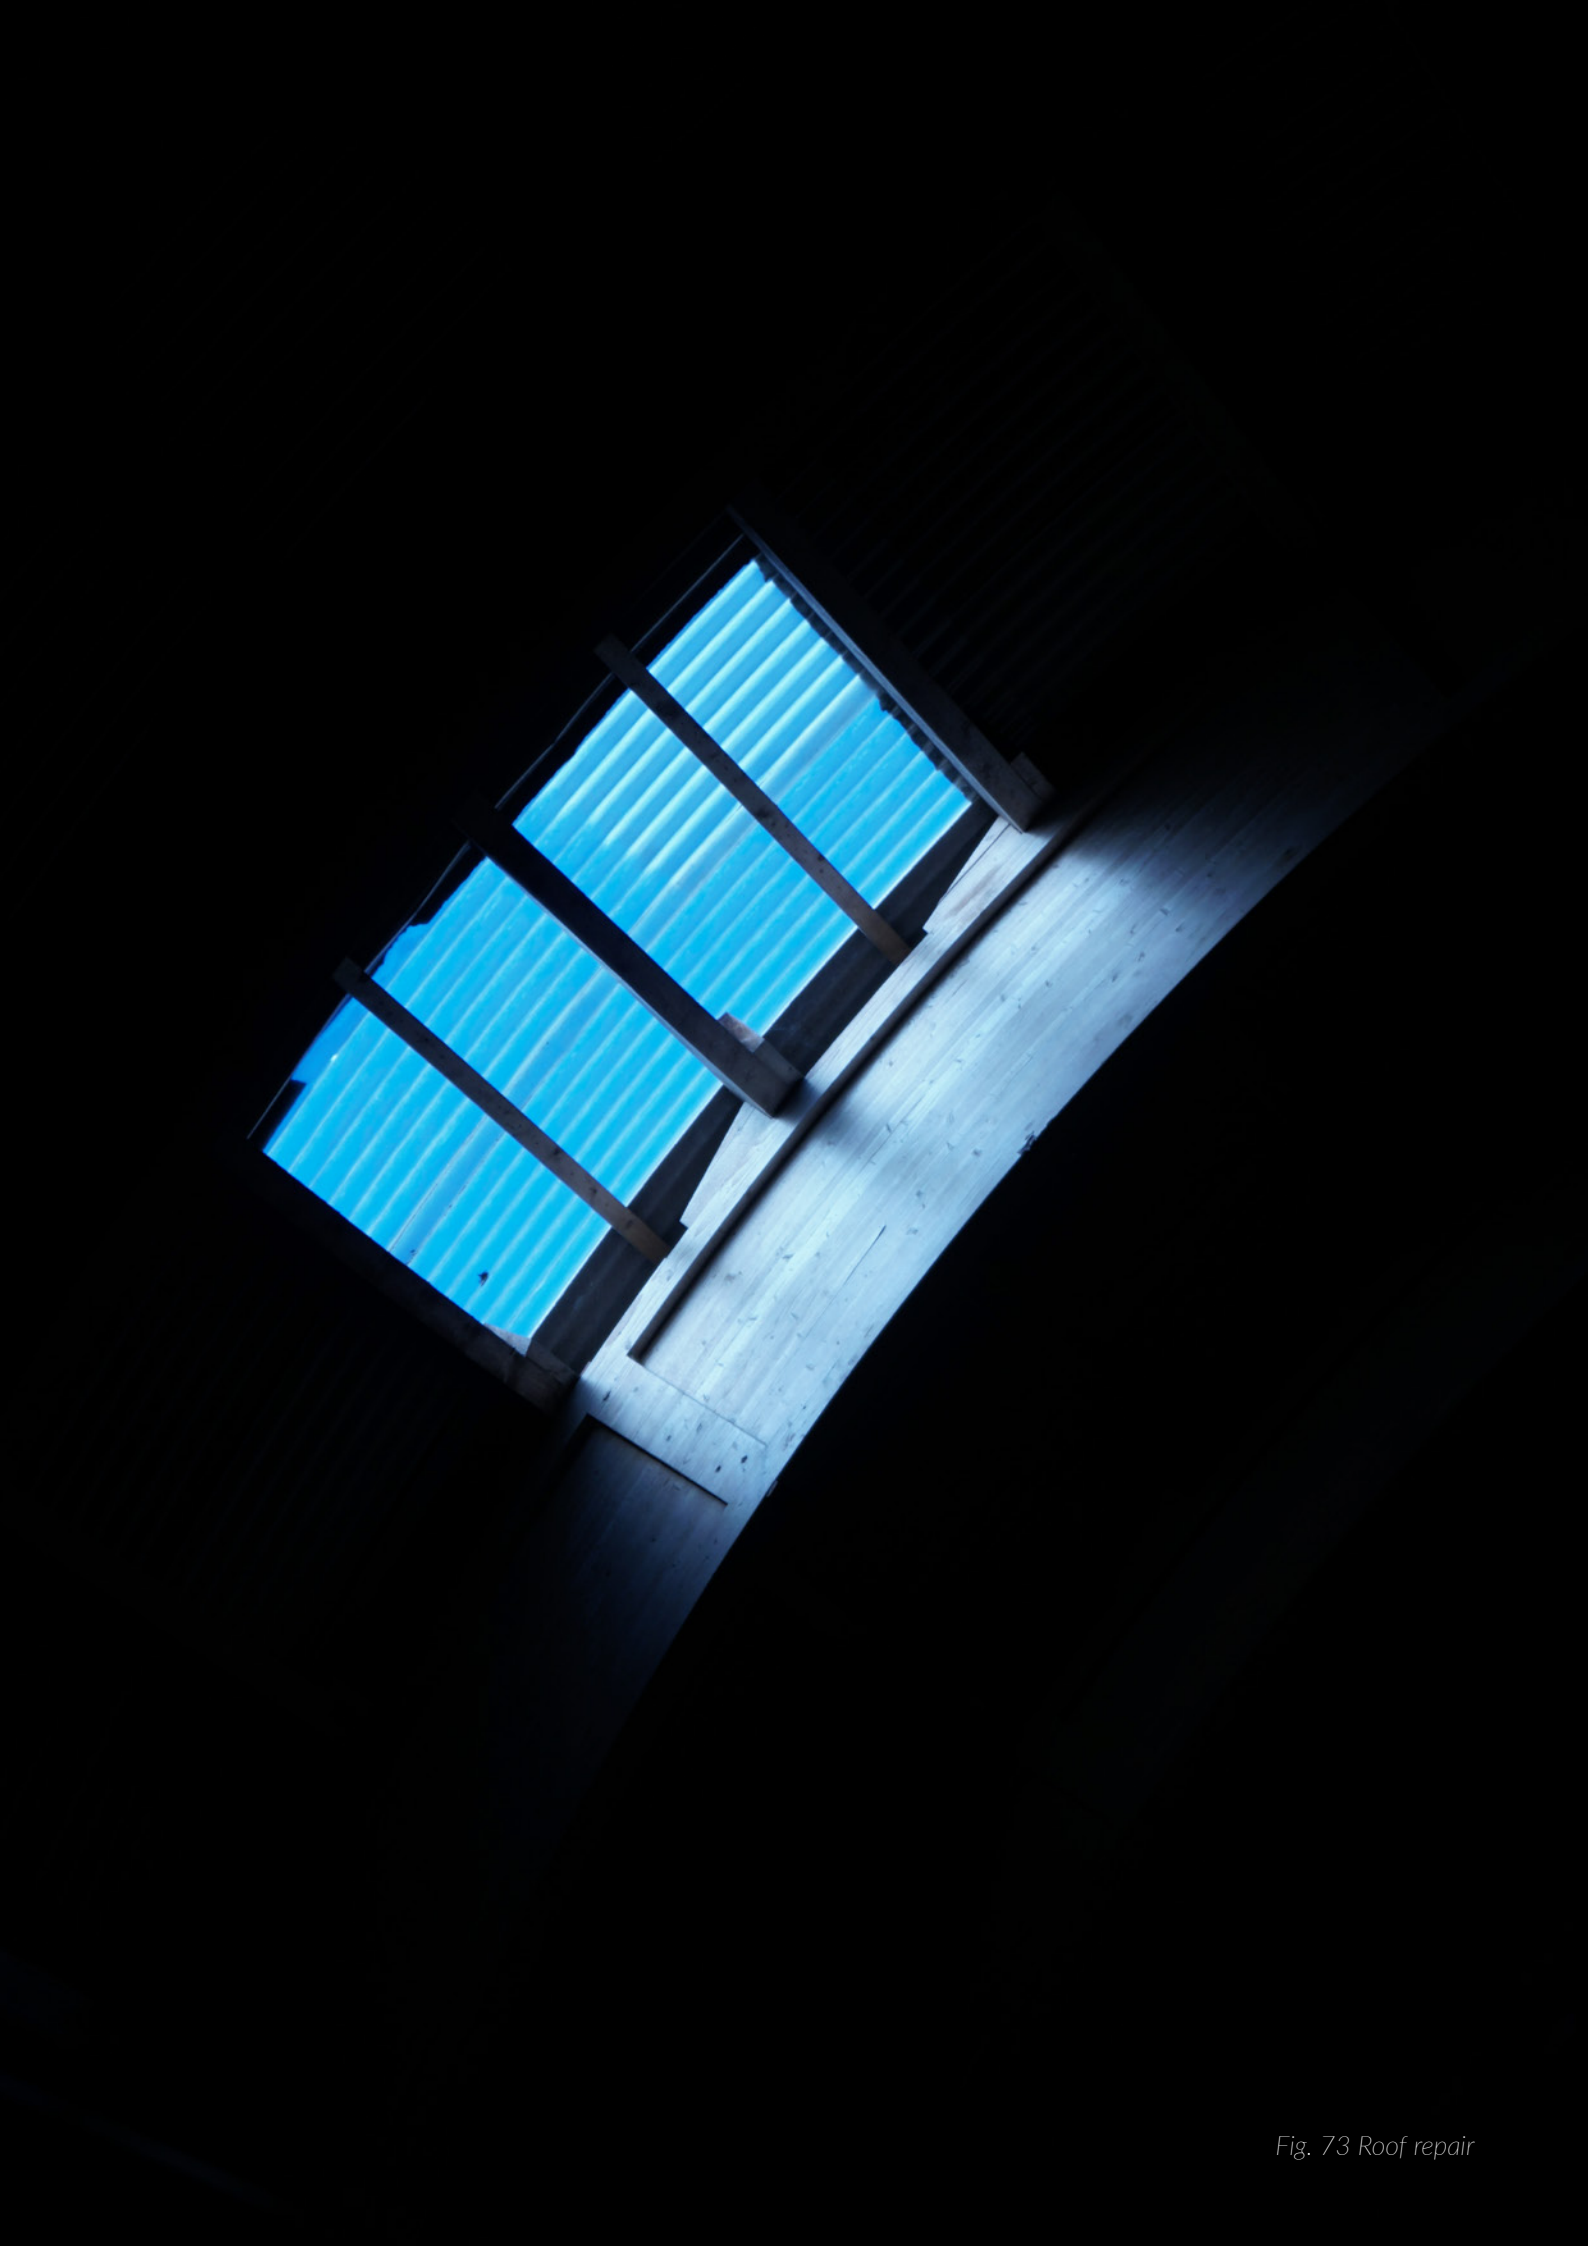
Fig. 73 Roof repair

Roof repairs consisting of translucent panels, along with the slight gaps between the gable facade panels result in a unique natural lighting of the space.

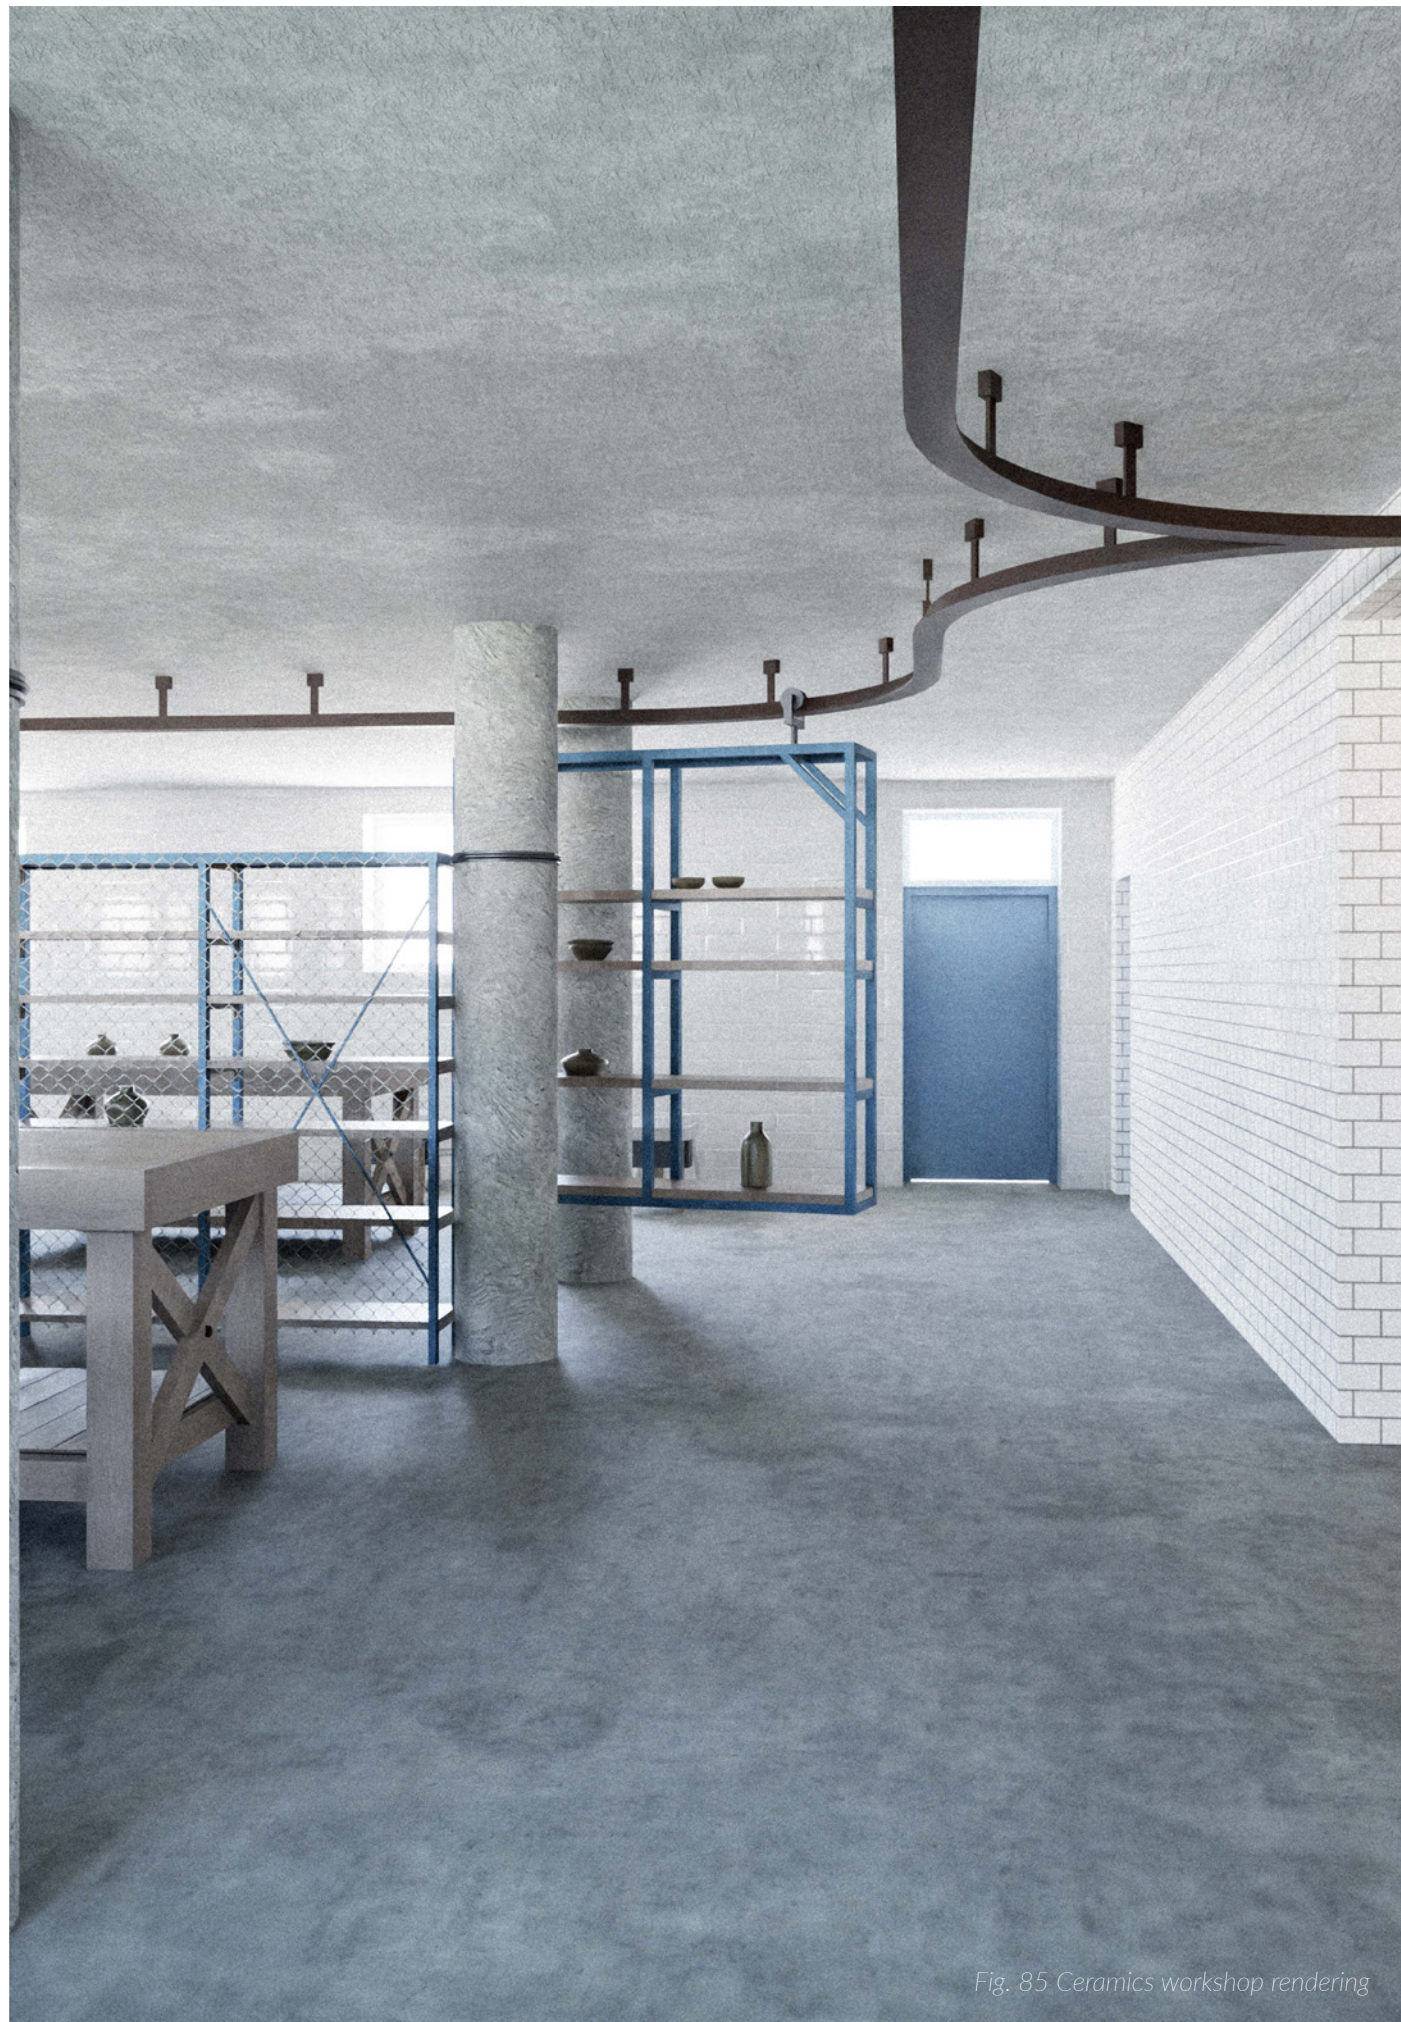
Fig. 85 Ceramics workshop rendering

The ceramics workshop utilizes the existing columns to create spatial division through integrated shelves.

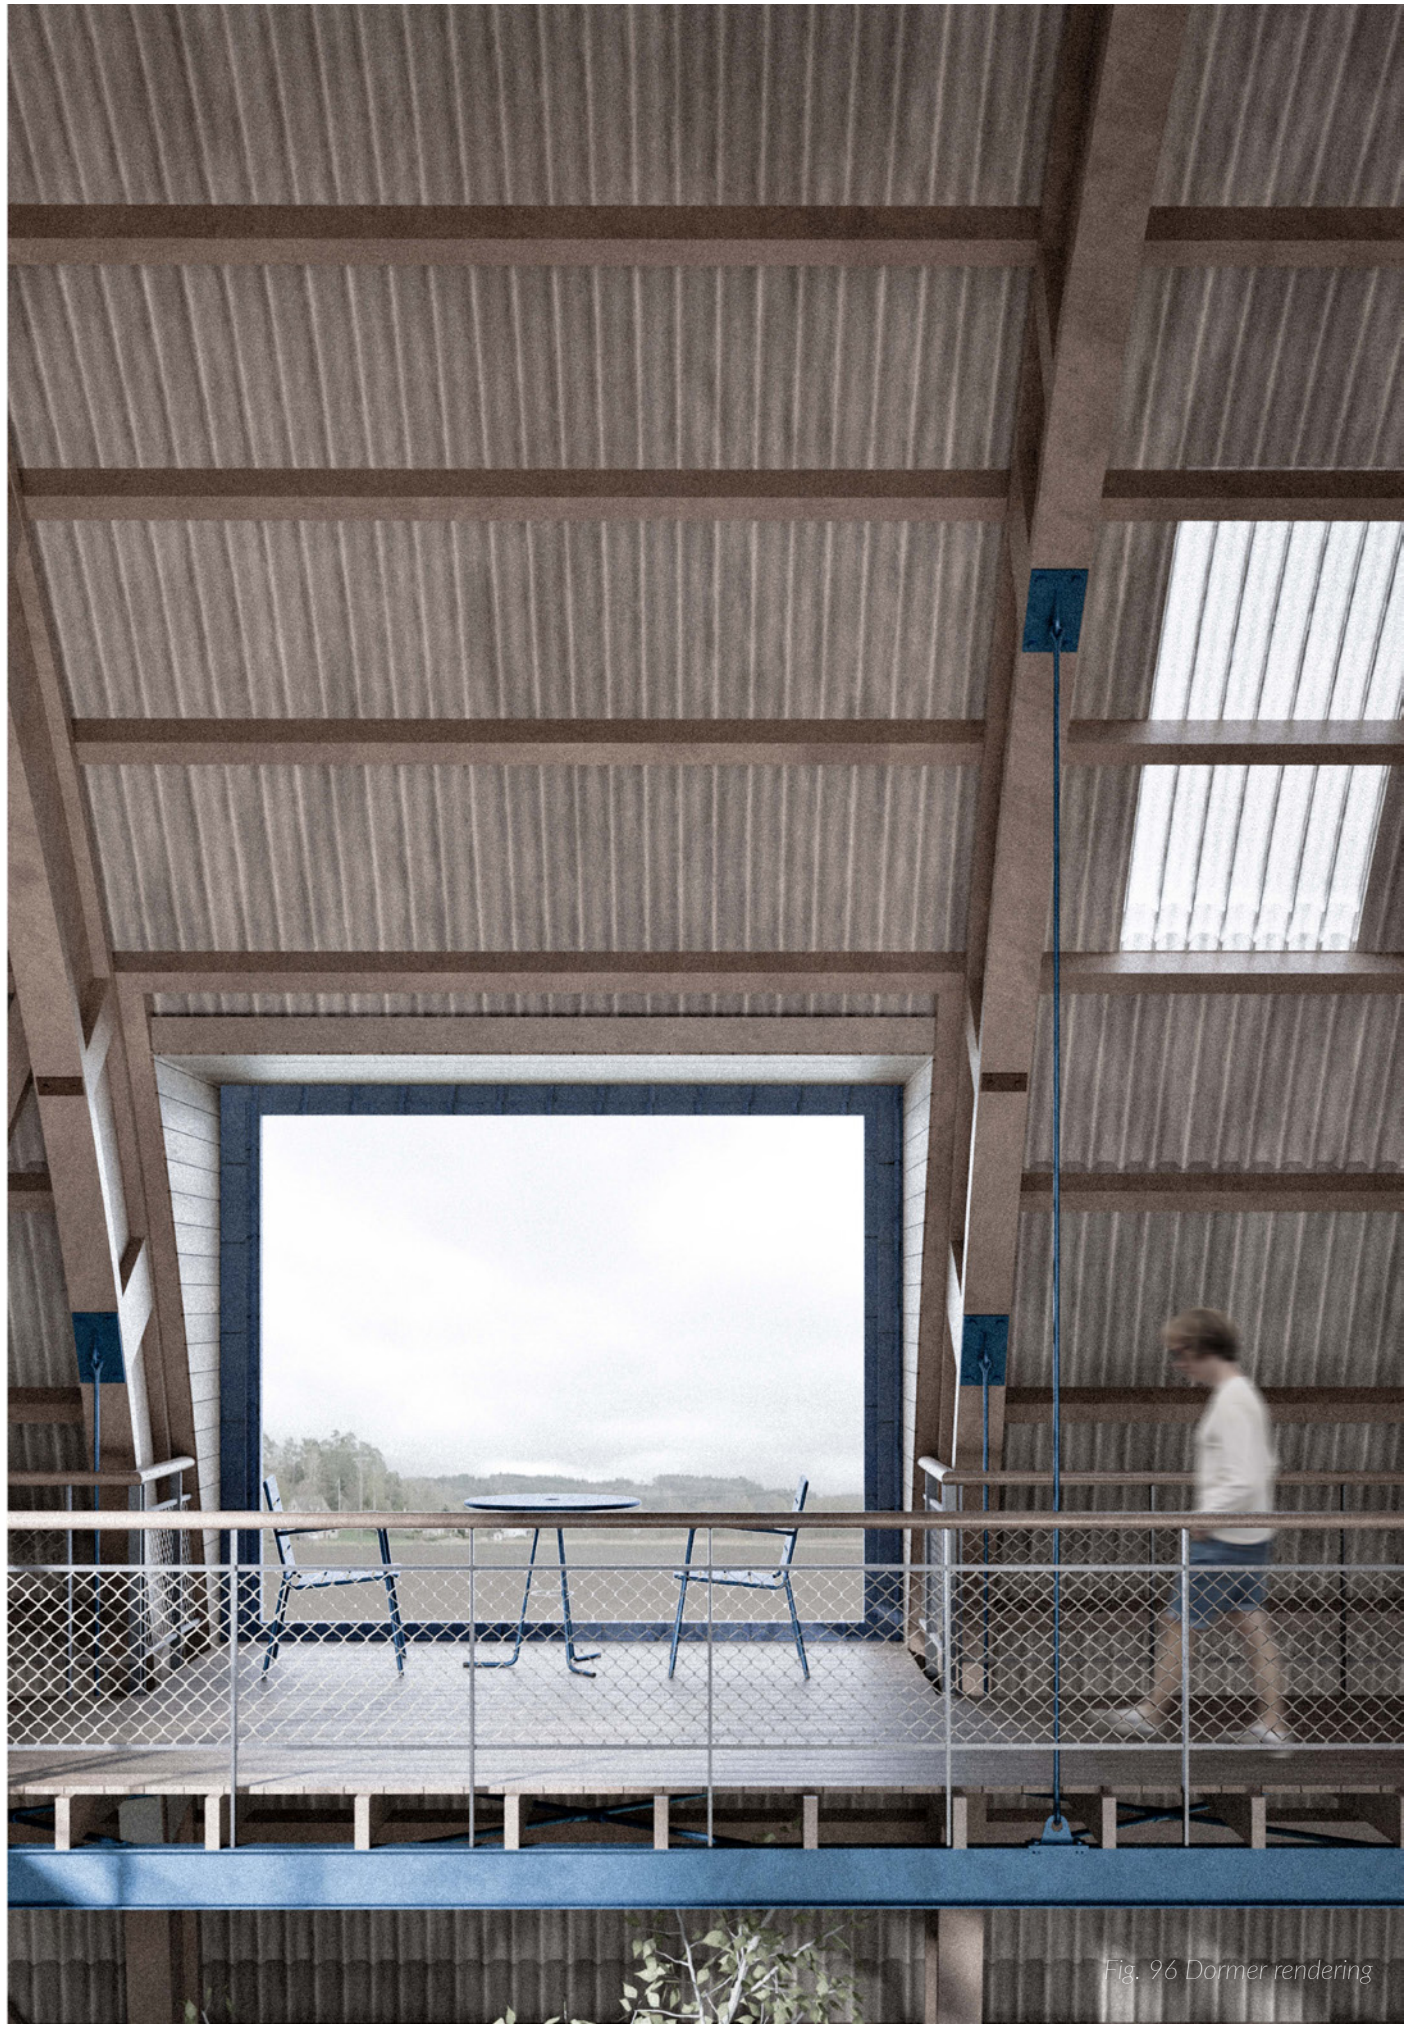
Fig. 96 Dormer rendering

Along the suspended walk path lies recessed areas extending into the dormers, creating intimate spaces for conversation with framed views of the surrounding environment.
