Resurrecting Håby church

Communicating a millennium of alteration and rehabilitation through conservation and adaptive reuse

Master's Thesis

Chalmers School of Architecture
Department of Architecture & Civil Engineering

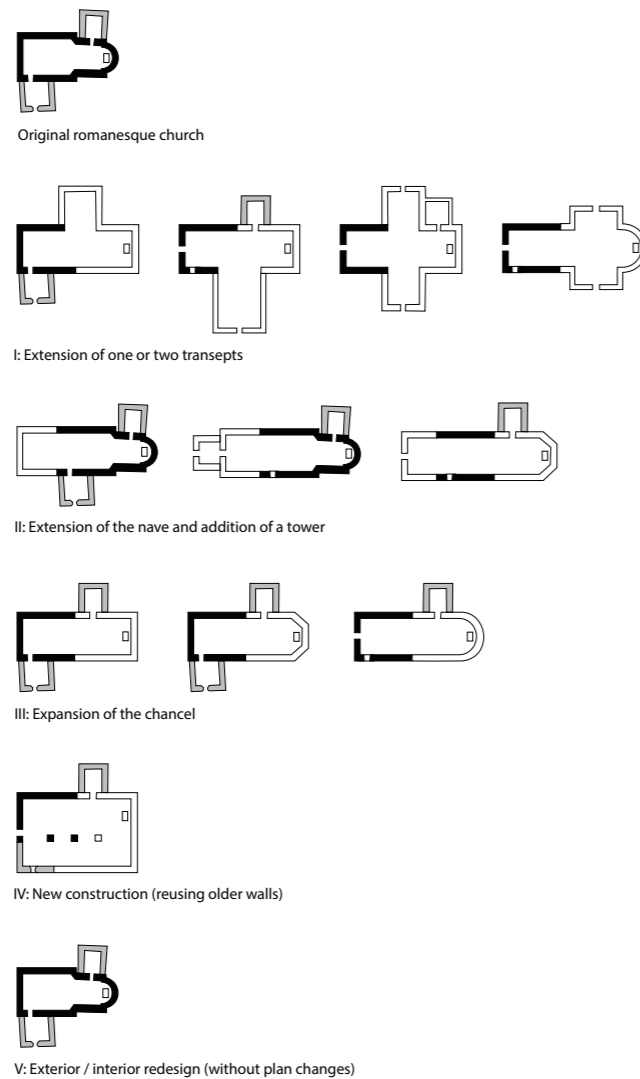
Fig. 1

Typical historical alterations to a medieval church extracted from extensive studies from the whole of Sweden. Illustration from the article "Sockenkyrkornas förnyelse genom ombyggnad" (Dahlberg & Franzén, 2008, p.276), used with permission. Text translated from Swedish to English.

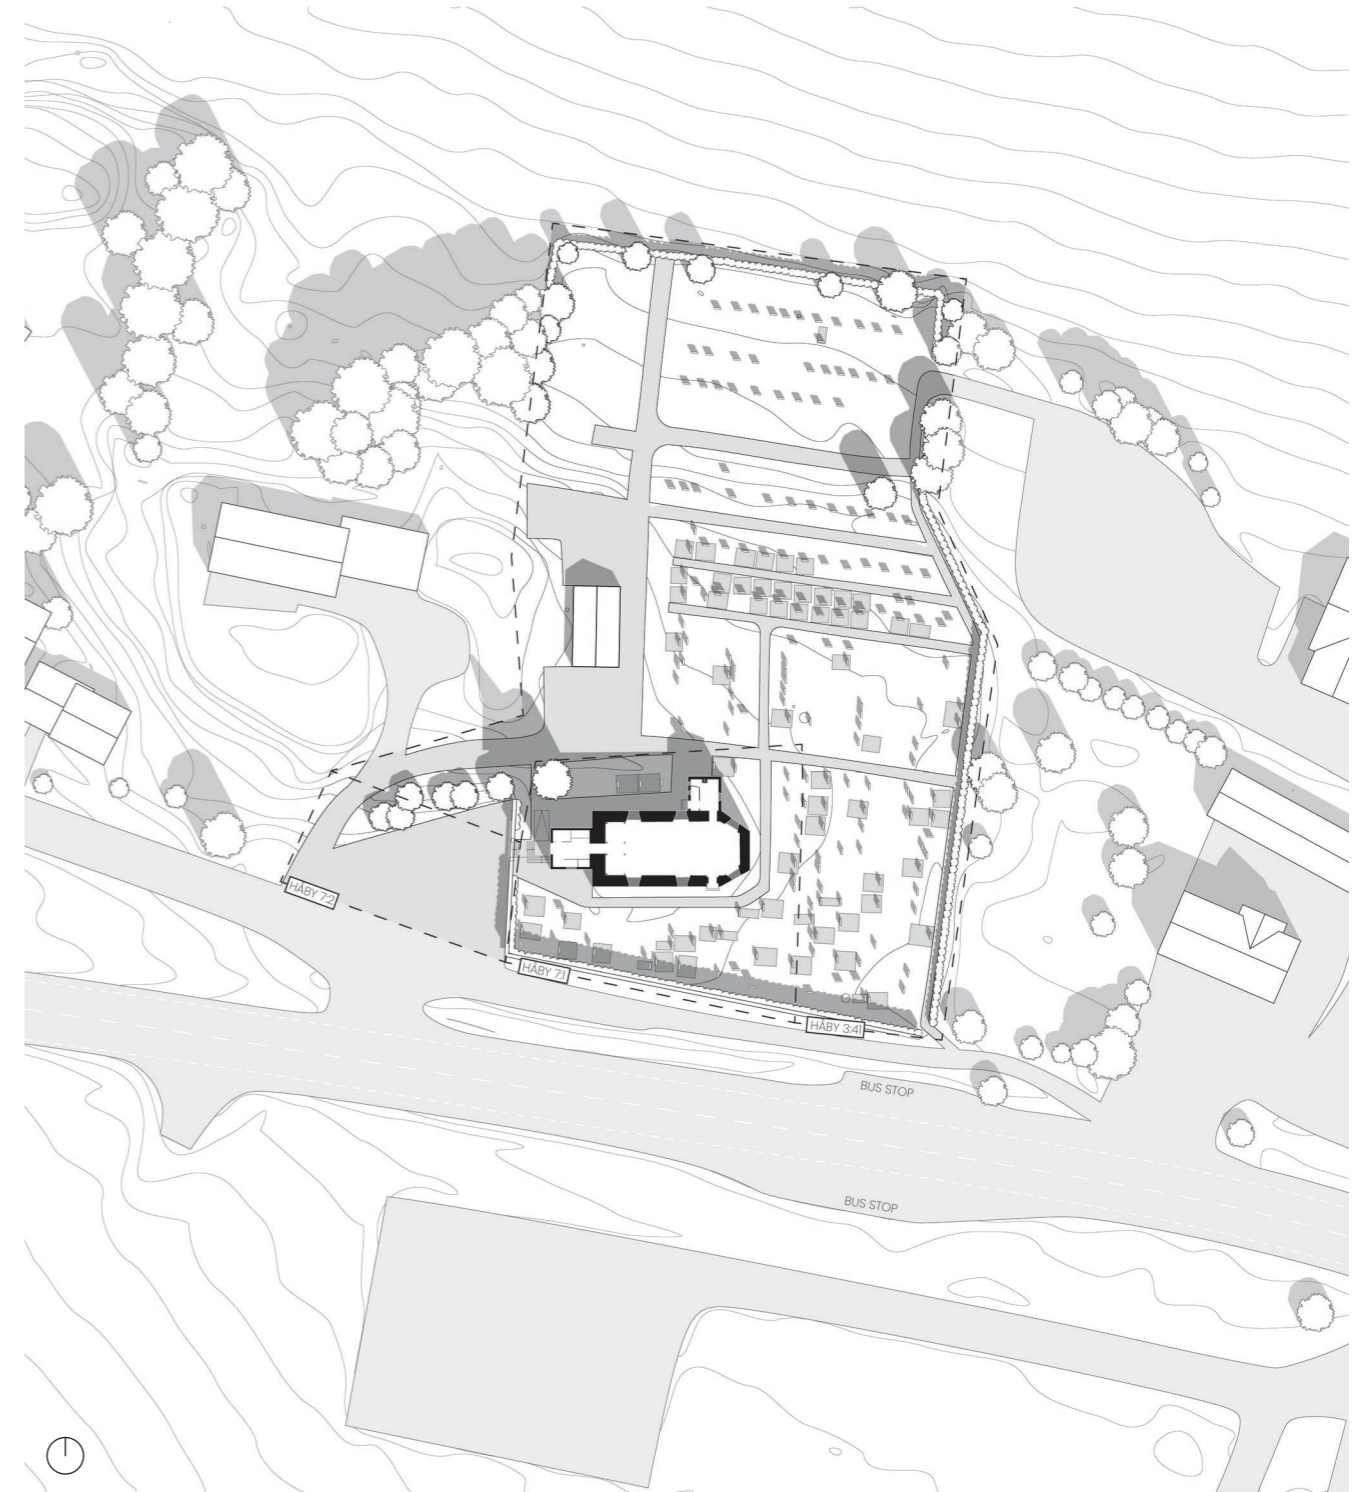
Fig. 30
Siteplan
surrounding the
cemetery
Scale: 1:1000

Surrounding the church there is a cemetery with a maintenance building, a small parking-lot and a bus stop (Fig. 30). This makes the church fairly well-connected to Munkedal, and the E6 facilitates even further connections. Being located on a hill surrounded by farmland, the church is clearly visible from the whole village (Fig. 28-29) and when passing by on the E6.

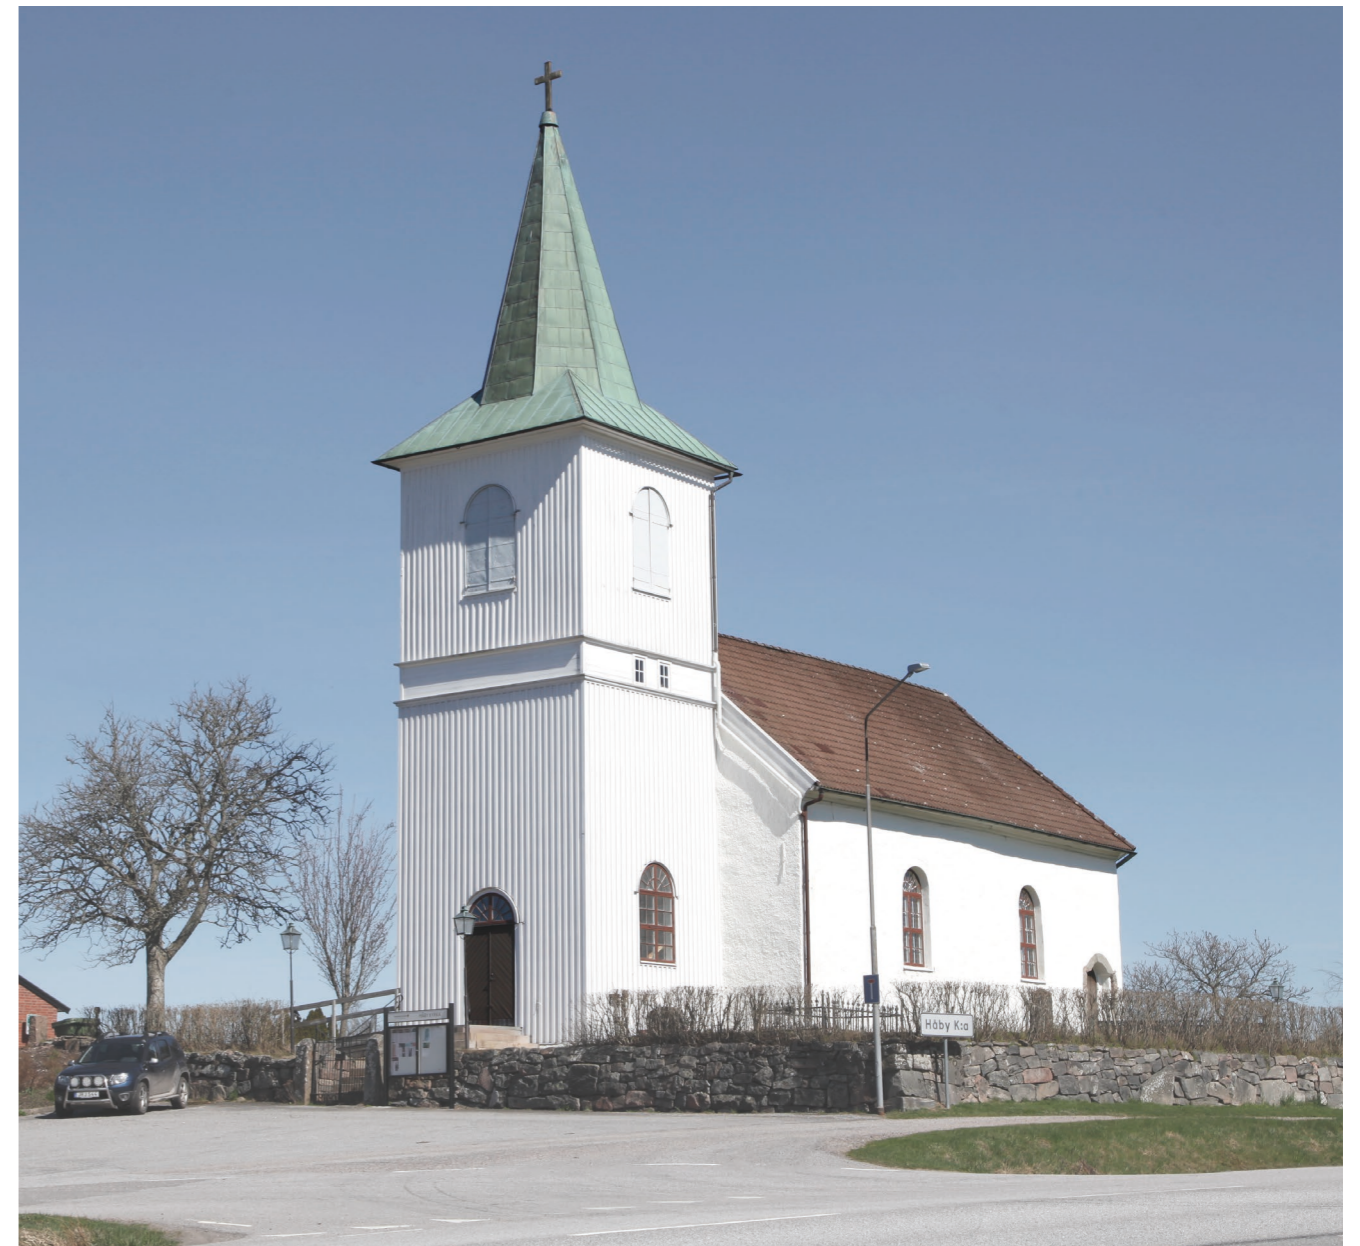
Fig. 31

Exterior
photograph of
Håby church
2026.

Håby Church (Fig.31) was built some time in the 12th or early 13th century and has undergone several alterations, rehabilitations and additions during its life. In the 1390s the bishop wanted the then derelict church to be demolished, but it was somehow saved. Once again in 1728 the bishop wanted the church demolished but a local initiative started a national collection to have it rehabilitated. In 1731 the rehabilitation was finished, with a widened chancel and a new roof. Later in 1868, a tower was added and in 1871 a sacristy was built to the east. This sacristy was later demolished in 1939 when a new sacristy was built to the north (Riksantikvarieämbetet, n.d.)

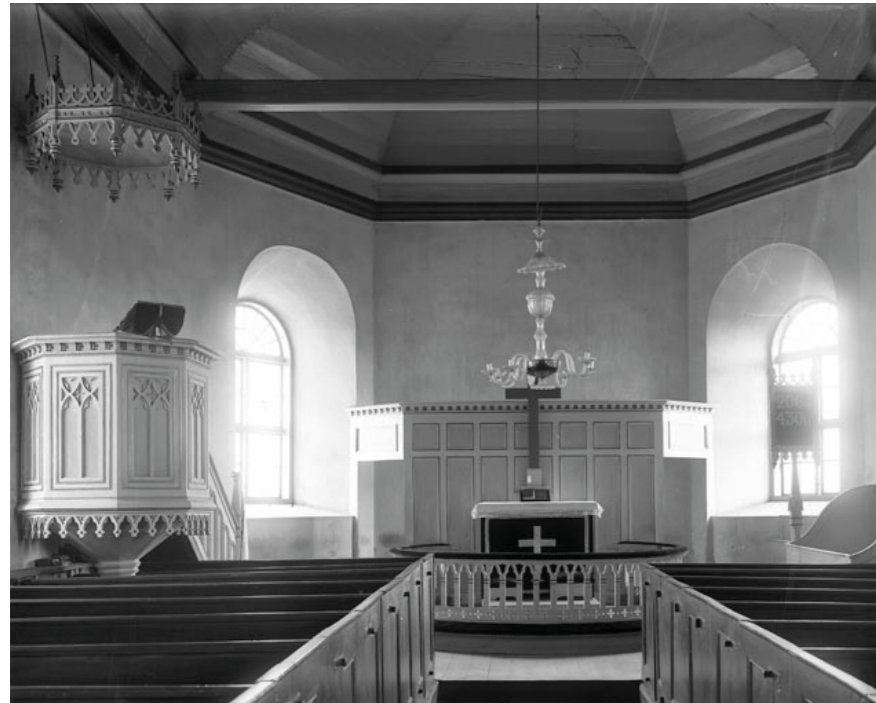
Fig. 32

Interior photograph of Håby church from the 1920s in its 1870s neogothic style-restoration appearance.
Photo: Selma Sahlborg, CC BY-NC-ND 4.0

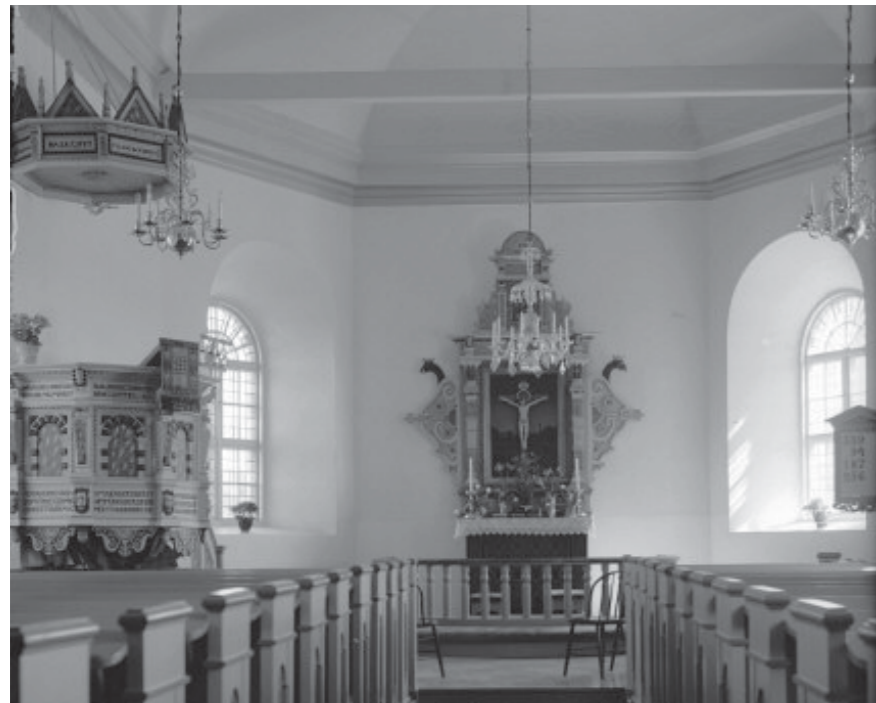
Fig. 34

Interior photograph of Håby church from the 1940s in its 1700s restorational appearance.
Photo: Runo Grolander, CC BY 4.0

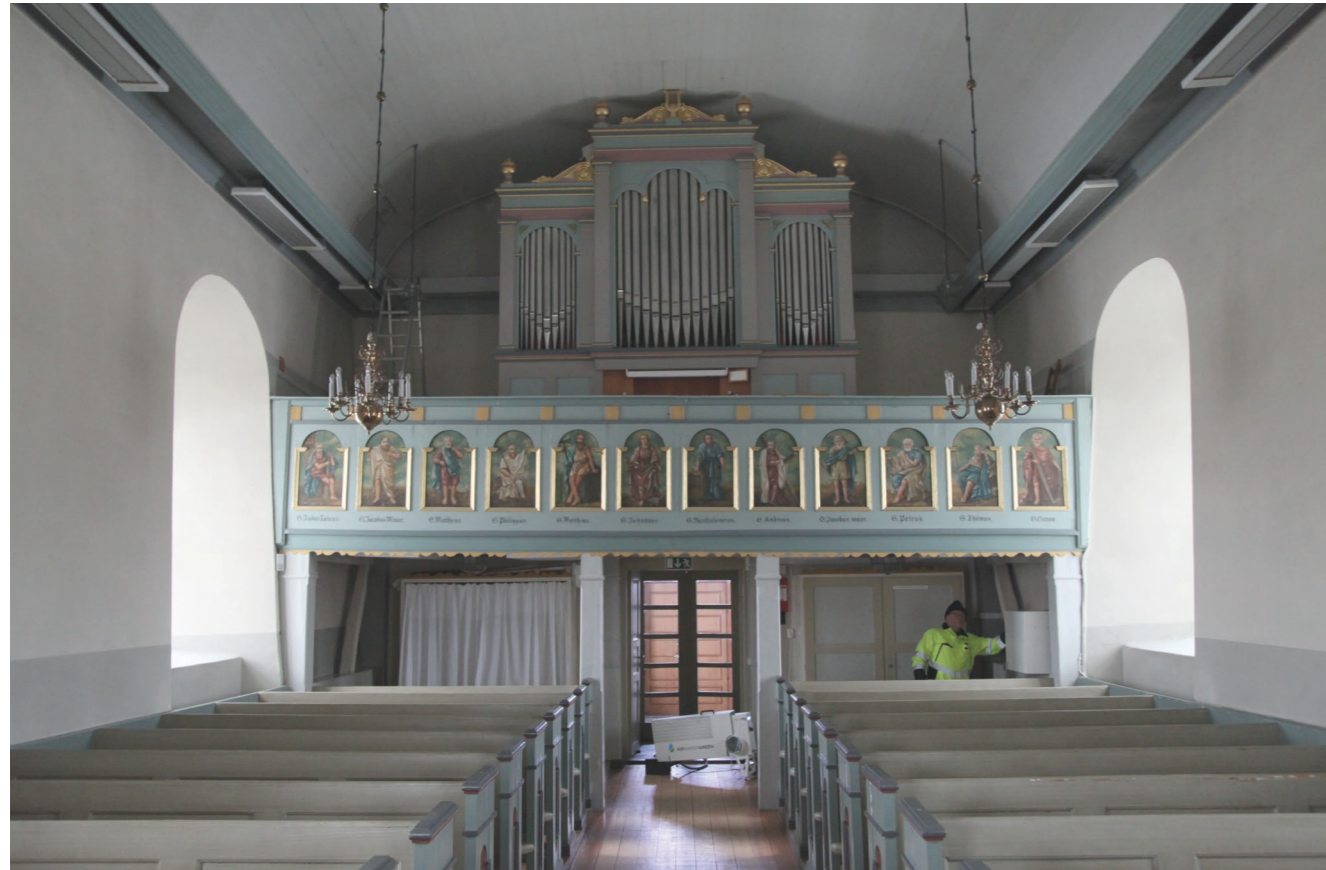
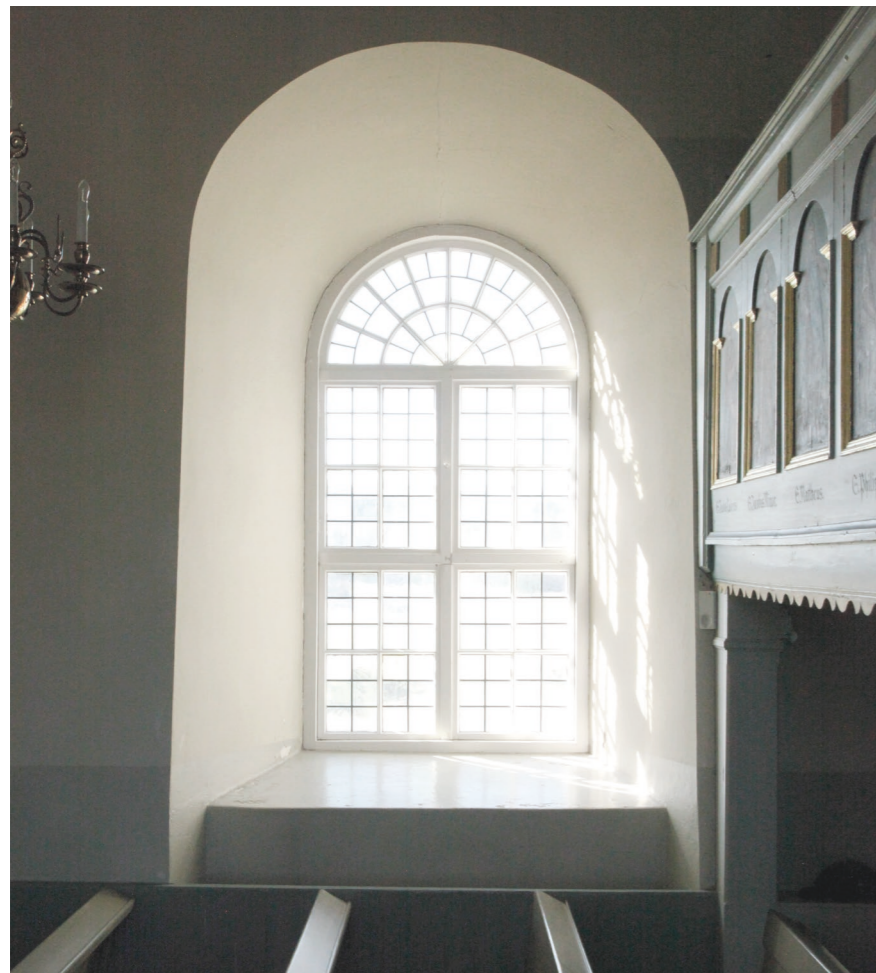
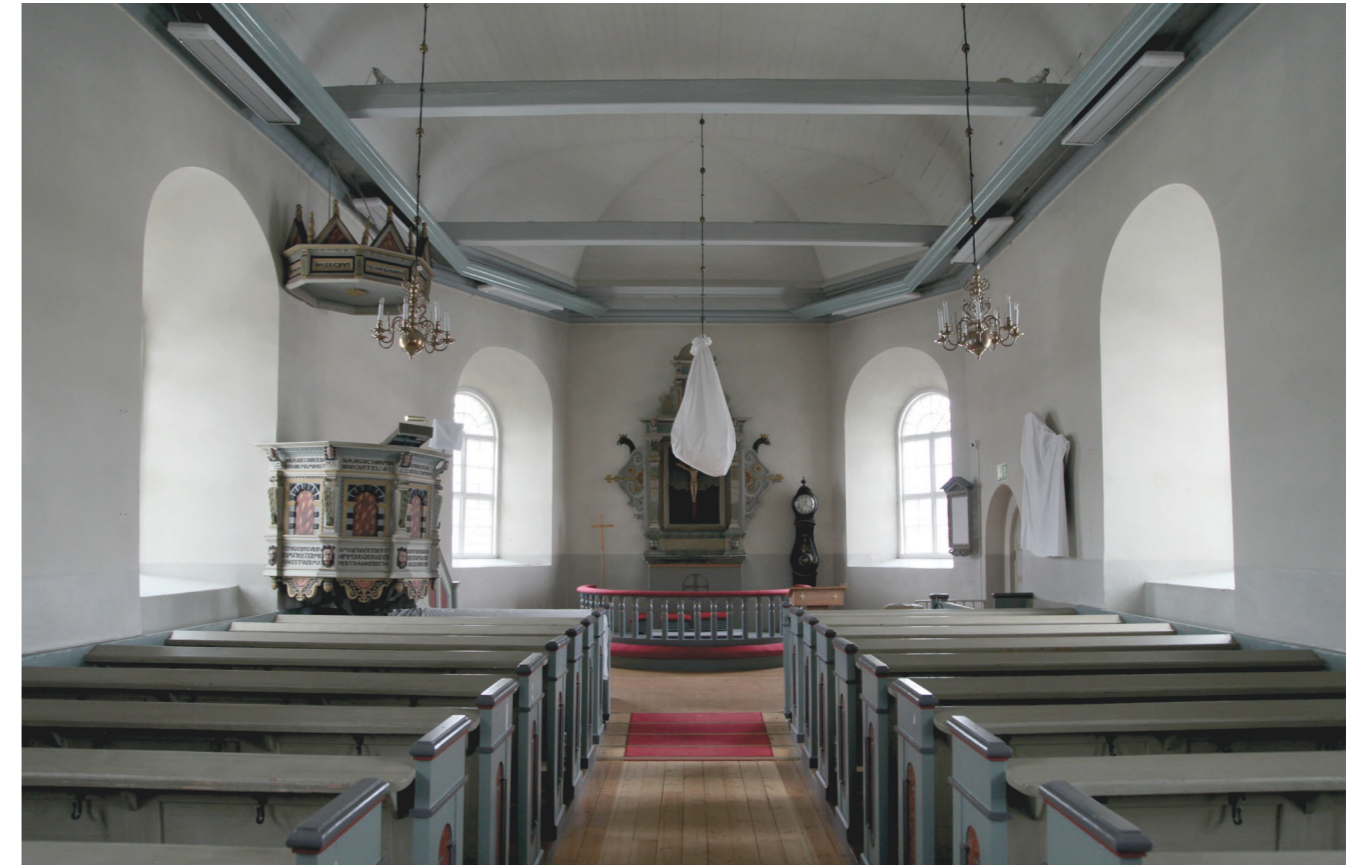
Fig. 38 Top
Nave interior
towards gallery

Fig. 39 Left
Nave window
beside gallery

Fig. 40
Nave interior
towards chancel

This makes Håby church essentially frozen in a state of reconstruction to a stylized pastiche of something that claims to be original but is in fact not (Fig. 38-40). The church was deemed redundant by Munkedal's parish and closed in 2023. It now stands cold, with only space heaters to control the moisture in the interiors, and in need of a new roof.

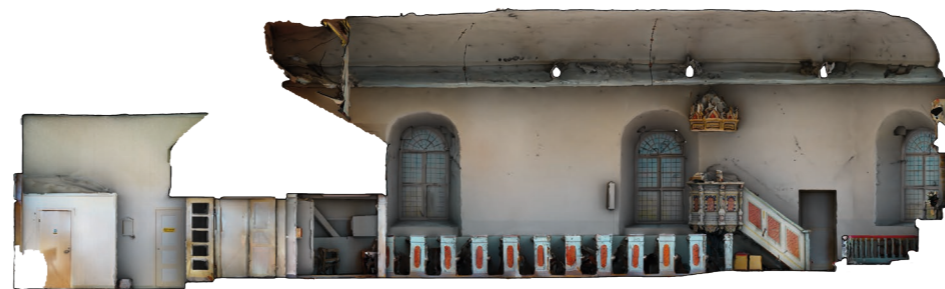
Fig. 57

Section C-C of the photogrammetry of the nave and porch. Photogrammetry: Carl-Johan Claesson, used with permission

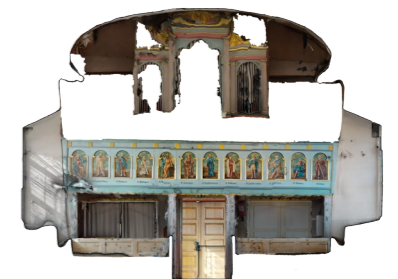
Fig. 58

Section B-B of the photogrammetry showing the gallery. Photogrammetry: Carl-Johan Claesson, used with permission

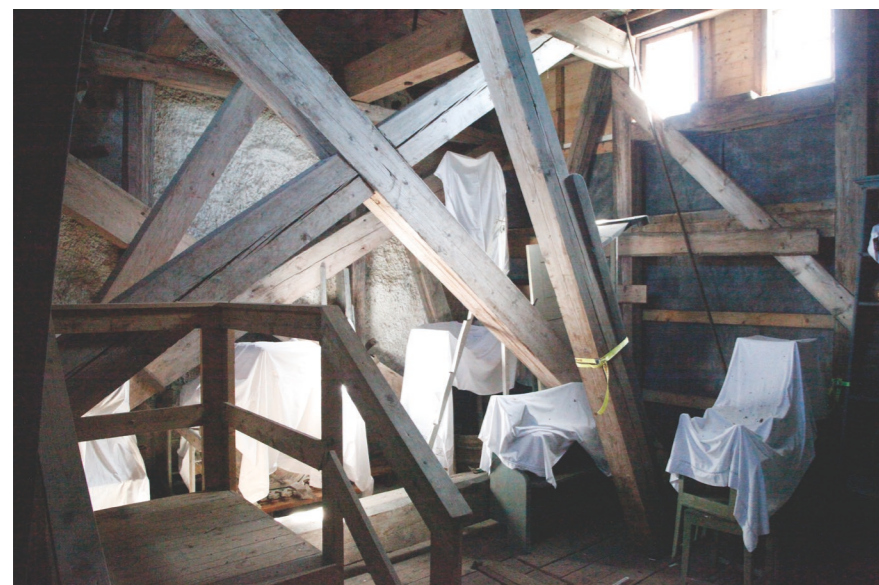
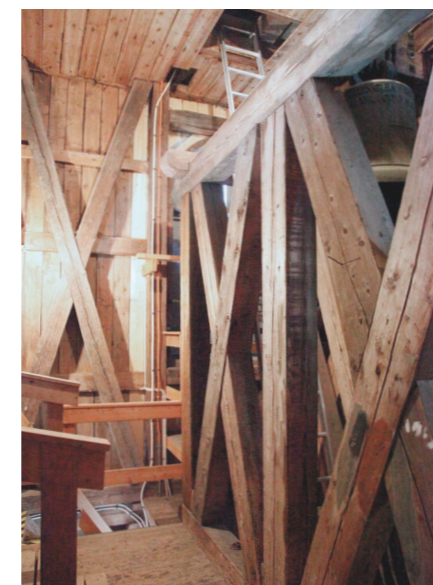
Fig. 61 Bottom right

The third floor of the tower where the church-bells are mounted.

The tower is a timber structure with several layers of redundancy in the horizontal bracing to safely carry the loads of the swinging church bells (Fig. 61). The second floor of the tower (Fig. 59-60) is mainly used for storage of unused inventories but is quite obstructed by the bracing members. Clad with copper, the roof was repaired in 2016.

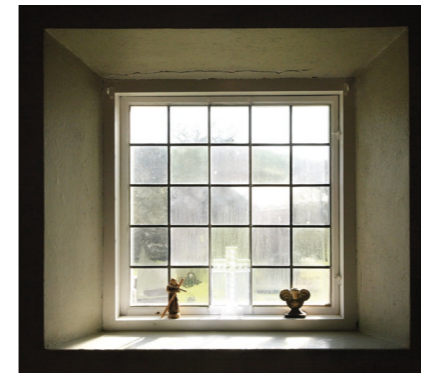
Fig. 63 Left

The main window in the sacristy.

Serving as a workspace and storage for the people working in the church, the sacristy (Fig. 62-63) is secluded from the rest of the church. In the basement, the oil-boiler is left from when it served as the source of heating for the church which explains the existence of the chimney. The sacristy walls are made out of brick, which also clads the floor. The roof is carried by a small timber truss (Fig. 64).

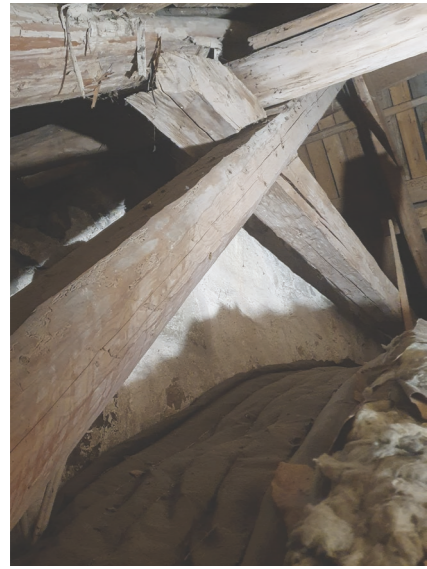
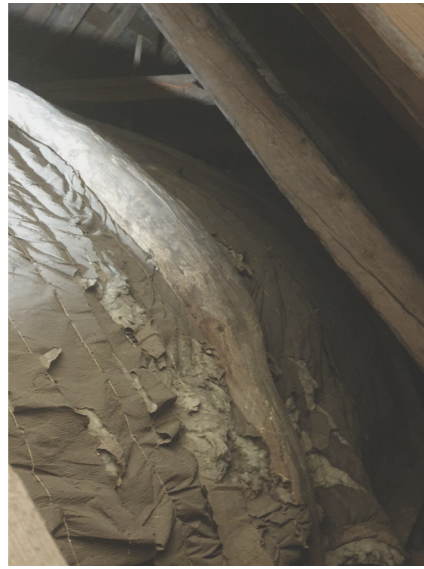
Fig. 65-66 Left

Photographs from the attic over the nave

Through archival research of historical drawings and own photographs of the nave attic (Fig. 28-29) and crawlspace, the structure of the church is understood. The stone masonry walls are 1,6m at their thickest, tapering up toward the roof. Having evidently been altered, repaired and retrofitted multiple times, the current timber truss holds the roof over the nave leaving a thin timber shell only carrying itself as the visible vault (Fig. 68). Underneath the concrete roof tiles, there is probably an old timber-shingle roof covered by a layer of plywood according to Kristin Balksten (2024), as stated in her assessment of the roof where she argues it is in need of replacement. The floor of the nave is made of pine, put there in the 1940s, and below the floor is a ventilated crawlspace (Fig. 67).

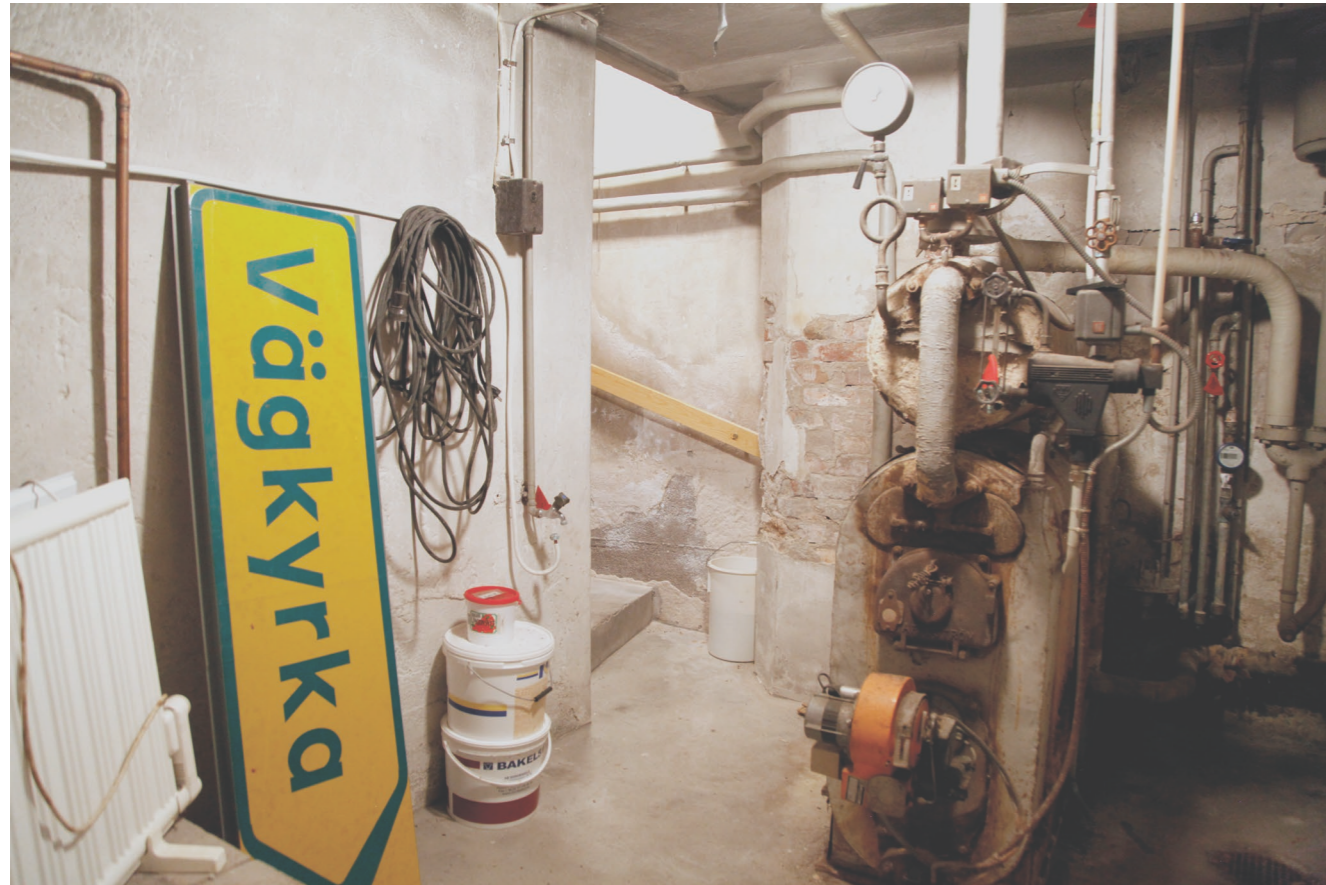
Fig. 70

The cellar of the sacristy where the road sign for when Håby was a road church is still stored.

A road church is in Sweden defined as a "resting-place for the soul" where a passer-by can stop to go to the restroom, get a smaller snack and stop to reflect. It's open during summers and should have daily small church-services, but other than that it is similar to any rest-stop along a motorway. Håby has under an unknown period in the 20th century been a road church and the road sign is still stored in the cellar of the sacristy (Fig. 70).

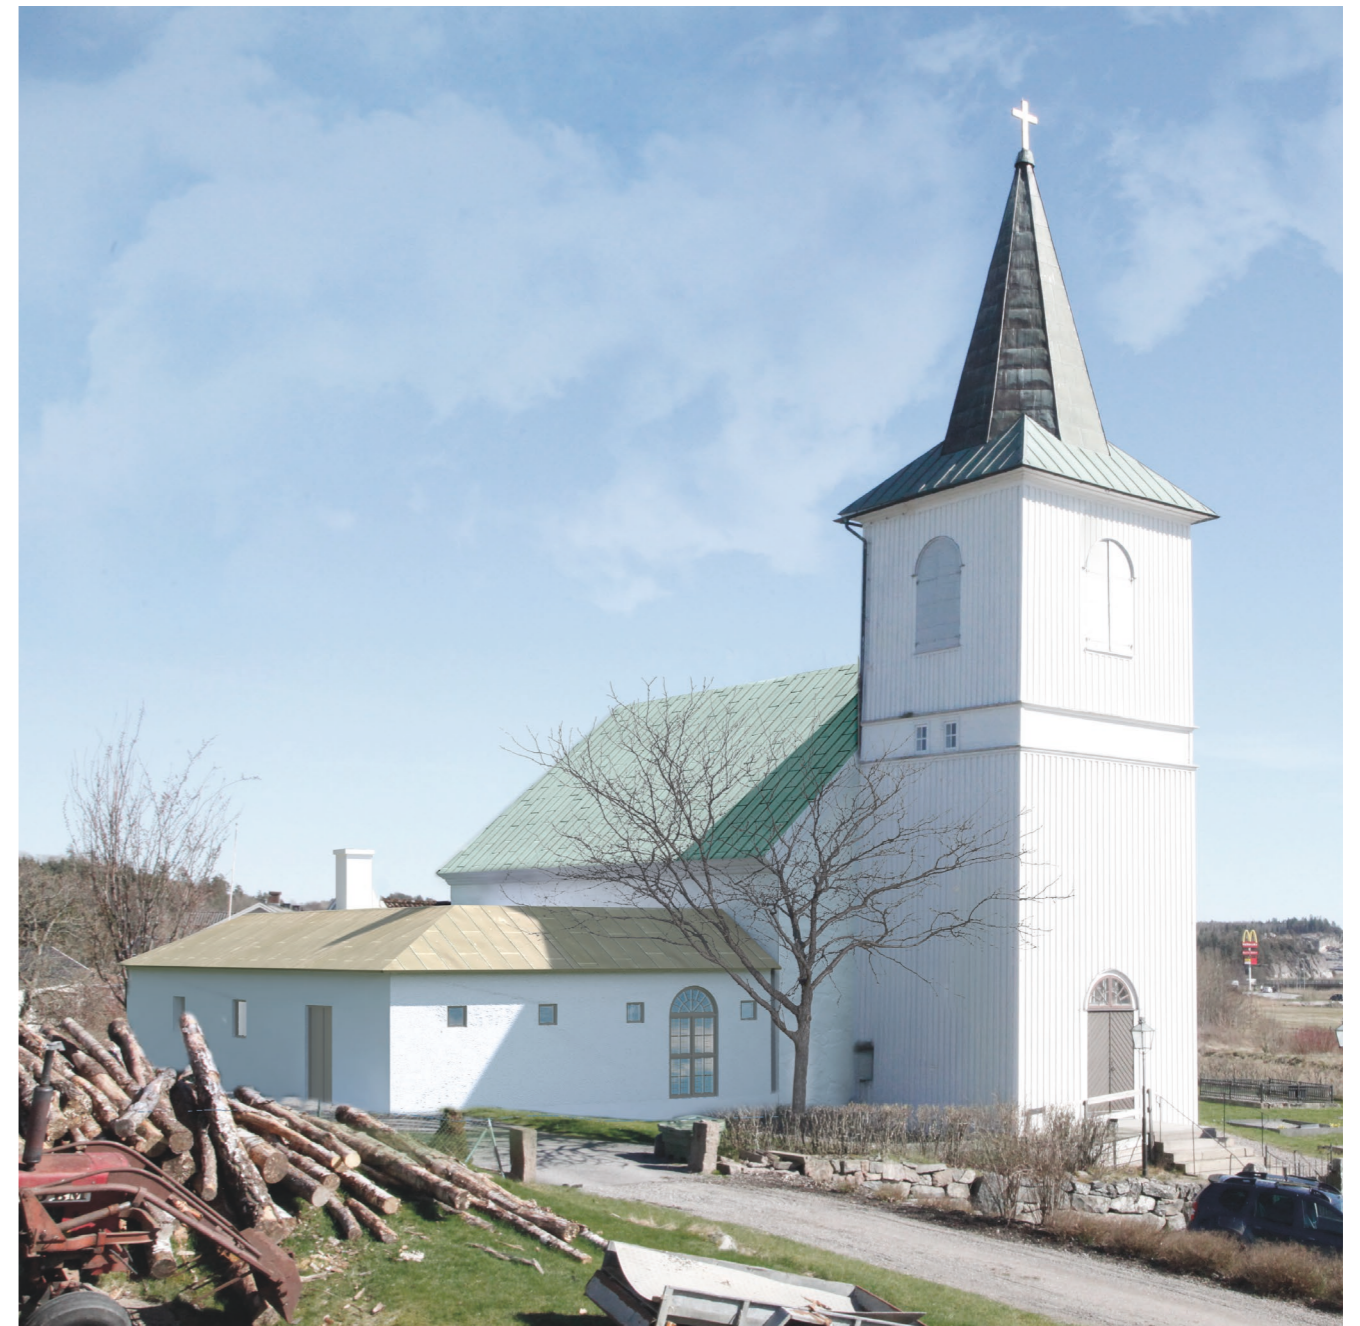
Fig. 74

Exterior
perspective

Coming from the E6 or from the adjacent road, Håby church looks mostly as it has done the last 100 years, however on the north side of the church a low volume peaks out behind the tree next to the tower (Fig. 74). The parking lot in front of the church is preserved and an accessible parking is provided in the space between the maintenance building and the addition (Fig. 75). The whole ground floor (Fig. 75) is unified without steps, except for the sacristy which keeps its tiling and floor level.

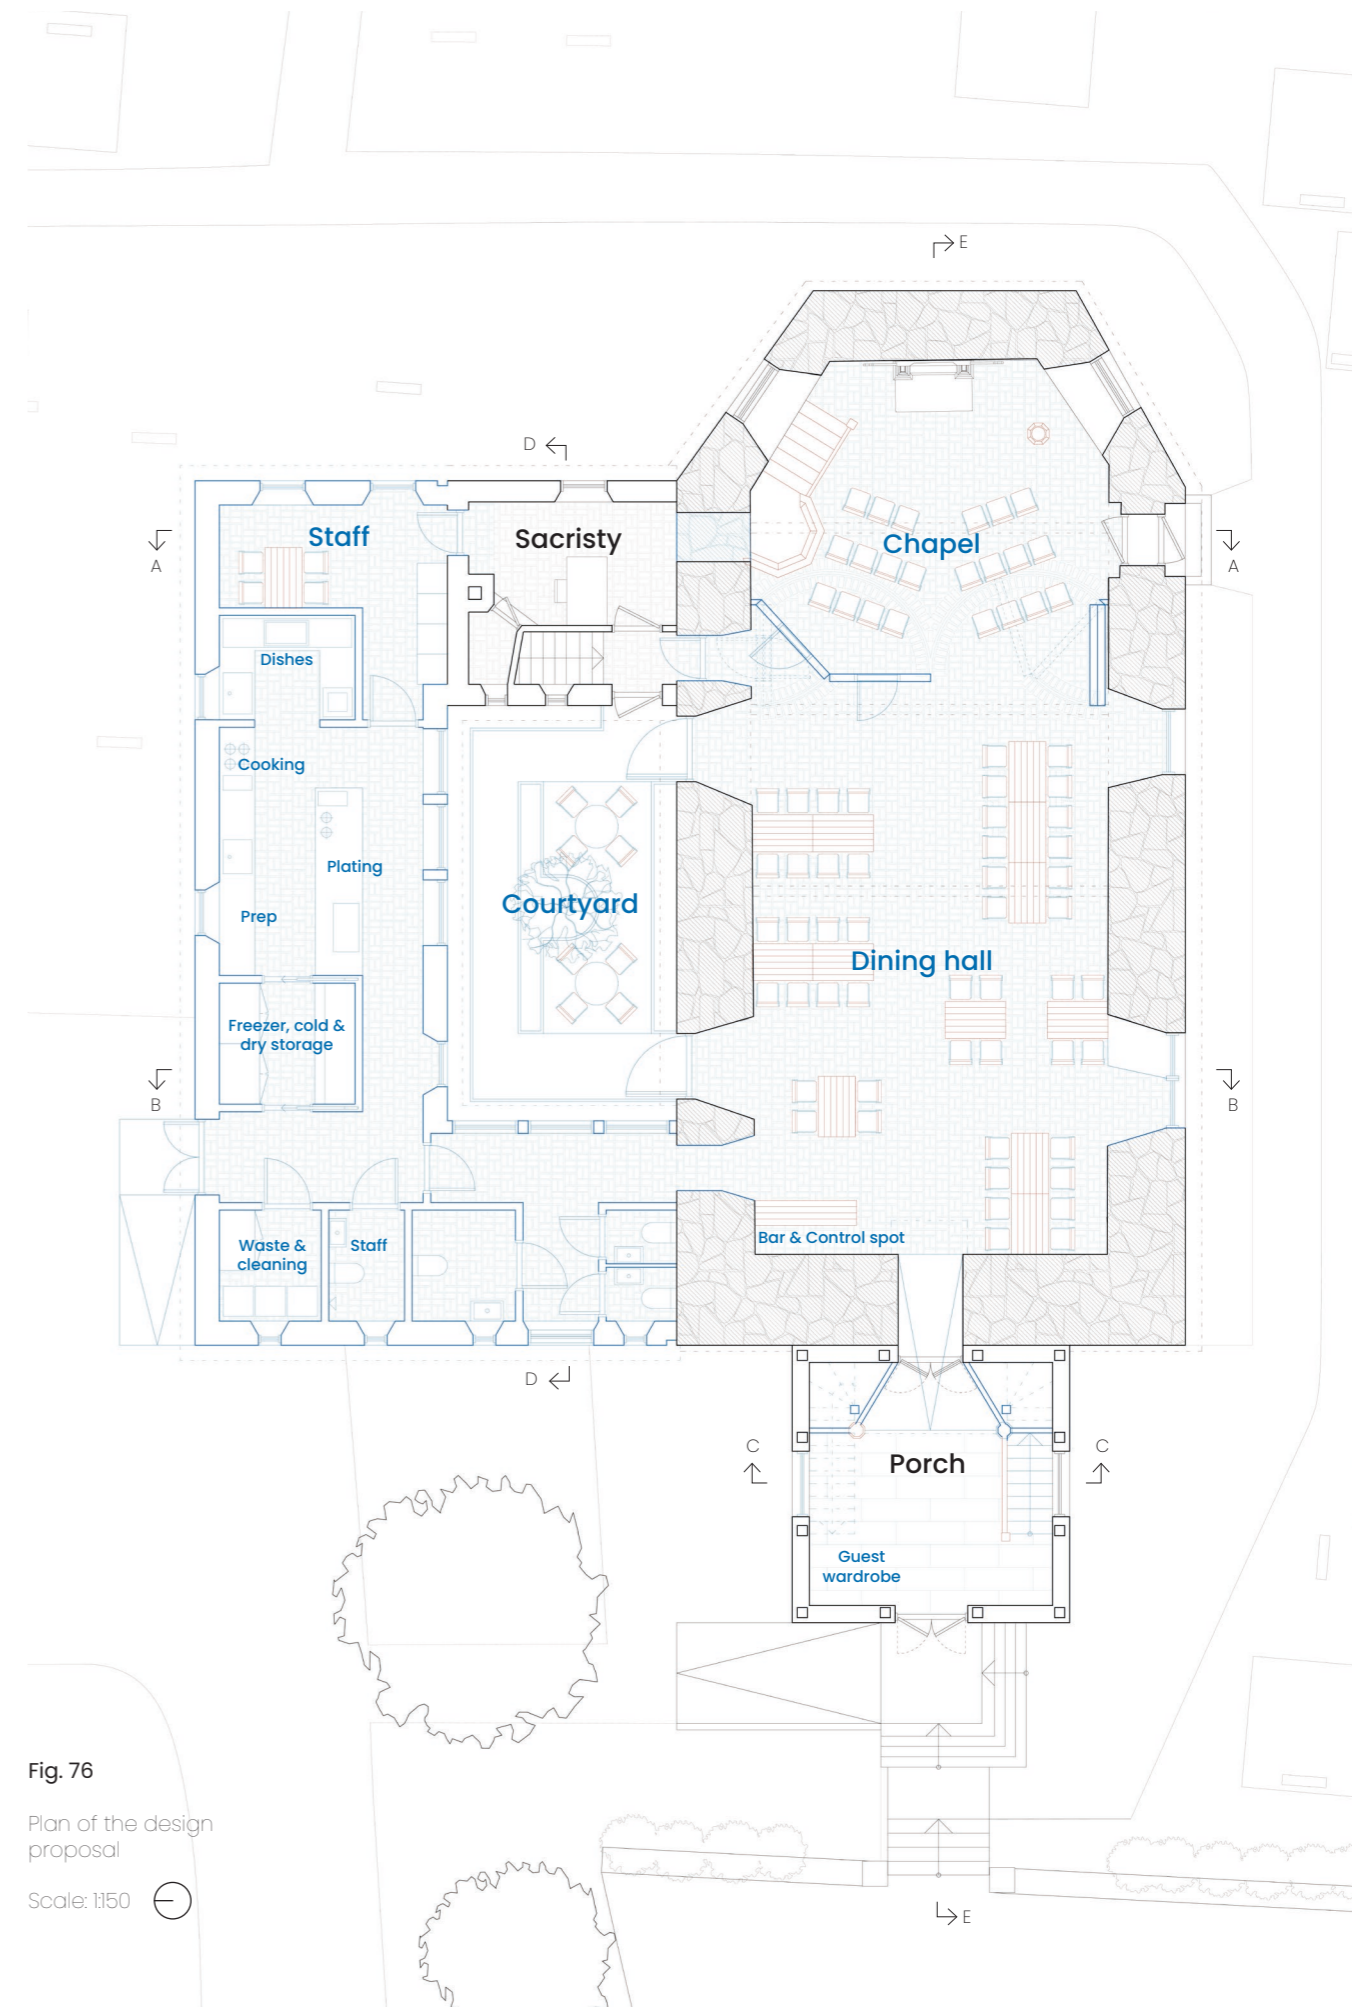
Fig. 76

Plan of the design proposal

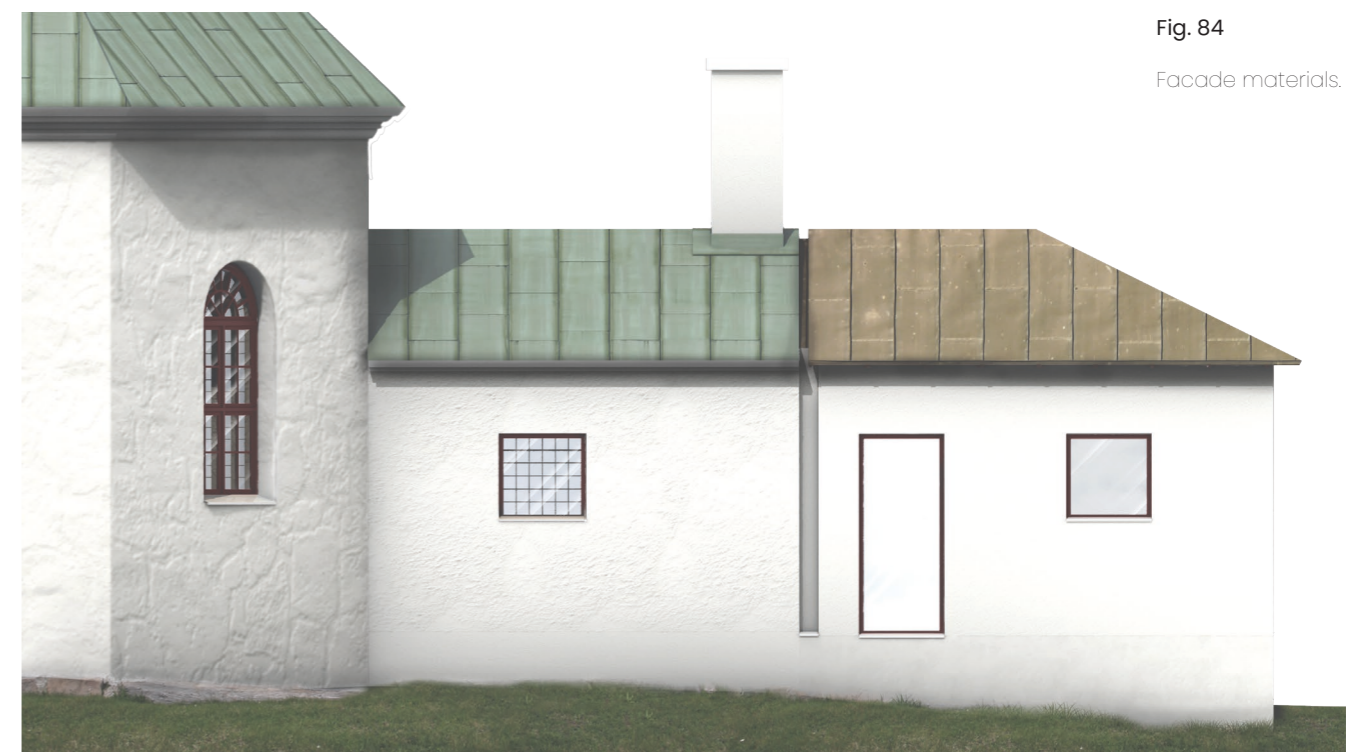
Fig. 84

Facade materials.

To communicate the different phases of the existing while unifying them, firstly the roof in need of repair is exchanged from concrete tiles to copper cladding (Fig 81-83). This is to refer to the tower roof and unify the building volumes. To further communicate the different volumes, reclaimed copper is used for the roof over the nave and sacristy while new copper is used for the addition. Thus even when having weathered over time, the distinction between the volumes will be shown. This communicative approach influences the whole of the additional building volume.

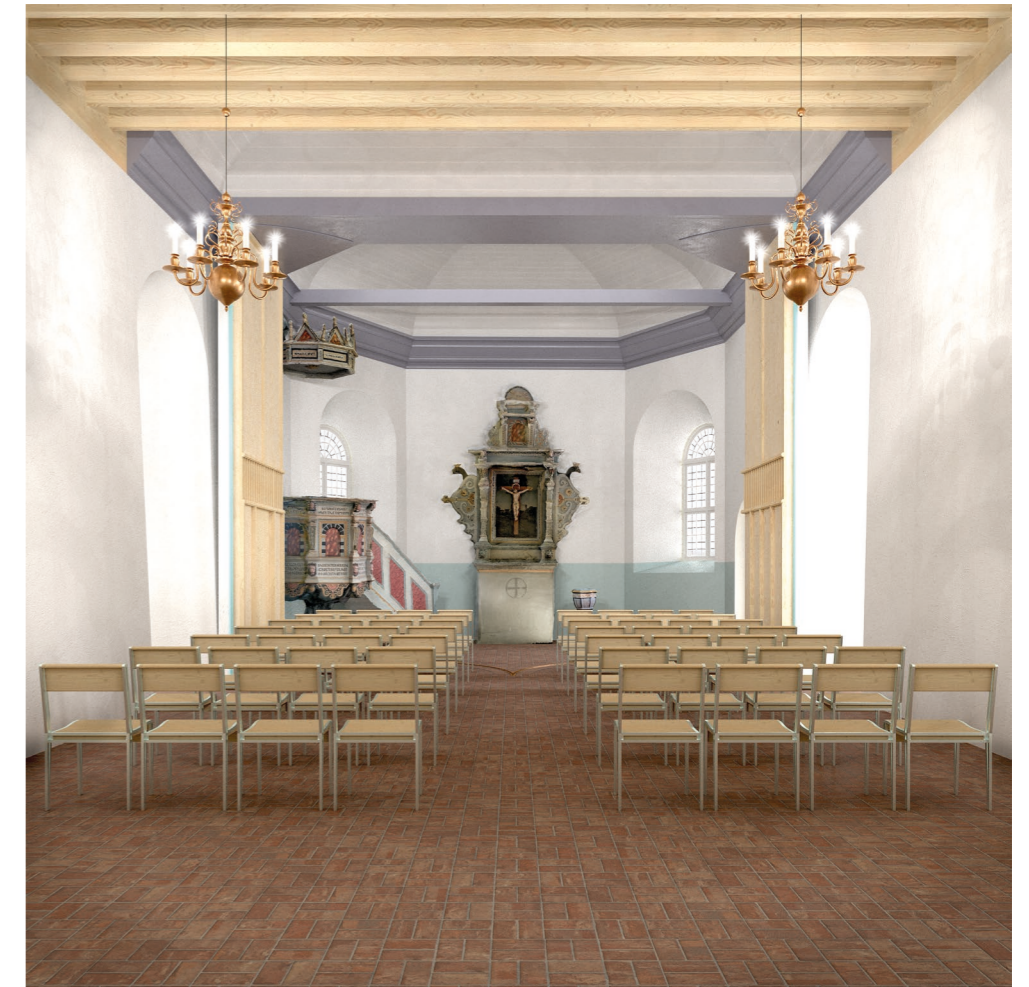
**Fig. 94**

View towards the chancel when the dividing walls are opened.

Toward the chancel, an openable dividing wall (Fig. 94) is put in place to facilitate separation between and different activities in the two spaces. The side facing the dining hall clearly separates itself from the surrounding walls, both through material and design (Fig. 95).

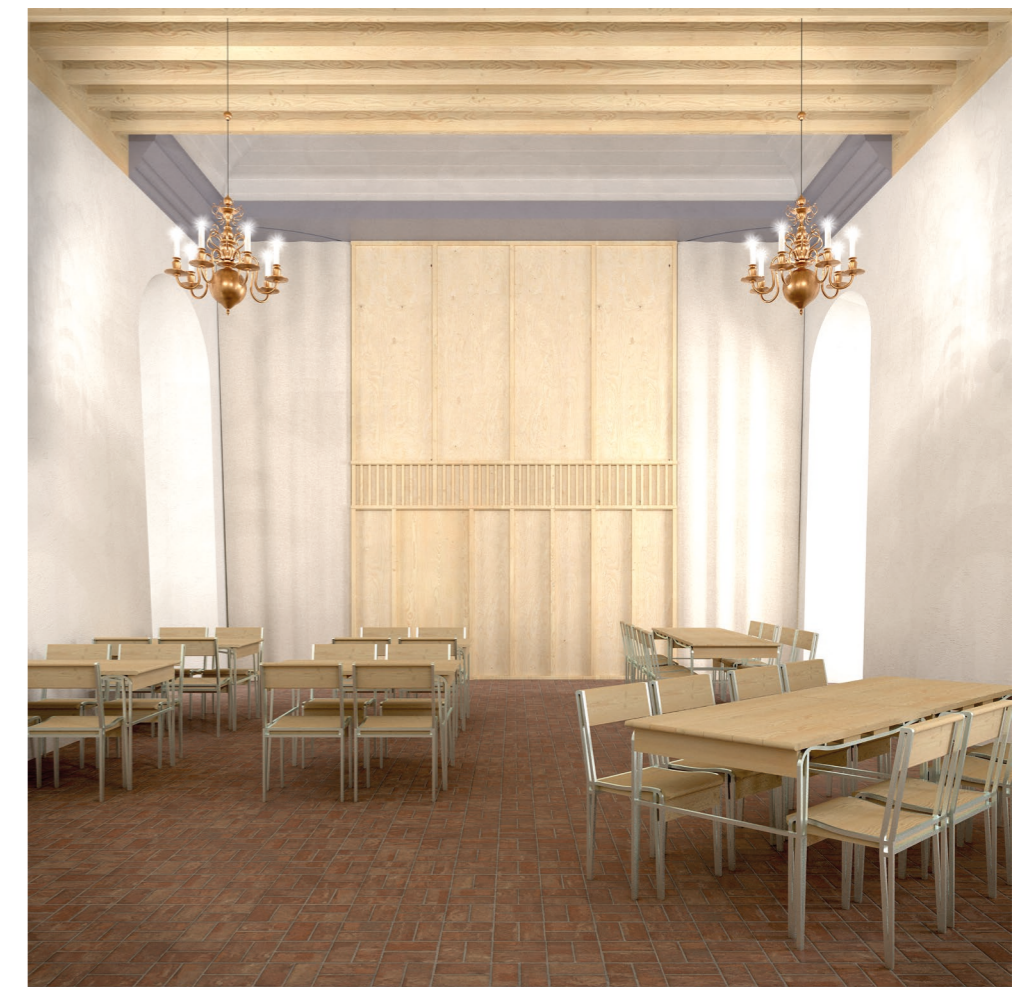
**Fig. 95**

View towards the dividing wall when it serves as a dining hall.

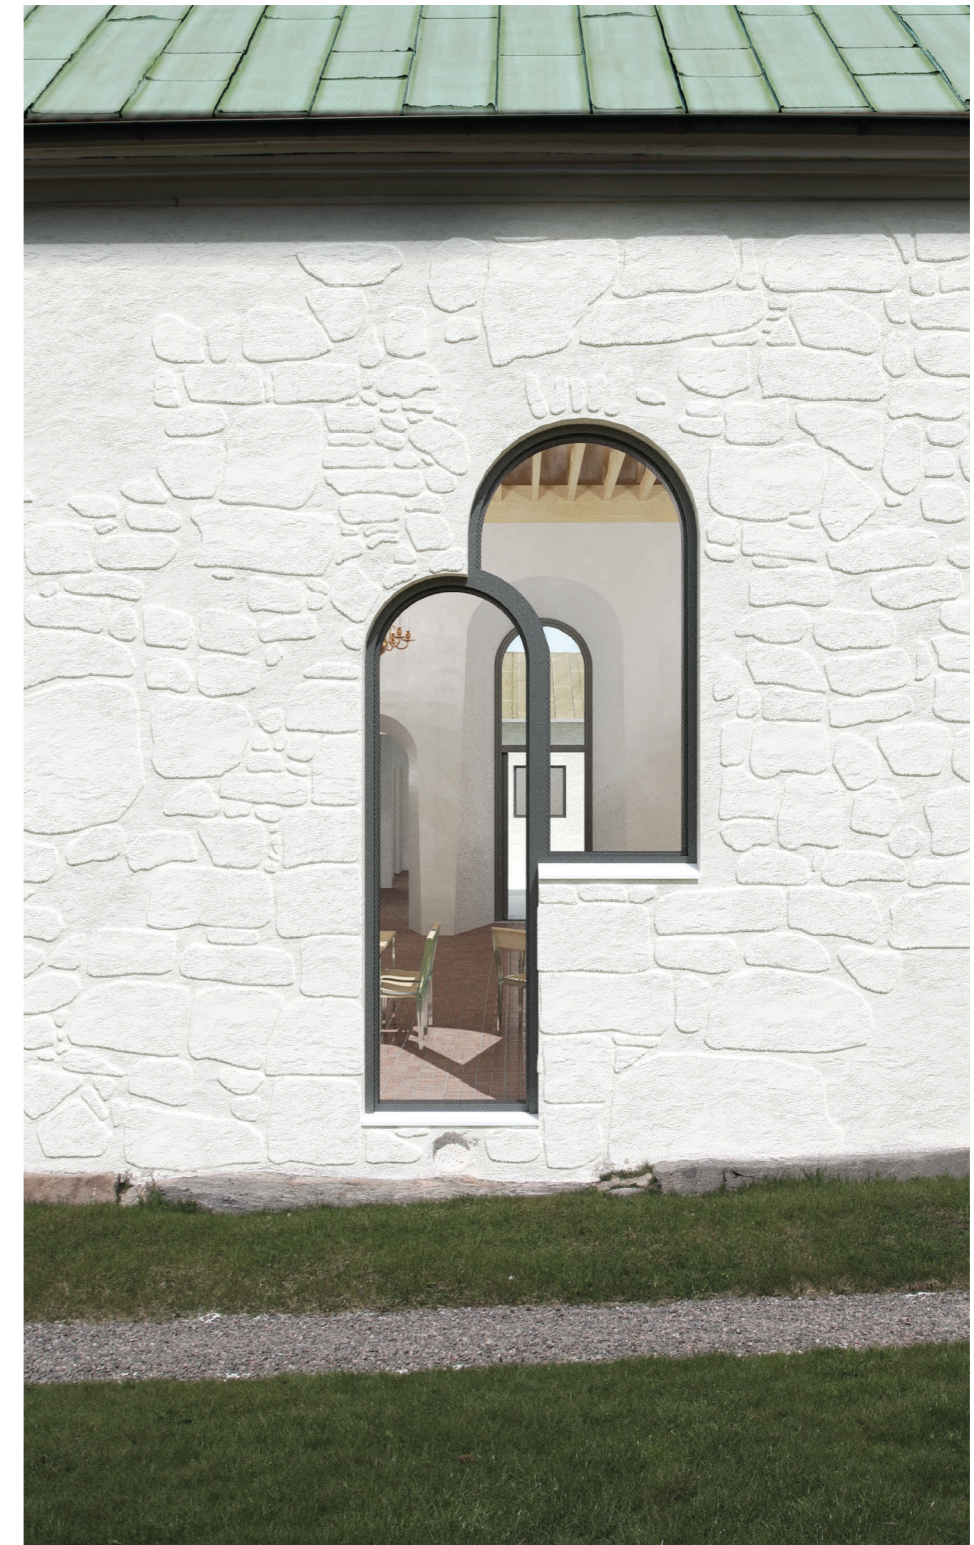
Fig. 97

View through the reopened south portal through the nave.

When the south portal below the southwest window in the nave was discovered during the re-render in 1939, nothing was done to emphasize its existence. This time however, the portal is reopened while preserving the opening of the original window to show both manifestations simultaneously (Fig. 97). The creation of the arches in the nave by enlarging the existing window openings down to the floor (Fig. 93 & 96) is also informed by the history of the building. Several times these openings have been altered and enlarged and this is just one further iteration of the same pattern.
