Resurrecting Håby church

Communicating a millennium of alteration and rehabilitation through conservation and adaptive reuse

Master's Thesis

Chalmers School of Architecture
Department of Architecture & Civil Engineering

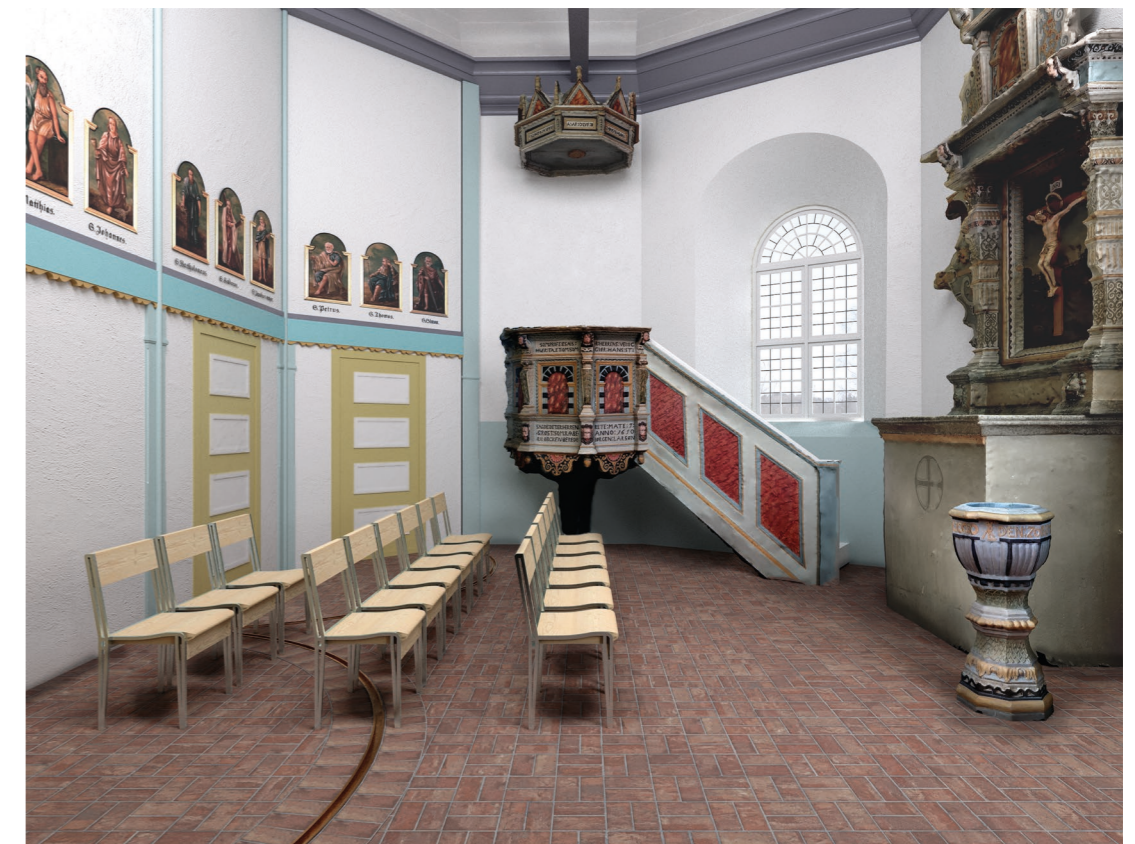
Fig. 100

View from inside the chapel.

To partially preserve the function of the building as a church, the chancel is converted into a small chapel (Fig. 100). Due to the expansion of the chancel into its current three-sided shape occurring in 1731, and the current interior coloring being in a 1700s style and chosen to complement the late 1600s inventories, the conservational strategy applied here is preservation.

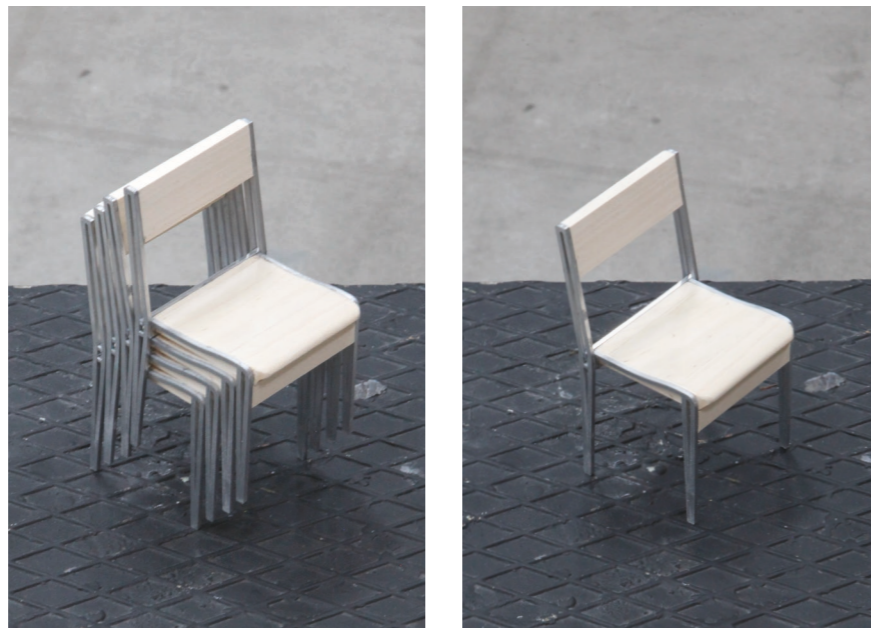
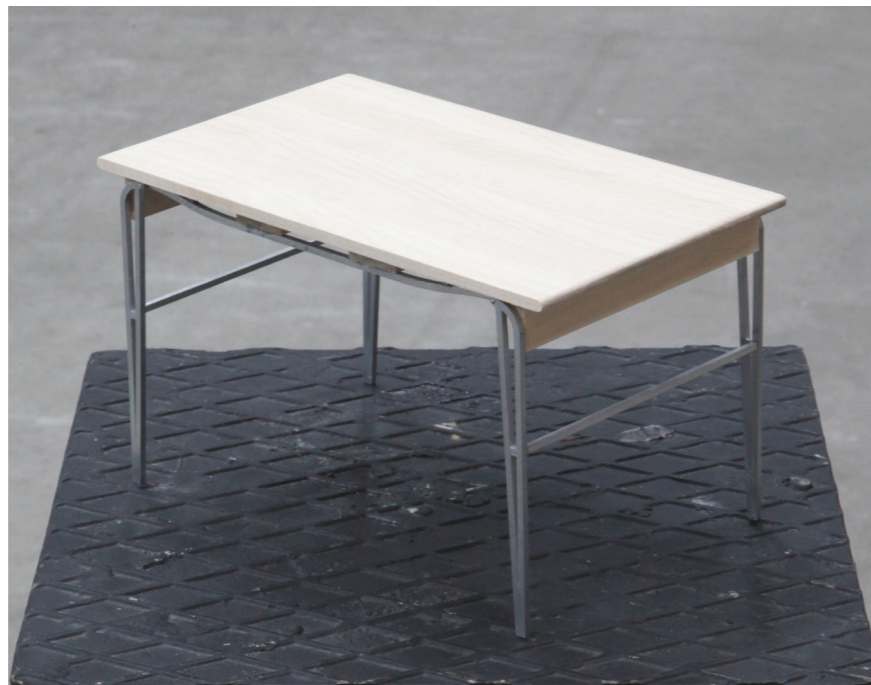
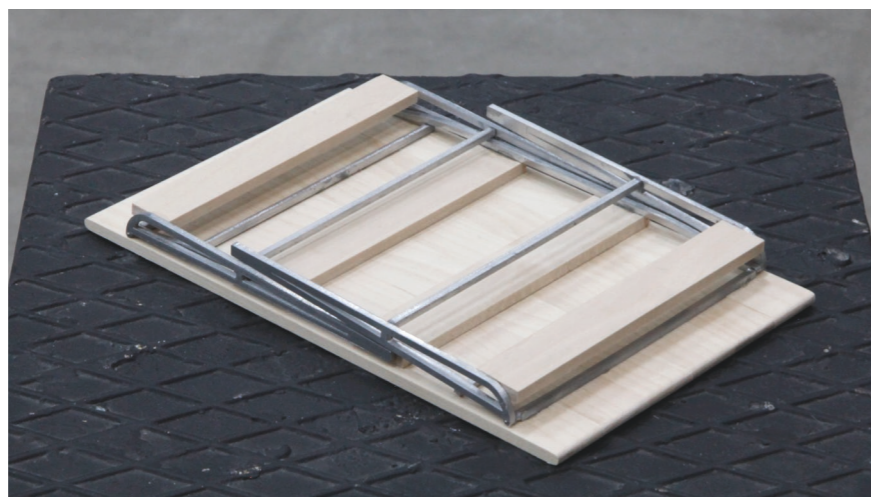
Fig. 101-106

Model pictures of chairs and table

The existing benches are made from solid wood and although a bit worn, they can be reused. The new dining hall needs seating and the flexible space would benefit from a flexible seating solution, therefore a movable stackable chair made from the parts of the old benches is proposed (Fig. 107). Preserving the patina of the benches, the wood-imitation paint on the benches is kept as-is and lets the chairs speak about their past. Contrasting the reused parts, a new steel frame with legs is designed to hold the seat and backrest. The material choice aims for a clear communication and to further apply Lundberg's idea of manifesting the present.

When remaking the floor, the pine floorboards are replaced with brick, which lends the boards to be used elsewhere. With a similar steel frame to the chairs, the boards are assembled into tables (Fig. 107).

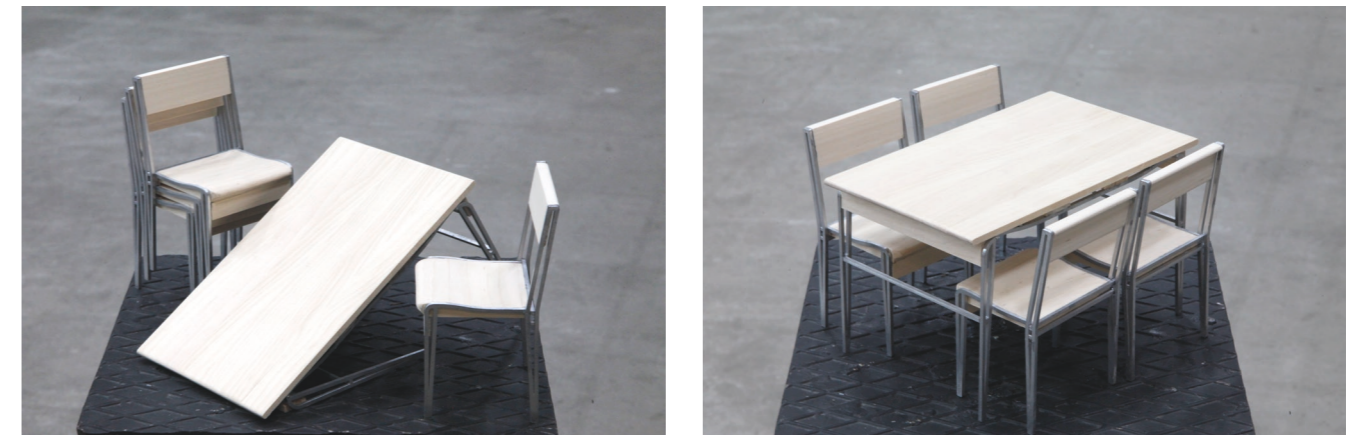
Fig. 107

Isometric drawing of bench turning into stackable chair and collapsible table reusing the removed floorboards
