Redemption of a Ruin

Creating Space for a Museum in the Ruins
of Wargöns AB

Johanna Bjurek & Wilma Hultgren
Chalmers School of Architecture
Department of Architecture & Civil Engineering
2026

Chalmers School of Architecture
Department of Architecture & Civil Engineering
MSc Architecture & Urban Design
Building Design & Transformation

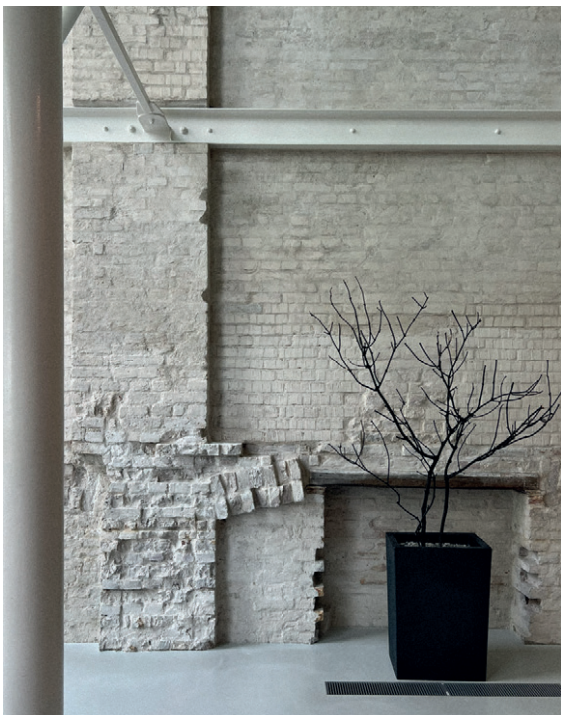
Figure 4. Valencia.

The renovation aimed to bring back its spatial qualities and give it a new function while respecting heritage. The former dance pavilion is made into a triple-height hall with a skylight running the length of the room. Internally, existing walls of the hall are maintained and gently renovated to preserve character (Dorte Mandrup).

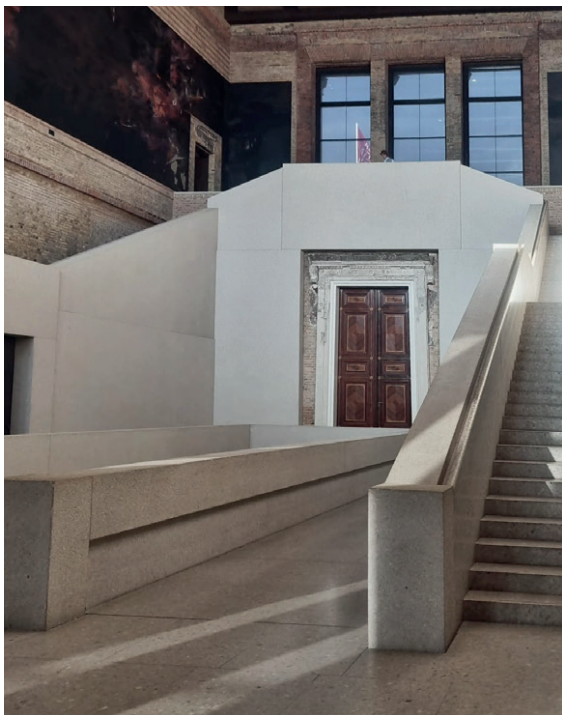
Figure 6. Staircase in Neues Museum.

The restoration by David Chipperfield Architects began in 1997 and was completed in 2009 and has since gained much recognition for its innovative approach to restoration. For the practice, it was important to respect all phases of the building's history, including the many years it spent as a ruin. The transformation is neither an exact reconstruction nor a contrasting contemporary addition. New materials are carefully inserted in the existing fabric and the result is a convincing, modern interpretation of the 19th century building (David Chipperfield Architects, 2009).

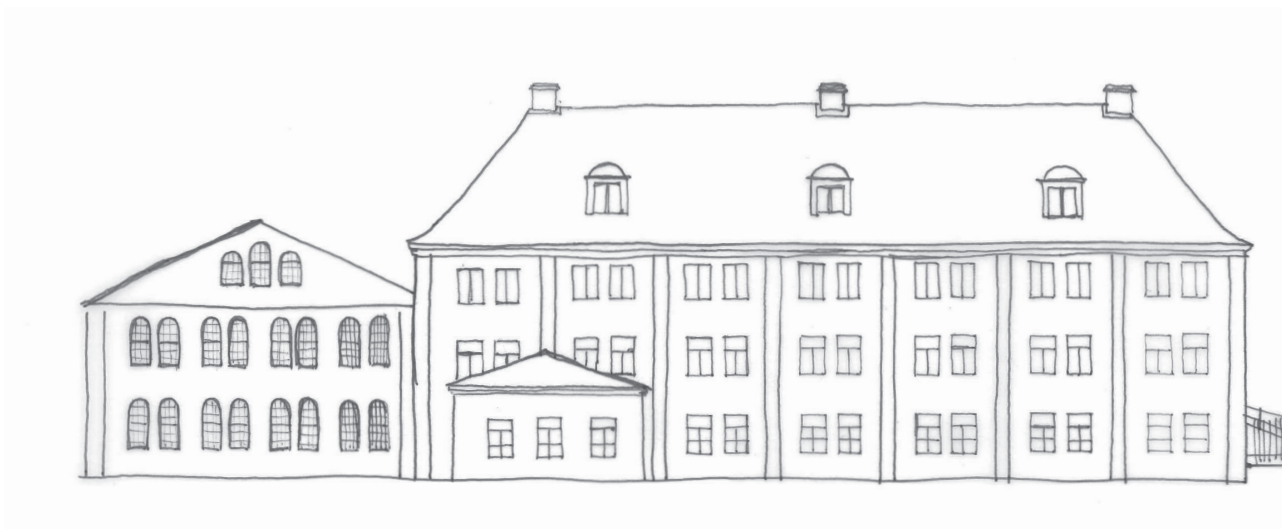
Figure 17. Facades of the old office (right), the gate and additional office building (left).

The old office of Wargöns AB is a two storey building with a basement, constructed in red and yellow brick. Since its original construction in the late 1800s, it has undergone several extensions and adaptations. The southern part, indicated in red in figure 18, is the original structure from 1888 and consists of load bearing, massive brick walls. The ground floor is constructed with two-stone thick walls. Steel beams have been utilised when needed to achieve larger spans. The foundation is in granite and the floor structure between basement and ground is presumably done in a combination of brick and steel with a possible concrete casting on top, a combination typical for its time. Both the roof structure and the floor structure between the ground floor and first floor were originally in timber (Wallin & Holm, 2020).

In the 1940s, the building was extended to the north. The inner walls and the floor structure were this time carried out in in-situ cast concrete, which explains the shift seen in wall thickness between the two parts. However, the exterior walls and basement were constructed in similar manner to the original construction, with a possible inner addition of concrete in the basement (Wallin & Holm, 2020).

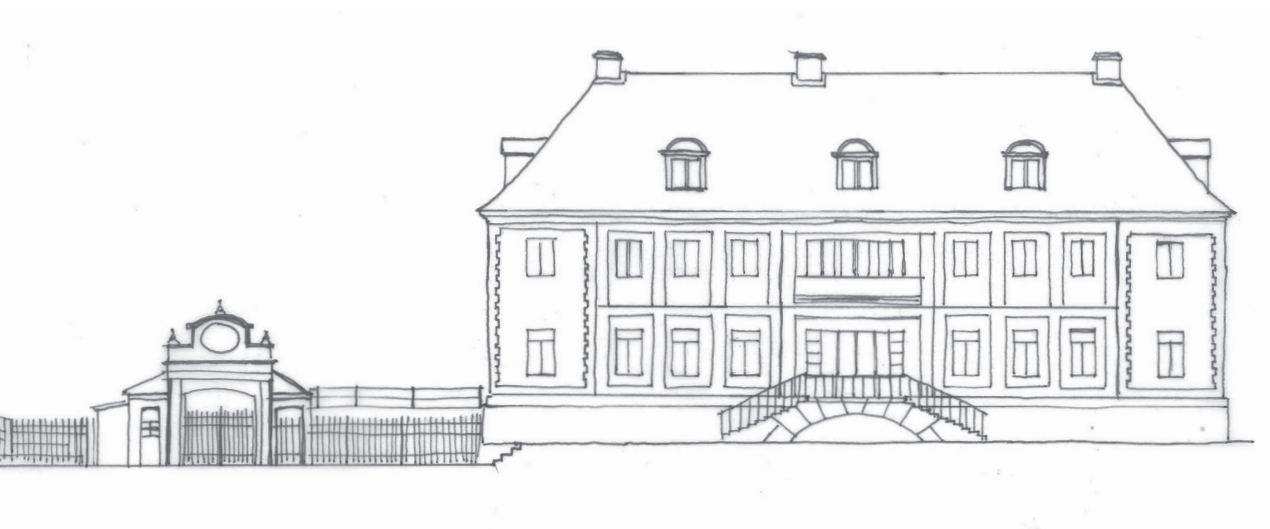
In the 2020 fire, the wooden roof construction was completely eradicated, along with the timber floor structure in the original part of the building. The steel beams have been deformed from the heat and are at risk of collapse. The same applies to the balcony on the western facade, which is considered to be at serious risk of failure. All installations are assumed to be unusable and there is a prevailing risk of smaller building parts falling down. Apart from these damages, the exterior and interior brick walls remain in good condition despite the fire, showing limited signs of deterioration. The same applies for the concrete interior walls. Overall, the structural system is assessed to be stable and its load bearing capacity intact (Wallin & Holm, 2020).

Figure 19. Facades of the old office, current state.

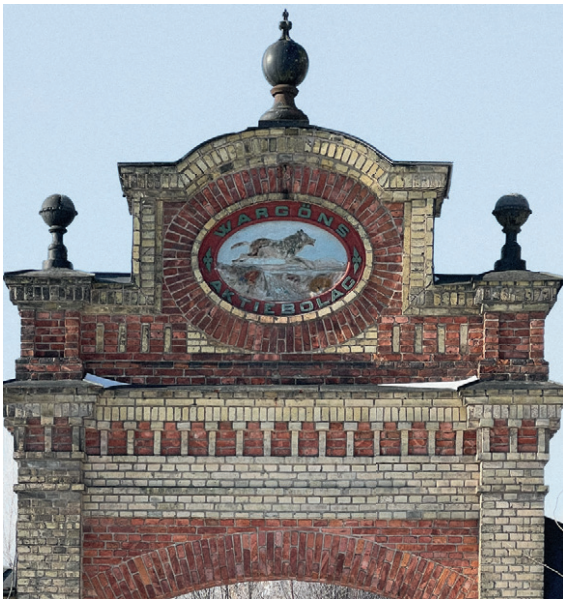
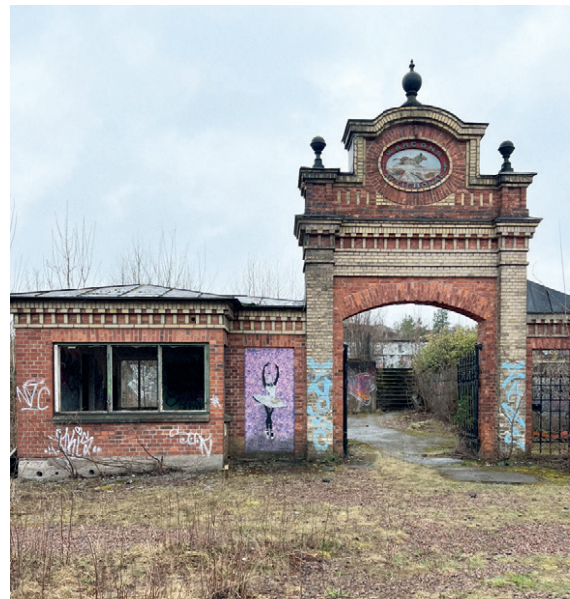
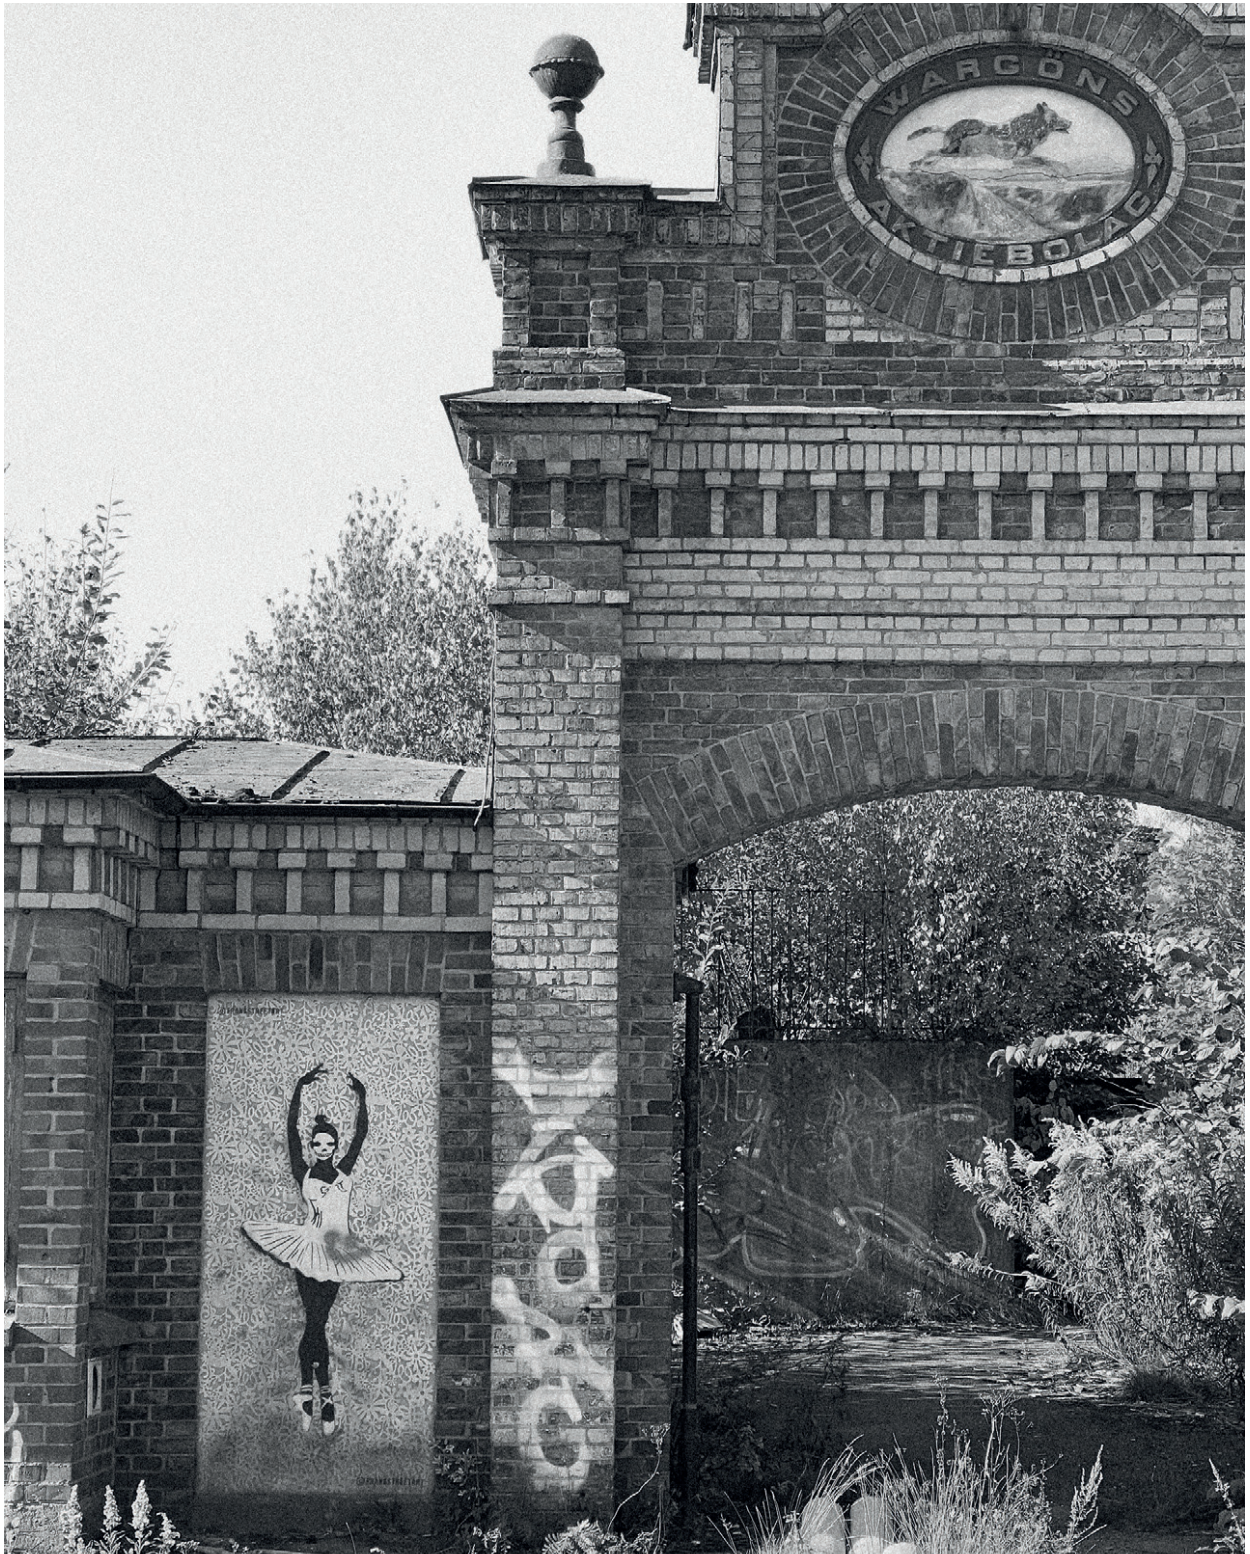
The gate was constructed around the same time as the old office, similarly in red and yellow brick. Before the canal was filled in in the 1940s, the gate stood at the end of the bridge connecting Vargön to the mainland (Bergström, 2009). Thus, all workers passed through the gate when arriving at and leaving work, giving it a strong symbolic value. After the canal was filled in, its symbolism became less prominent. However, it remains a strong identity marker for the old mill. The sign on the gate showcasing a wolf is the symbol of Wargöns AB, 'varg' in Swedish meaning 'wolf'.

Figure 29. Photograph of the gate.

Figure 30. Photograph of the gate.

Figure 31. Photograph of the gate.

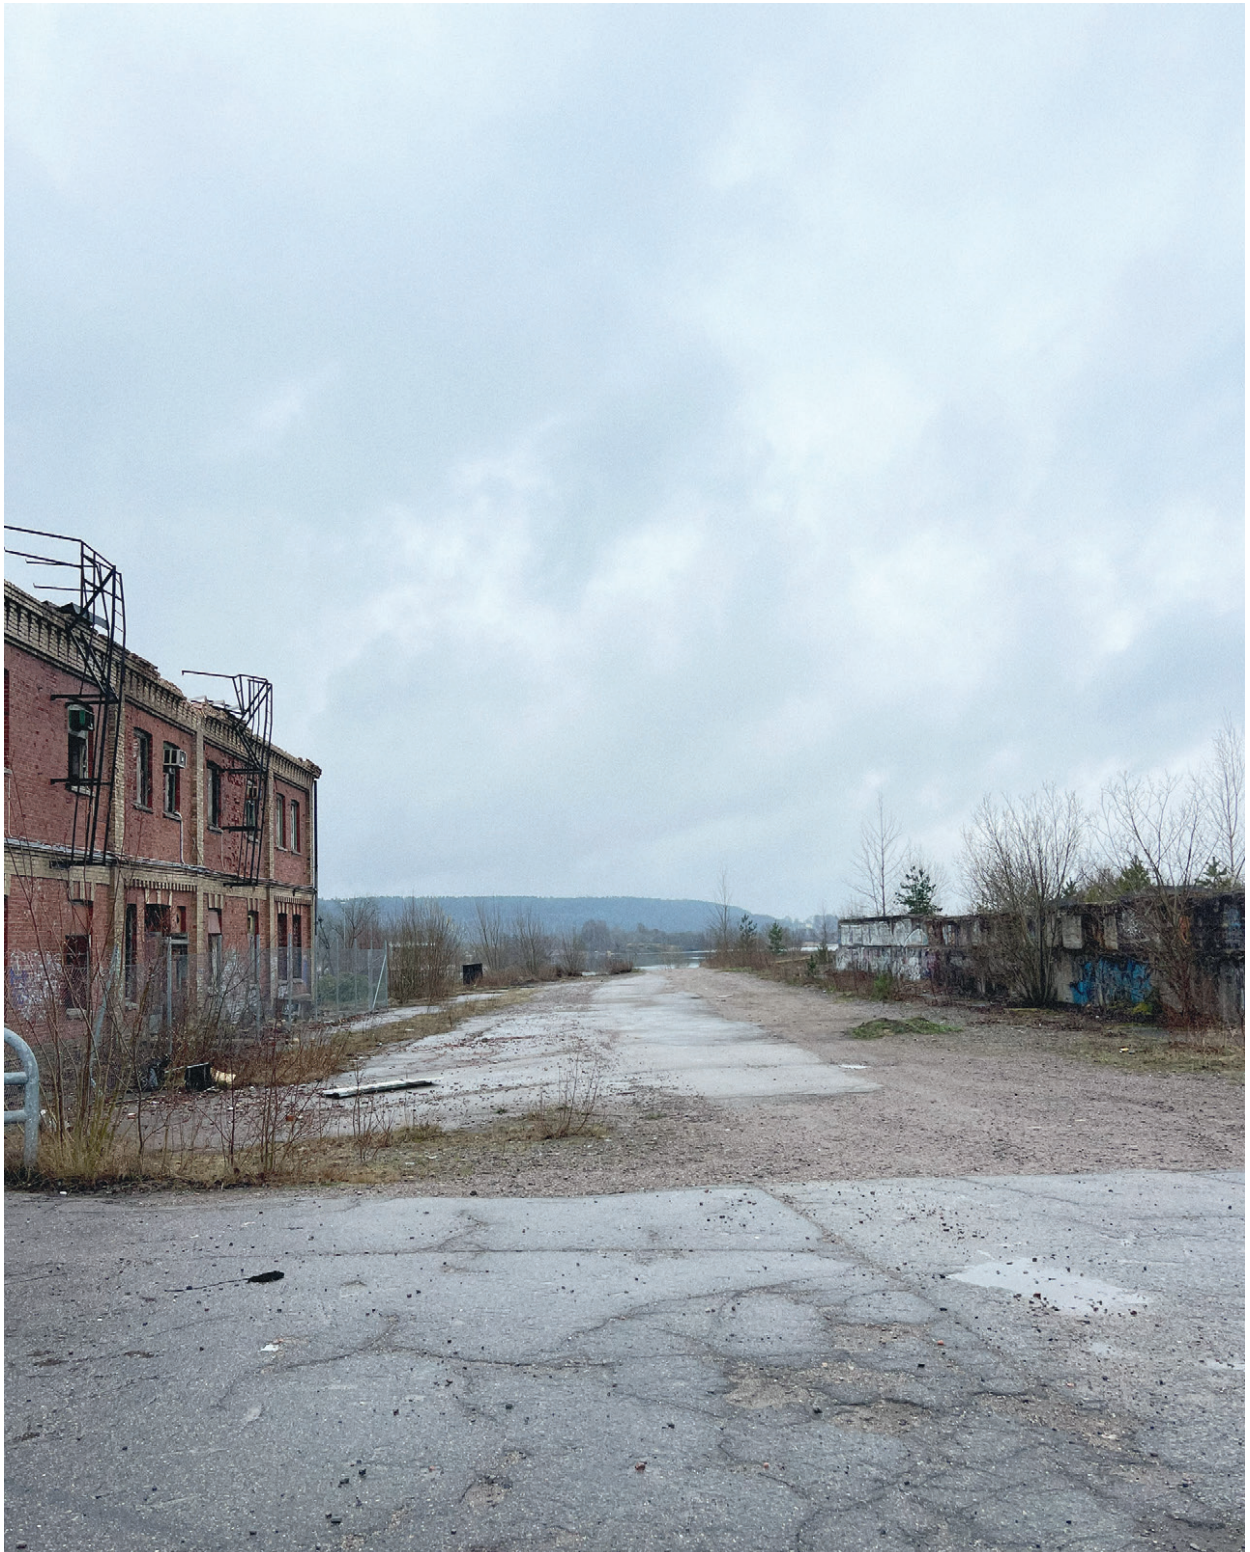
The 20 000 m² site housed many different buildings during the active years of the mill. As they all were demolished following the closure of the mill, only foundations and traces of the former structures are visible at the site today. The topography varies with large height differences, telling a story in its rough, post industrial landscape. Over the years of abandonment, the site has developed into a space for informal culture. Today, it hosts, among other things, an impressive graffiti collection and a skate park.

Figure 34. Photograph of the site and west facade of old office.

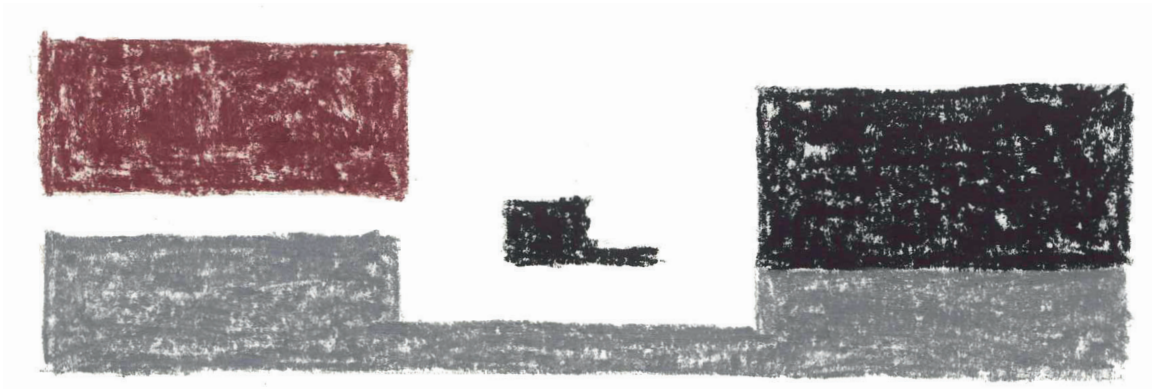
Figure 37. Interventions in plan. Red marks new building. Grey marks reintroduced water.

In this thesis, the existing building is treated as a *palimpsest*, where traces of time are preserved and reinterpreted. Through continuity, reimagination and addition, the proposal is grounded in an *adaptive reuse* strategy where the aim is to extend the building's life by introducing a new layer rather than returning it to a former state, aligning with principles defined by Plevoets and Van Cleempoel.

Similarly to how Chipperfield Architects viewed the years Neues spent as a ruin as just as important as any other epoque in its history, this thesis aims to do the same. Interventions should not be an act of erasure, but rather an act of directing and expanding on the existing character of the site. Furthermore, there will be a clear distinction between old and new. The clear visibility of time and change creates a balance between memory and presence. Through this design approach, the proposal allows a dialogue between the past and the present. By letting memory and renewal coexist, the transformation aims to not be a replacement, but rather a continuation. Thus, the new additions do not replicate the past, but respond to it, balancing remaining and introduced elements.

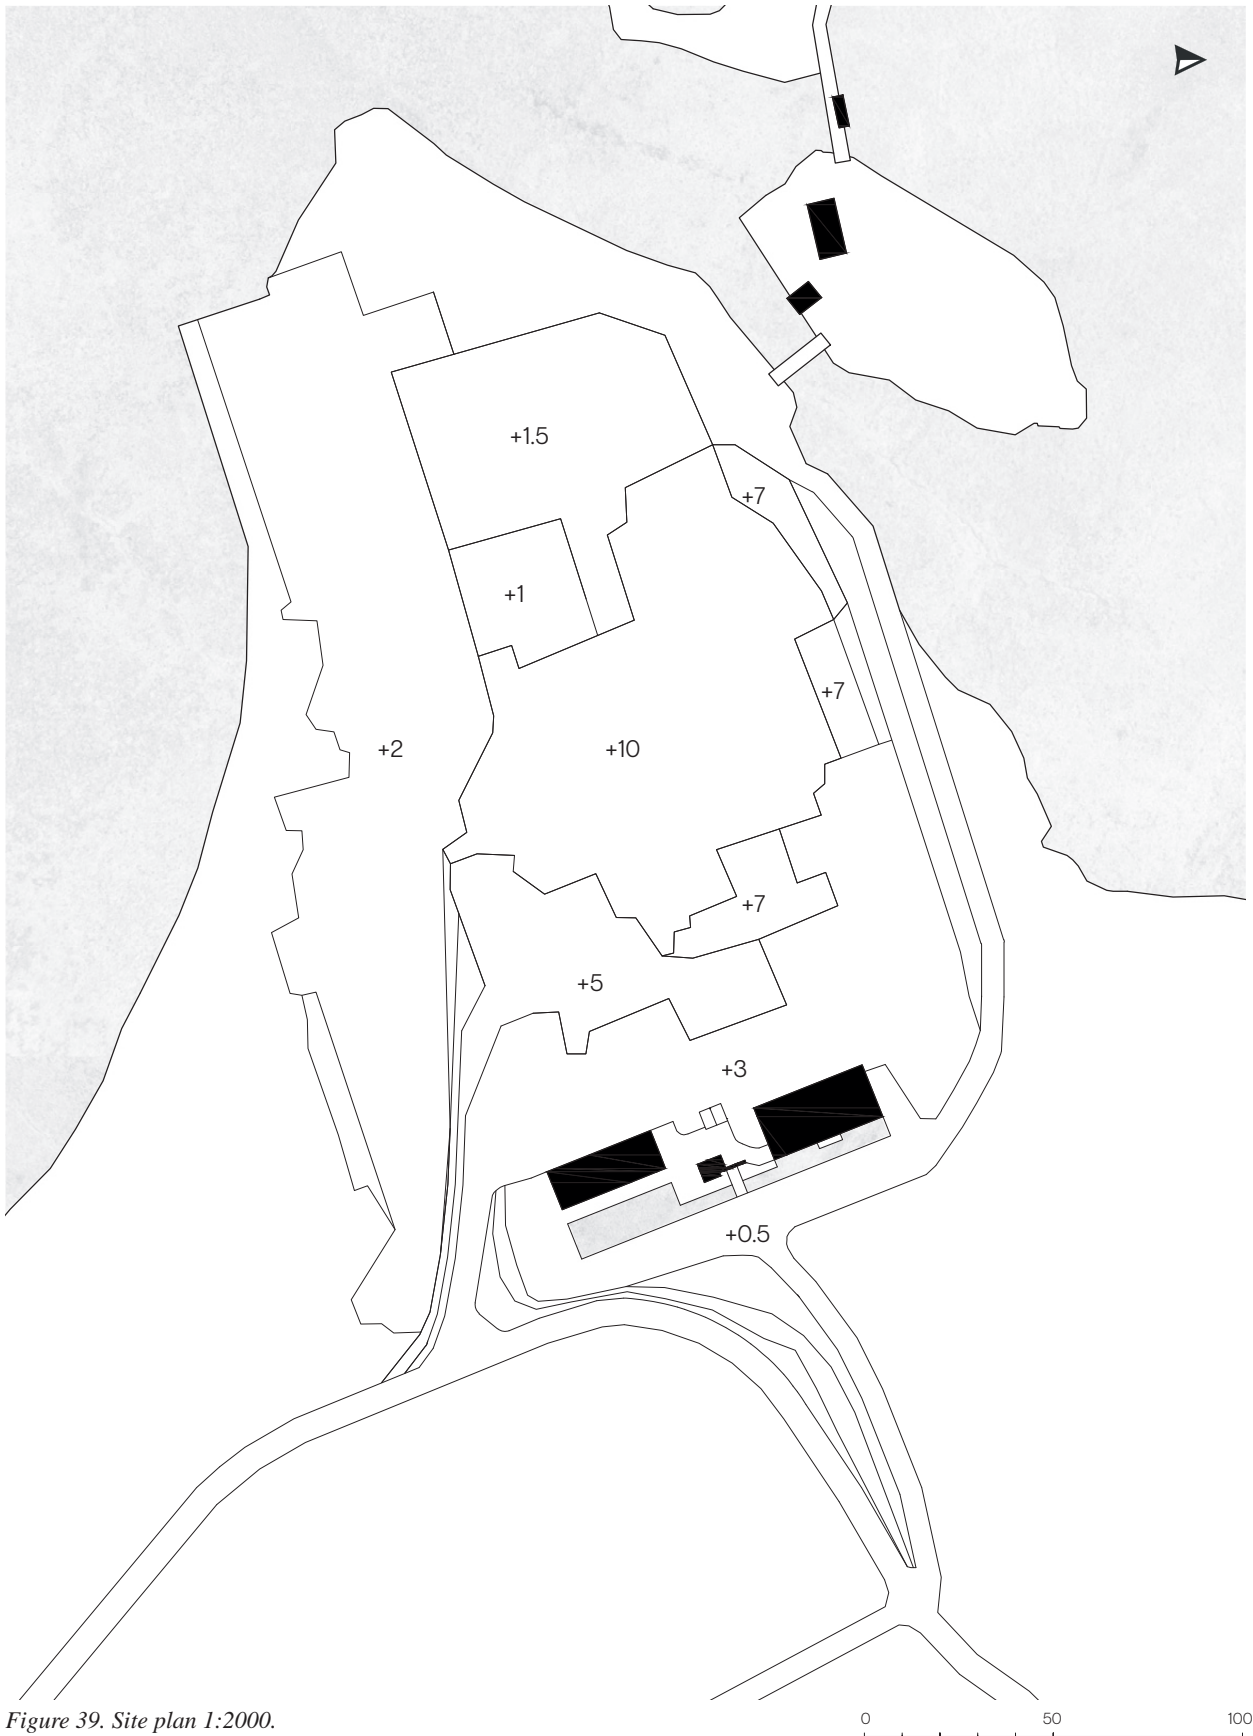
Figure 39. Site plan 1:2000.

Water is reintroduced at the site as a homage to the former canal that once separated Vargön from the mainland, aiming to reconnect to its history as well as providing reflections of the buildings. It also helps steer the movement towards the gate to achieve a new entrance sequence. A core idea of the transformation proposal is to strengthen the gate's position at the site and once again let it serve as the entrance to the area, thereby reconnecting to the history of the site.

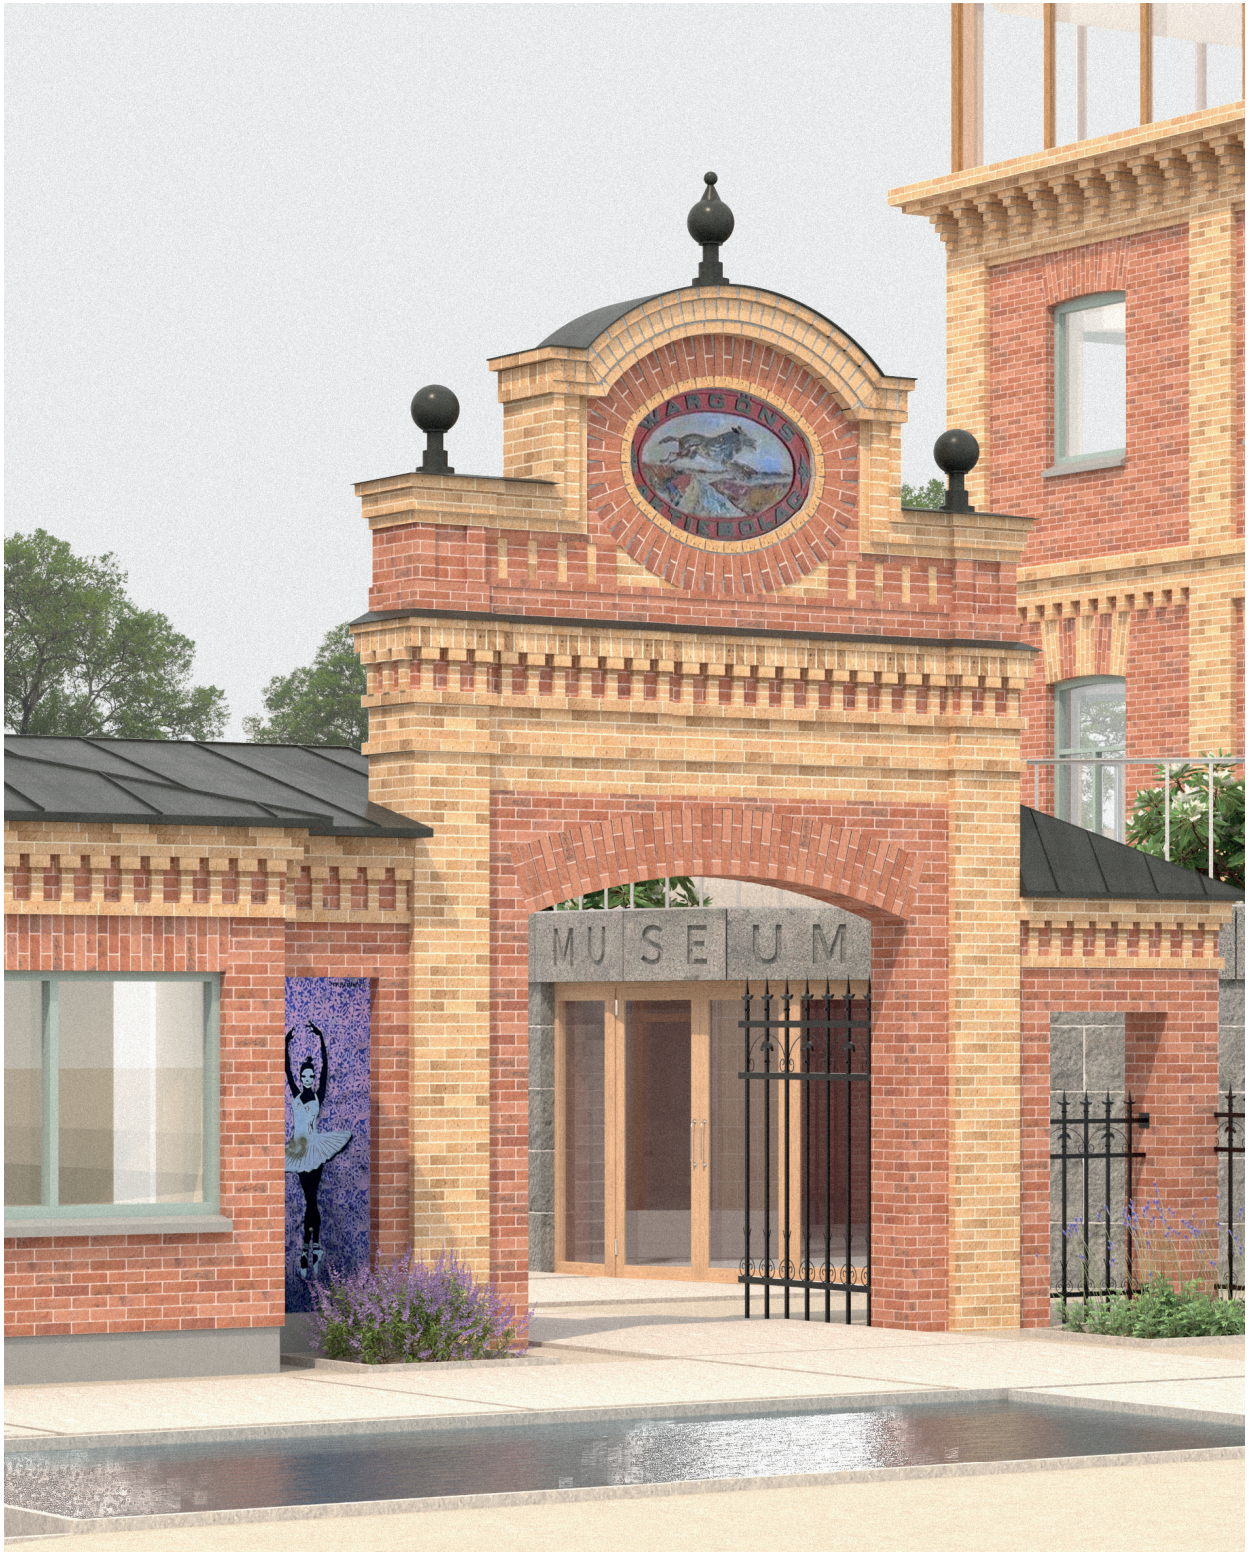
The new floor structure consists of a composite steel and concrete system, supported by the existing walls as well as by additional steel beams and columns where required. Where additional columns are necessary, they are integrated within a wood fibre board which also serves as interior insulation. The interior insulation improves the old office's energy performance and is finished with plaster, creating a cohesive interior expression. Space for installations are provided within the suspended ceiling.

Figure 44. Entering the old office.

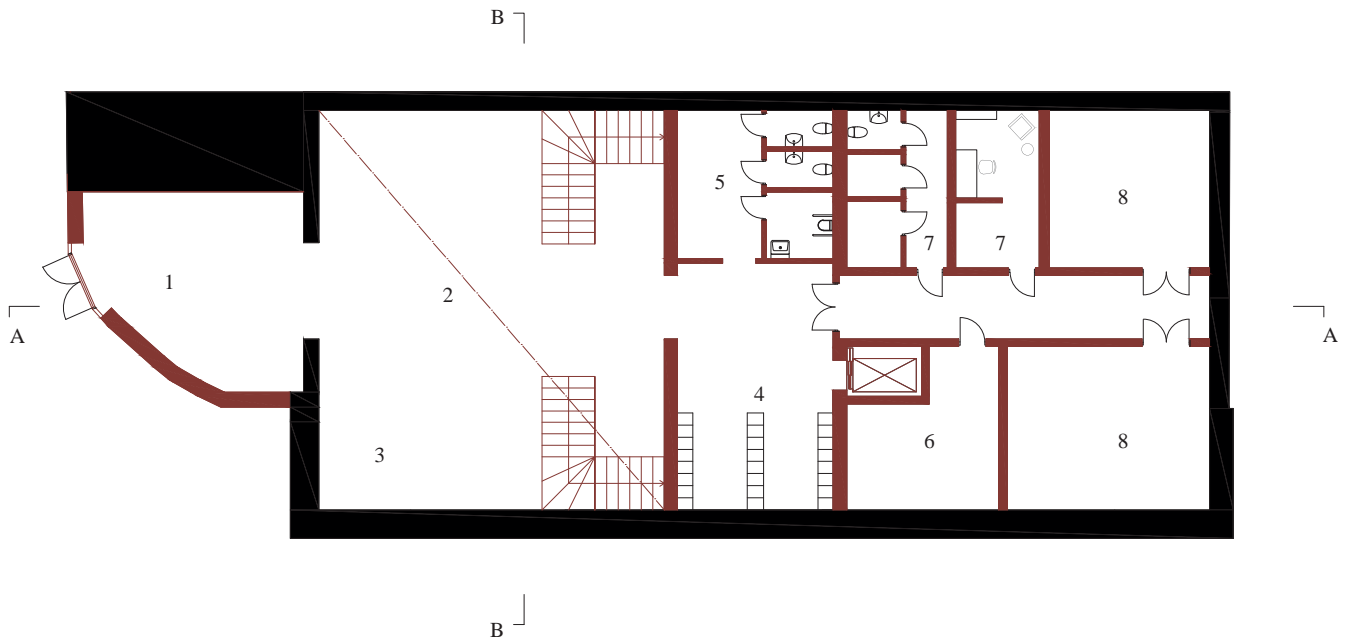
To recenter the gate as the primary entrance to the area, the main entrance of the old office had to be moved. An accessible main entrance is created on the southern side of the old office through utilising the existing landscaping to form an extension for the entrance room. After passing through the low and dark entrance room, the visitor enters a double-height hall in the former basement of the building, creating a dramatic contrast in the arrival sequence. A set of double staircases leads up to the first floor - former ground floor - where the exhibition continues. Here many of the original inner walls are preserved. A central staircase, introduced in the corridor from the original plan, guides the visitor to the second floor. The second floor has a similar floor plan to the original office. Here the new roof structure is visible with large windows bringing light from above into

Figure 45. Entrance floor 1:250.
 1. Entrance, 2. Entrance hall, 3. Reception/shop, 4. Cloakroom, 5. Restrooms, 6. Technical, 7. Staff area, 8. Archive.

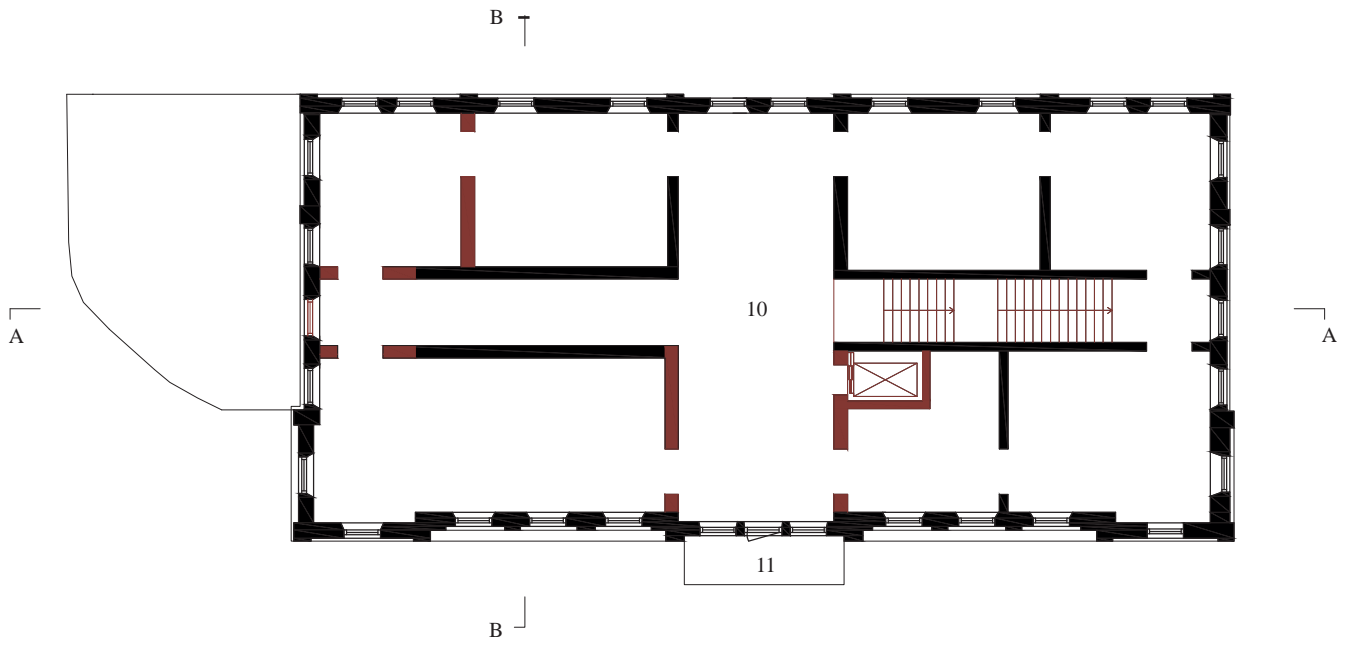
Figure 48. Second floor 1:250 .
10. Exhibition space, 11. Balcony.

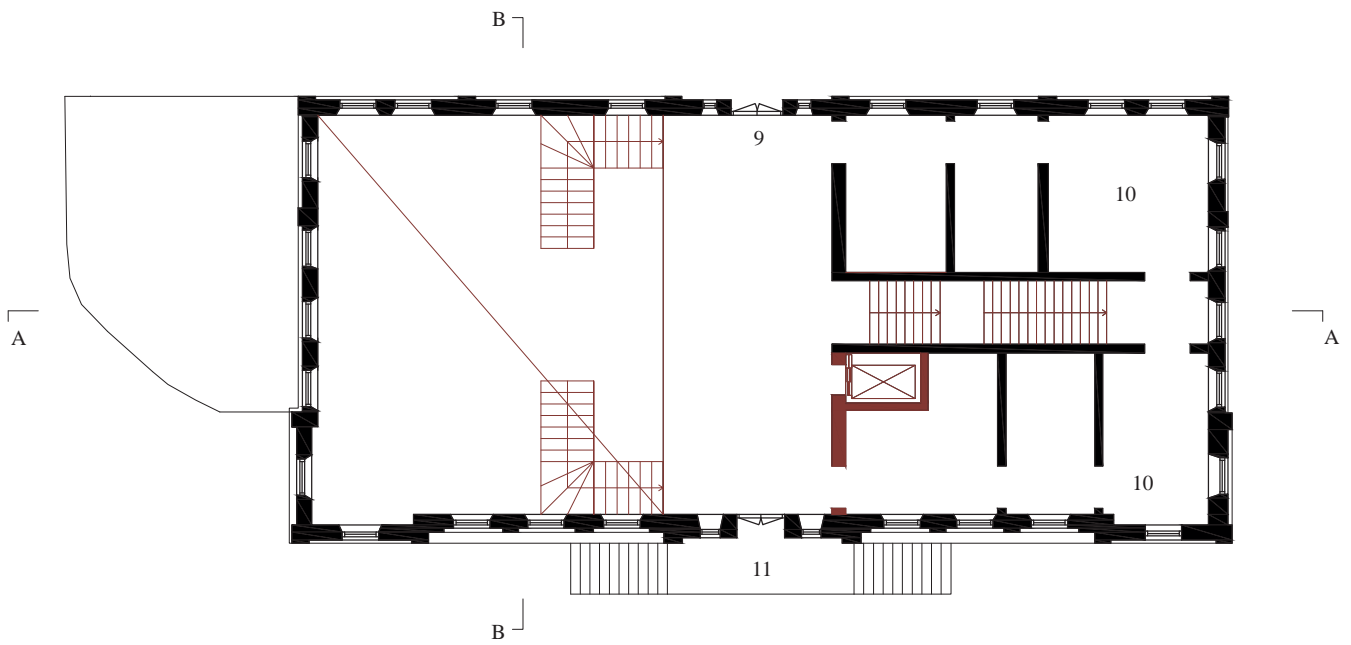
Figure 49. First floor 1:250.
9. Second entrance, 10. Exhibition space, 11. Balcony.

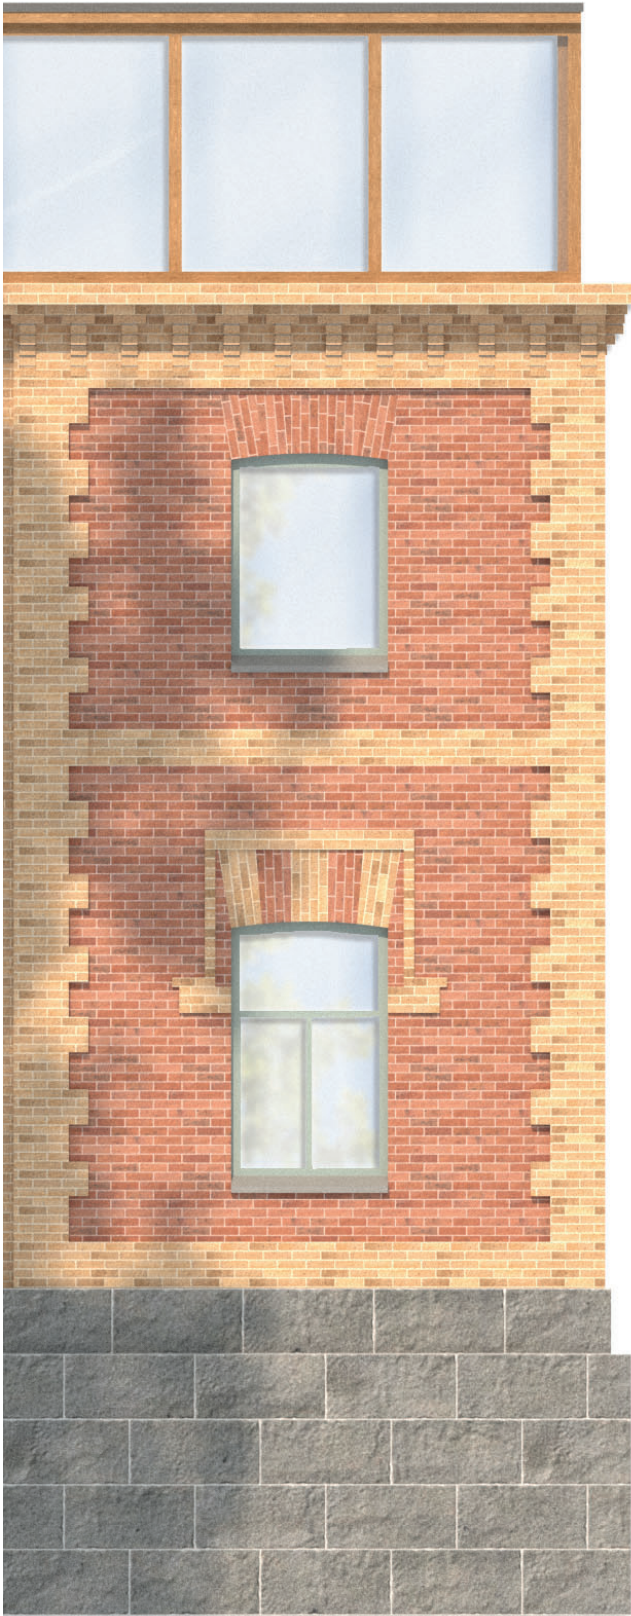
Figure 54. Detailed elevation, old office.

The proposal has further been developed through detailing and built models, to strengthen our work and explore it in more detail. A cast of the wolf symbol of Wargöns AB sits at the entrance of the new building. Four different floorings have been designed, for both the old office and for the new building. The window detailing for the new building incorporates both elements found from the old office as well as details found in historical pictures, to further anchor the proposal.

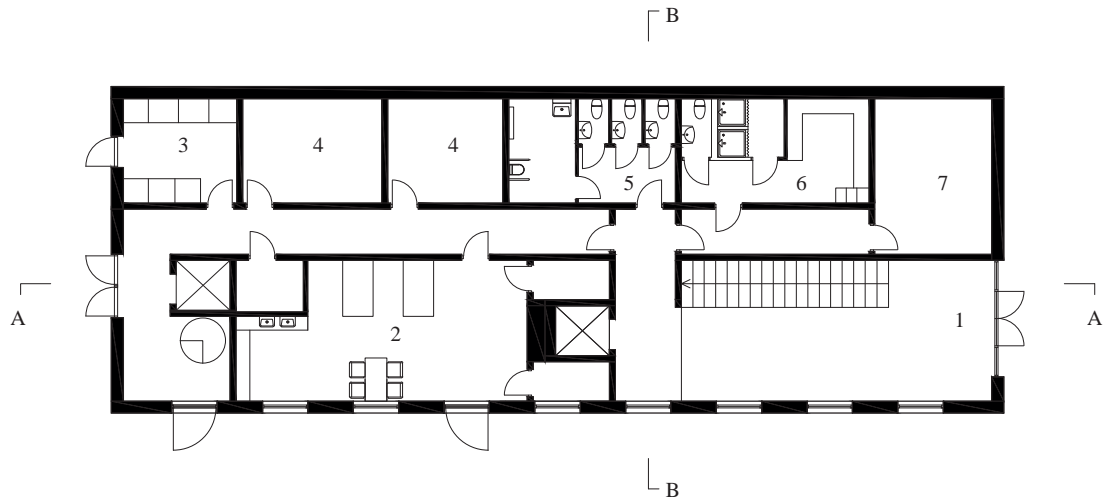
Figure 57. Entrance floor 1:250.

The new building is located south of the old office and is recessed compared to the old office, both to indicate secularity but also to break up the sequence when approaching the two buildings. The new building accommodates functions that could not be integrated into the old office, such as a restaurant, workshop space, an auditorium and offices. Its main entrance is located opposite the new entrance to the old office. The entrance hall is a double height space with a staircase leading the visitor to the first floor. On the first floor the restaurant is located, together with a kitchen and a temporary exhibition space. Another entrance is located on the first floor as well, allowing visitors to move more freely around the buildings. It also connects to the restaurant's outdoor seating.

1. Entrance, 2. Workshop, 3. Waste, 4. Storage, 5. Restrooms, 6. Staff changing room, 7. Technical.

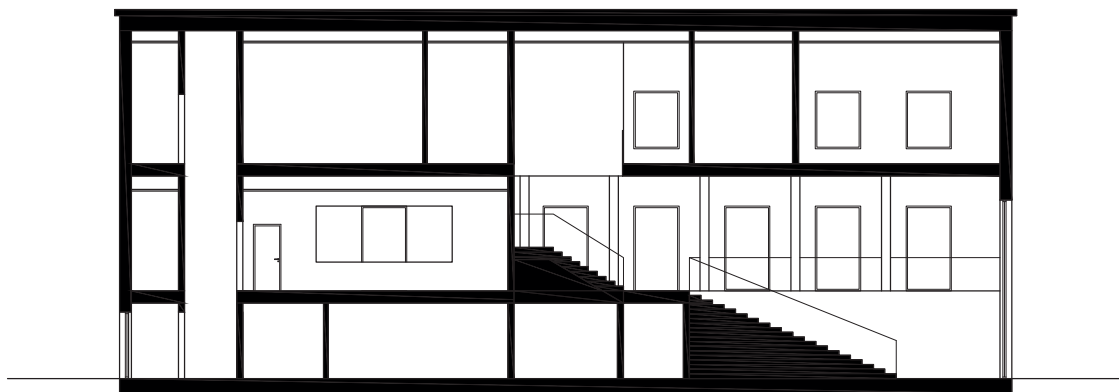
Figure 58. Section A-A 1:250.

While the historic structures of the mill have been load-bearing brick construction, the new building adopts a contemporary structural system of autoclaved aerated concrete blocks. This approach acknowledges the local building tradition while adapting it to current construction standards.

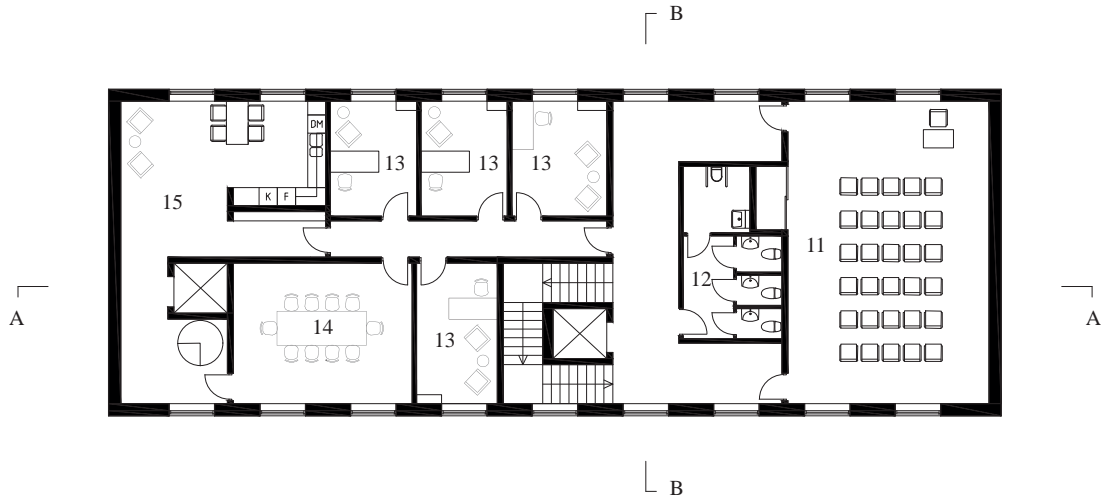
Figure 60. Second floor 1:250.
 11. Auditorium, 12. Restrooms, 13. Office, 14. Conference room, 15. Staff canteen.

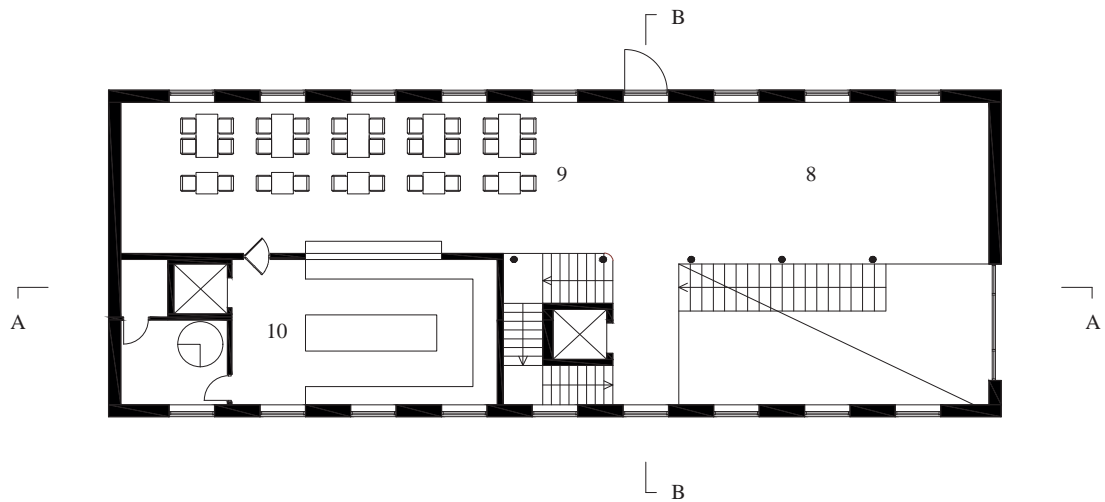
Figure 61. First floor 1:250.
 8. Exhibition space, 9. Restaurant, 10. Restaurant kitchen.

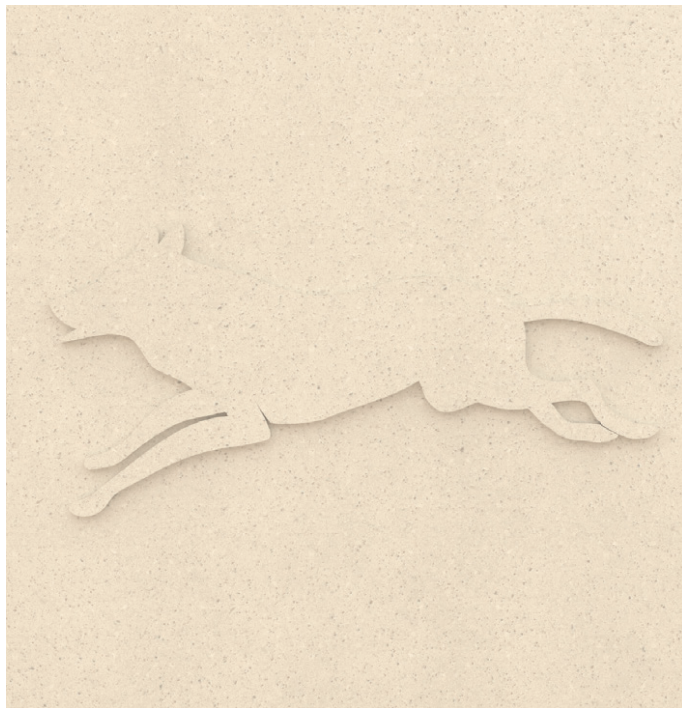
Figure 74. Entrance sign, new building.

Figure 74. Authors' own image. *Entrance sign, new building* [Rendering].

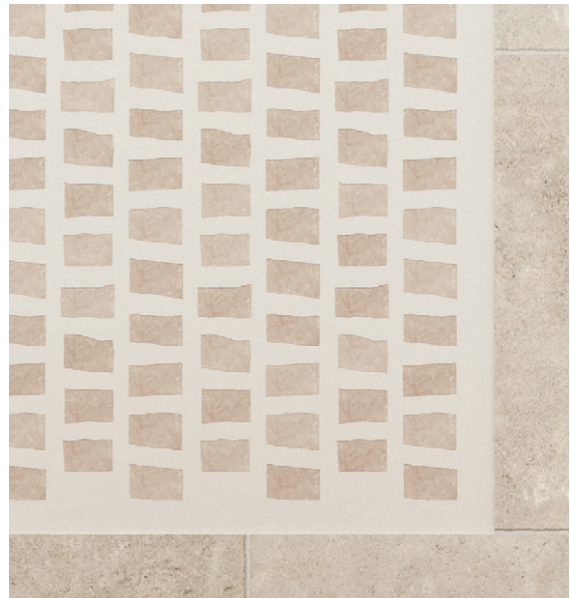
Figure 78. Floor in restaurant, new building.
