**ARK626 -
Architectural
Transformation and
Environmental care**

Damage report

The following report documents Orust Återbruk buildings damages that can be detected by superficial studies as of October 202. Large parts of the building were inacssable and thus the building most likely has more damages and a comprehensive study should be performed. The document is arranged by rooms and illustrated with examplatory images.

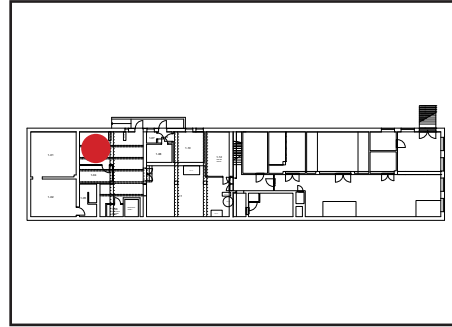
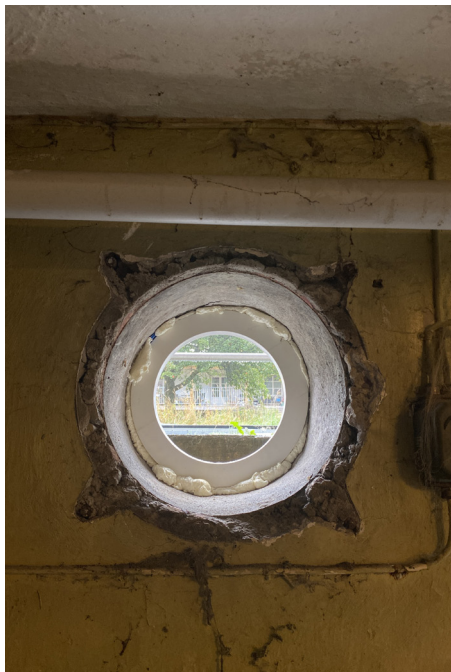
Room 01-03

Damages: Major: Leaking pipes, glass missing on window, smell, sewage pipe running over the floor is in the way, concrete fundamentals on the floor, walls are flaking, mold

Reperations: Sewage pipe that is running over the floor needs to be moved, walls needs to be fixed (add moisture barrier), leaking piped needs to be repaired, dehumidification

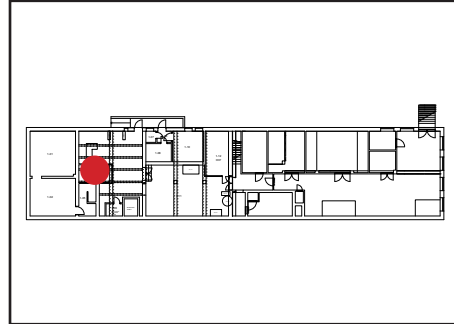
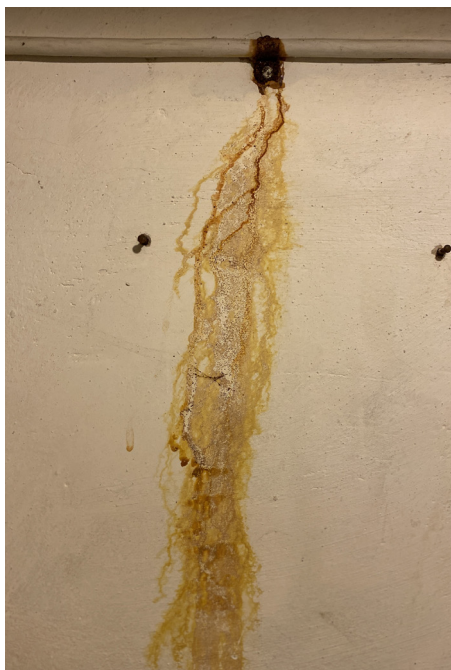
Room 01-04

Damages: Major: mold on pillar, leakage, pipe is blocking the door

Reperations: new surface layers (walls, ceilings and floor) dehumidification, move pipe that is blocking the door

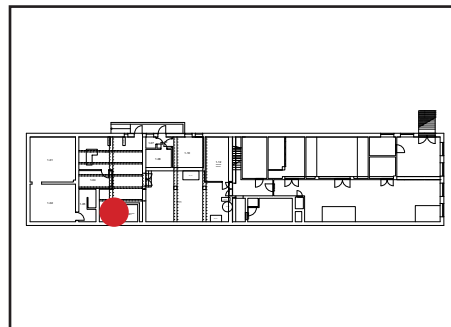
Room 01-06

Damages: Moderate: walls are flaking, accessibility (high edge)

Reperations: New surface layers (walls ceiling and floor)

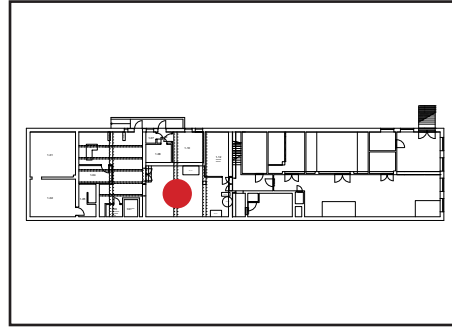
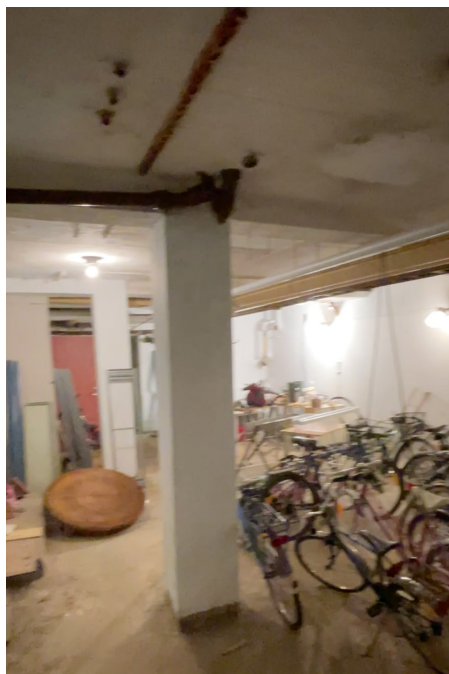
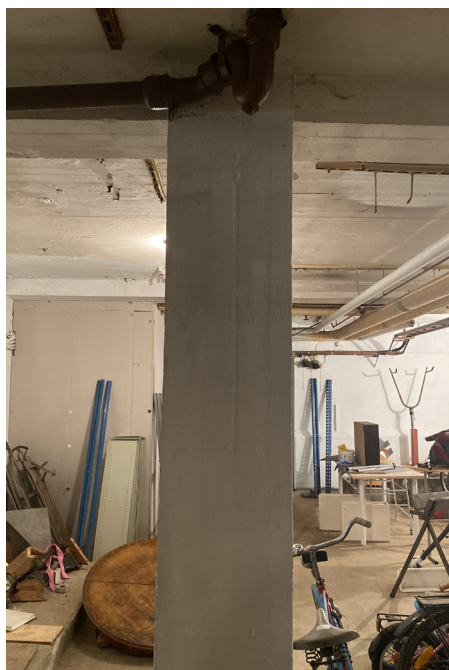
Room 01-11

Damages: Moderate: sewage smell, pipe is hanging down, hole for sewage close to stairs, concrete fundamentals on the floor that can be in the way, high humidity, pipes leaking

Reperations: New surface layers, pipe on floor close to the stairs has to be moved, dehumidification

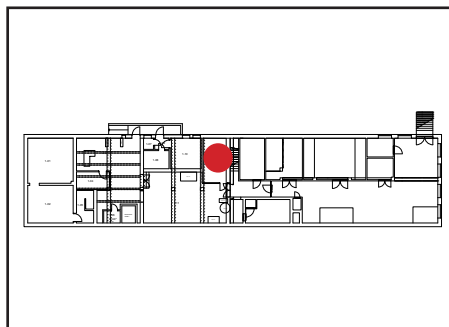
Room 01-12

Damages: Moderate: unfinished wall, but if you want to change the room's purpose a lot of installations have to be moved

Reperations: rust on door, new surface layers,

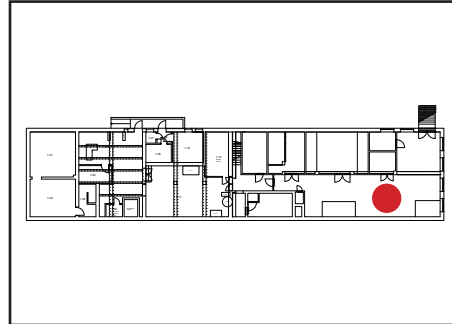
Room 2-01

minor: damaged plaster - on walls and ceiling; pipe system damage

moderate: holes in the walls and ceiling from the pipes, missing small amount of concrete layer on the ceiling

Reperations: Walls and ceiling plaster, parts of celing concrete layer, pipe system replacement + holes in the walls from the pipes, dehumidification, poorly installed new windows

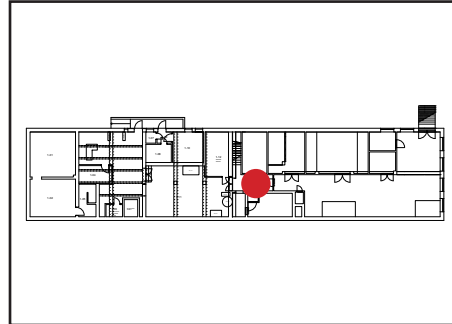
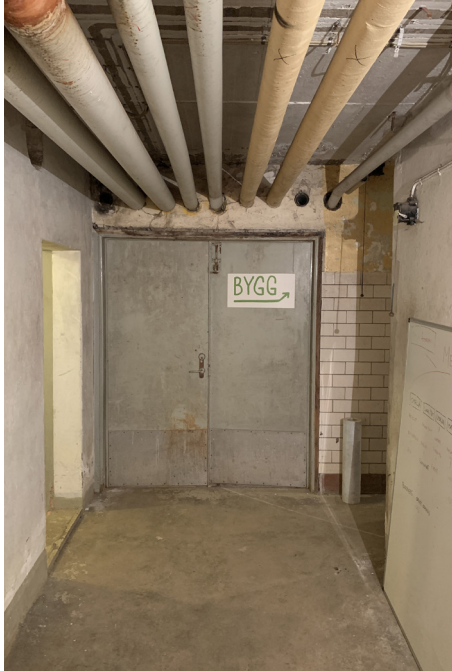
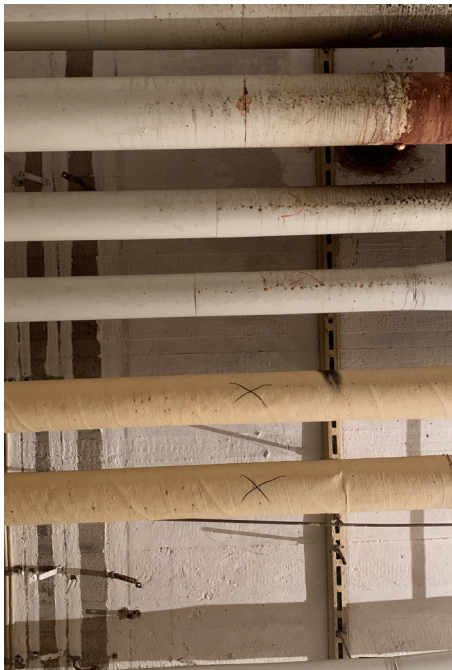
Room 2-02

minor. damaged plaster, wall colour, pipe insulation, water marks on the wall and door

moderate: holes in the walls from the pipes

Reperations: Walls and ceiling plaster, pipe system replacement + holes in the walls from the pipes, door frame, partition wall clading, fireproof door replacement

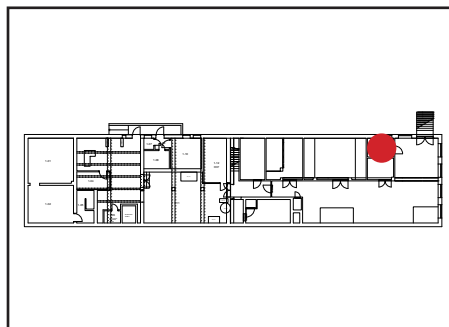
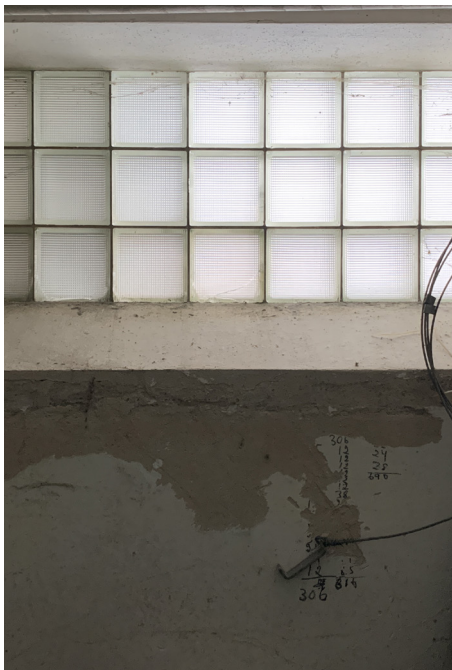
Room 2-03

minor: plaster on the walls, water marks; moderate: broken glass (window)

Reperations: window, plaster (surfaces)

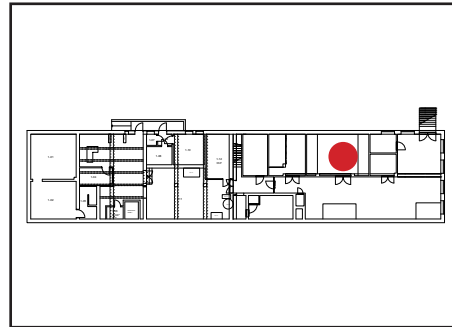
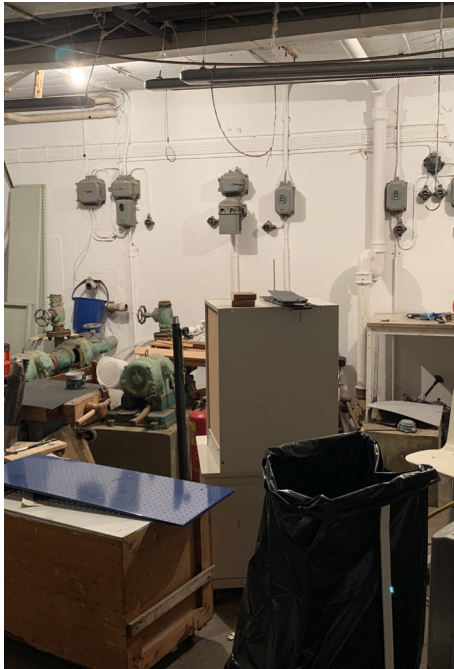
Room 2-05

minor: ceiling plaster, leaking sewage pipes, rusty pipe grid on the ceiling;

moderate: holes in the walls from the pipes

major: hole in the wall - missing bricks

Reperations: new surfaces, new pipe system, holes in the walls and rebuild part of the wall

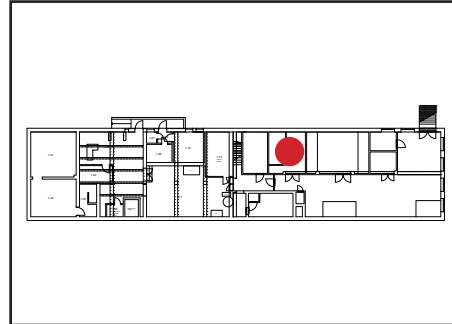
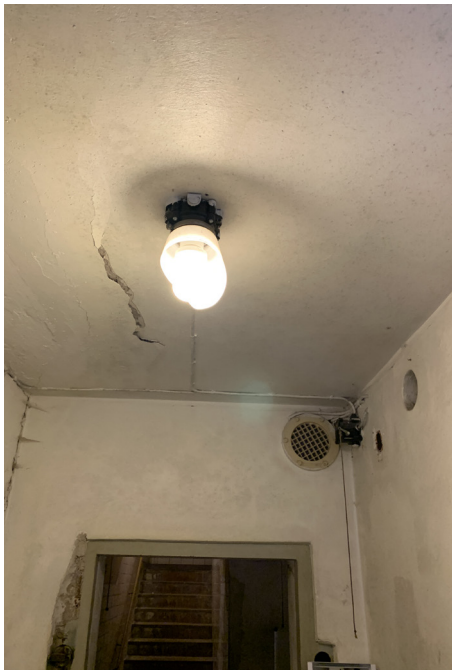
Room 2-06

minor: ceiling plaster, rusty pipe grid on the ceiling, concrete blocks fall apart, damaged door

moderate: holes in the walls from the pipes

major: hole in the wall - missing bricks

Reperations: new door, new surfaces, new pipe system, holes in the walls and rebuild part of the wall, repair/remove concrete blocks

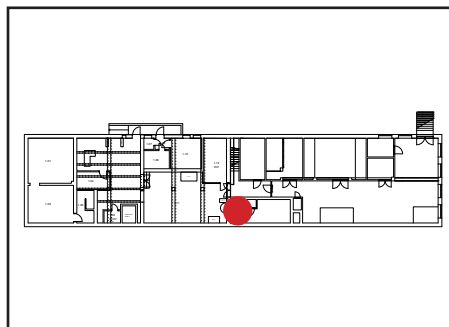
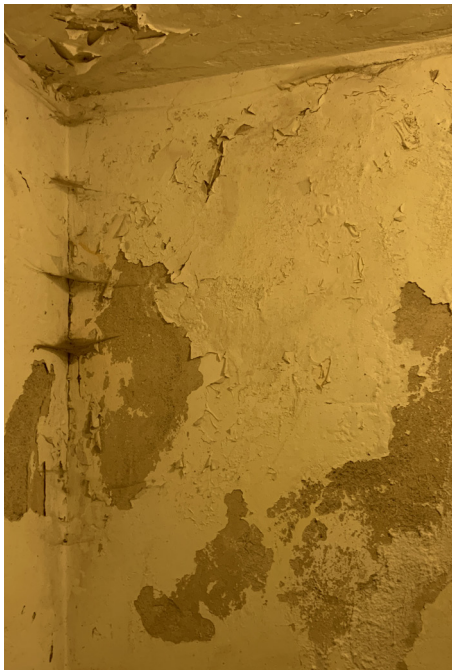
Room 2-08

minor: wall around the door

moderate: damaged ceiling, wall (water damage) - mold

Reperations: dehumidification, new surfaces, repairing the ceiling and the door frame

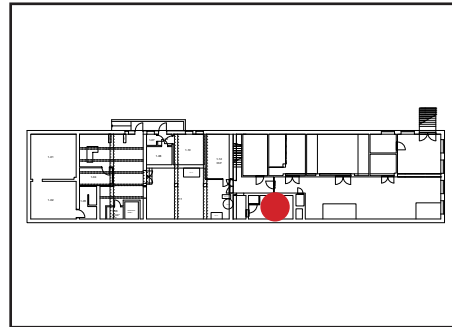
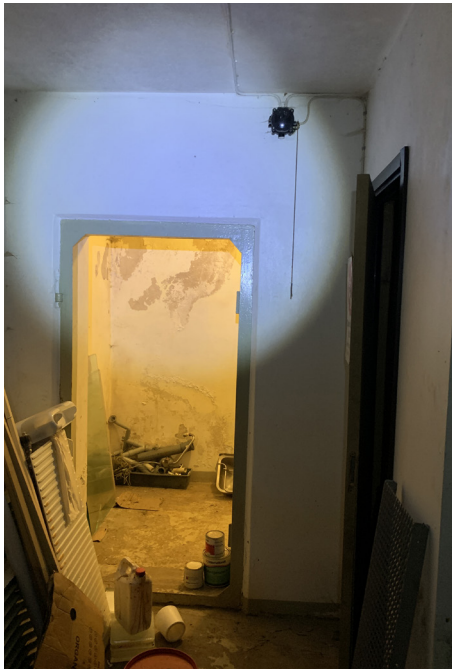
Room 2-09

minor: colour on the walls and the floor

moderate: water damage

Reperations: dehumidification, new surfaces

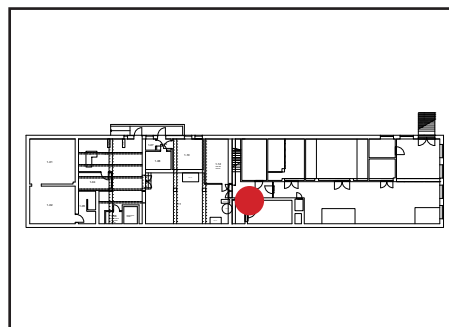
Room 2-10

minor: colour on the walls and the floor

moderate: water damage

Reperations: dehumidification, new surfaces

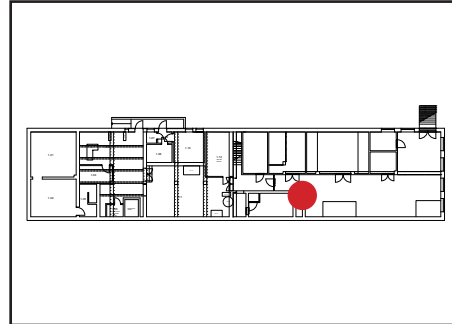
Room 2-11

minor: colour on the walls and the floor

moderate: water damage

Reperations: dehumidification, new surfaces

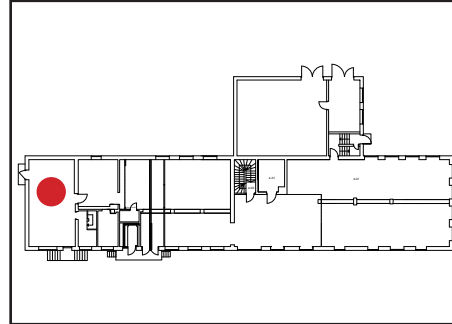
Room 03-01

Major : Discoloured with a yellow tone

Minor: Discoloured joints in some areas

Minor: Cracked tiles in some areas

Reperations: Some tiles has to be replaced. The joints has to be washed/painted. The discolor is perhaps difficult to fix.

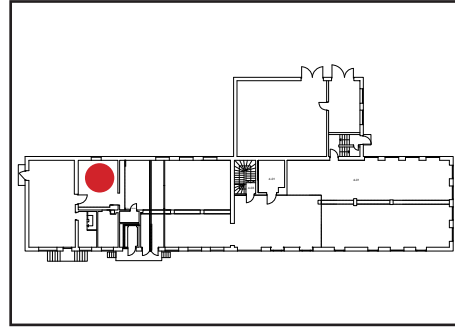
Room 03-02

No major damage.

Reperations: Look for external signs of damage that might not be visible from the inside

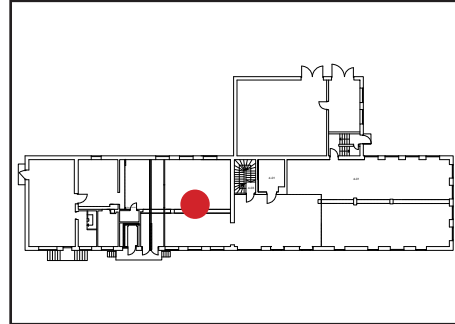
Room 03-03

Major : discoloured tiles, drilled holes, cracked bricks, water damage on roof and walls

Minor: Discoloured joints, cracked tiles, plaster damage, dirt,

Reperations: Some tiles has to be replaced. The joints has to be washed/painted. The discolour is perhaps difficult to fix. Fill the plumbing holes and spackle the plaster. Replace some tiles or fill in with concrete. Clean windows, decide wether to change the difference in bricks, replace damaged or missing bricks. Open up to the boarded up window. Remove damaged parts, replace material and check underneath for further issues

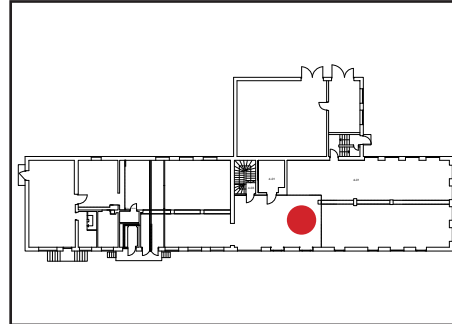
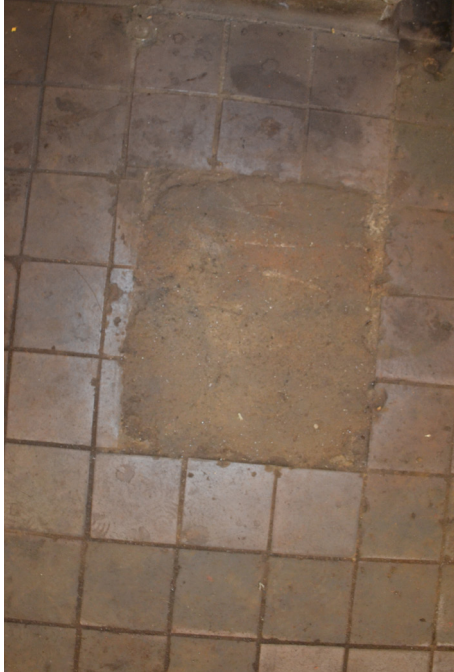
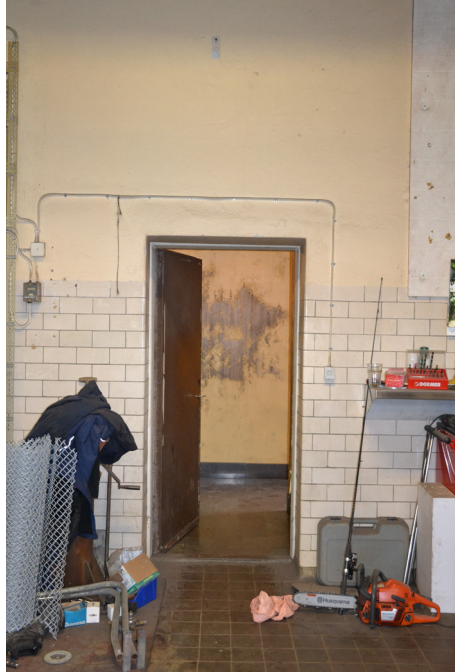
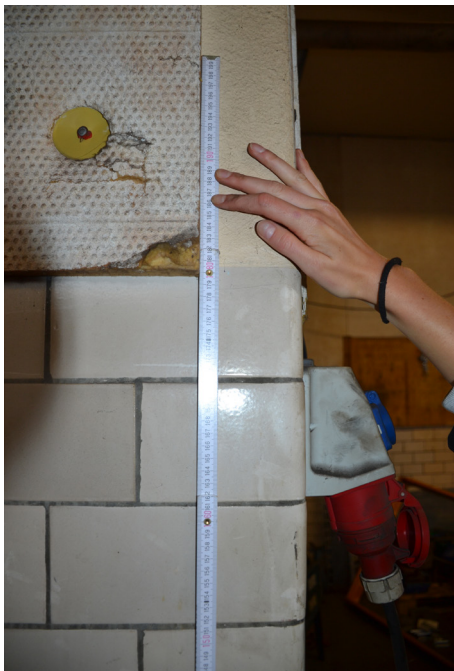
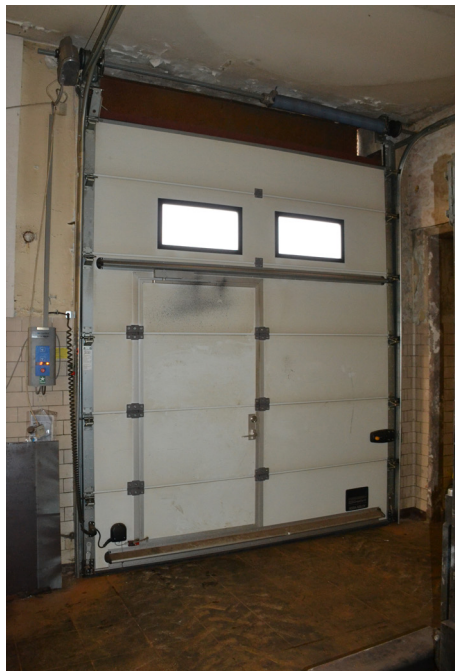
Moderate: Rust, cracks and dents in the floor tiles, cracked tiles, worn off paint, graffiti, hole in facade, broken glass in windows, water damage in the ceiling

Reperations: Windows, ceiling, exterior walls

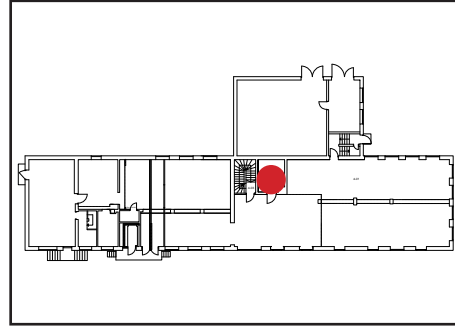
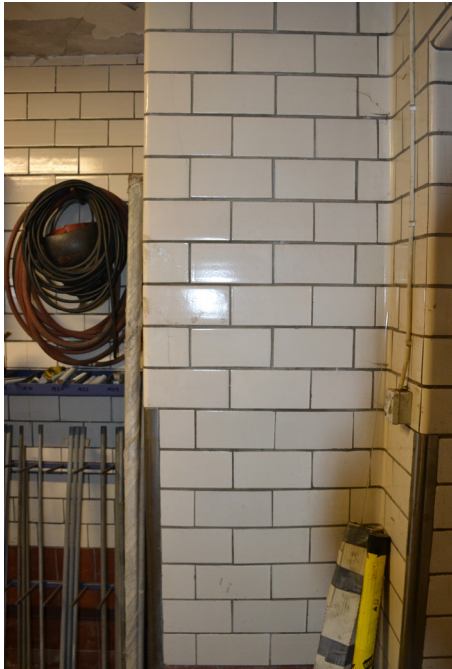
Room 04-02

Moderate: Waterdamage from the ceiling down on the wall

Minor: Rusty door, rust and dents in the floor tiles

Reperations: Ceiling

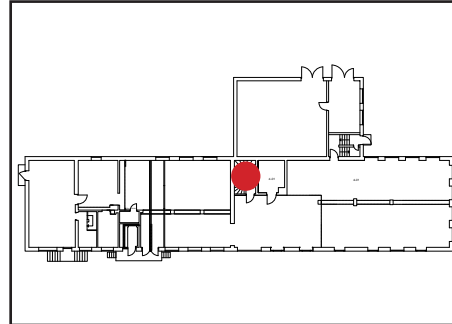
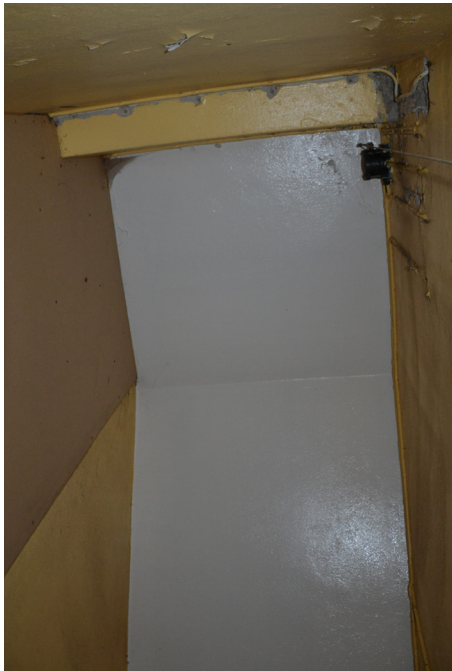
Room 04-03

Moderate: Holes in wall

Minor: Worn off plaster, tiles and floor tiles

Reperations: Walls

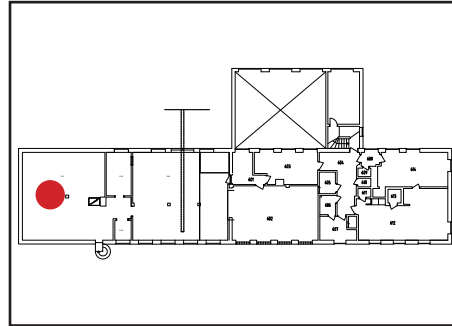
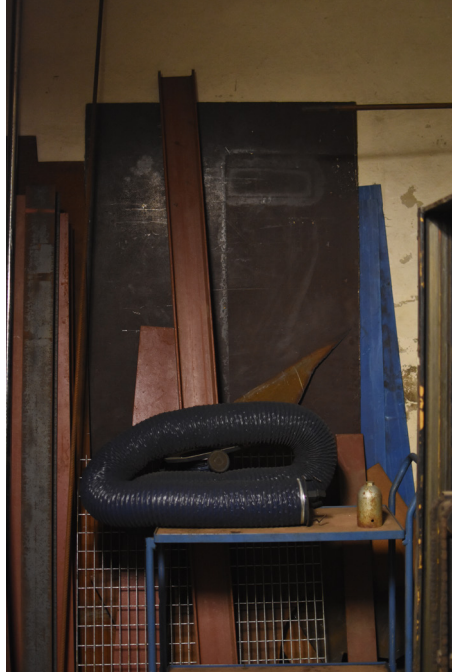
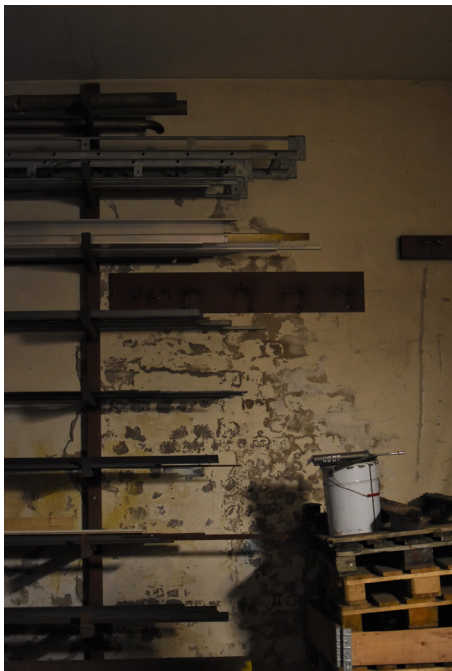
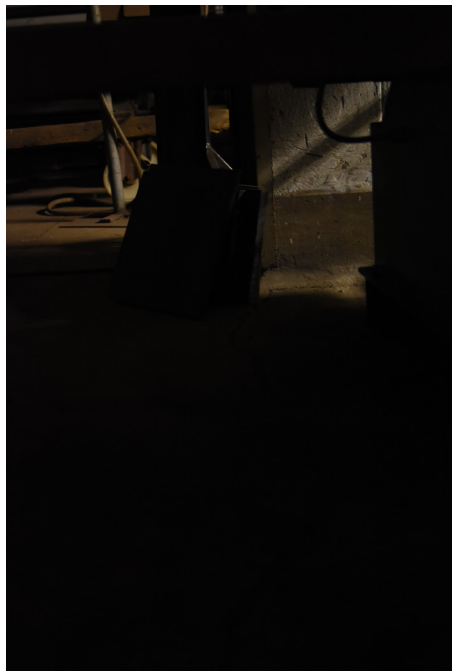
Major: Water damage in ceiling, non accessible. Crack in concrete following all way around the room (floor, wall, ceiling)

Minor: Possible door to exterior fire exit, non accessible. All walls include markings in varying levels

Reperations: Water damage needs futher investigation. Large crack needs further investigation to determine the severity of the damage. New finishes on surfaces depending on future use

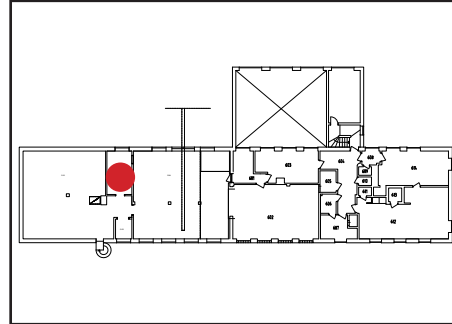
Room 05-02

Major: broken window bricks.

Moderate: ventilation cared into a wall, disturbs airflow. Water damage in the roof, no access to inspect if an ongoing issue. Crack starting from window leading to the ceiling

Reperations: Windows need to be changed, water damage and reason for the crack need inspection

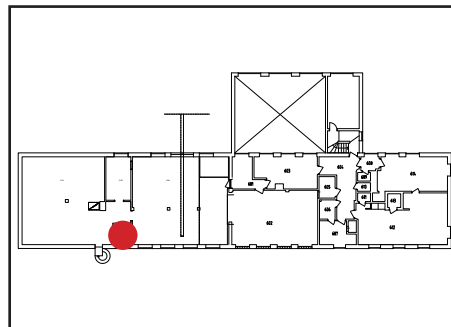
Lift does not work

Reperations: Lift is not working, hence needs reparing

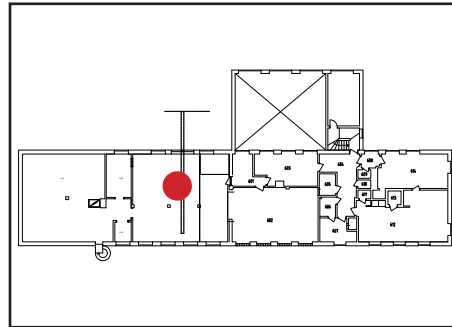
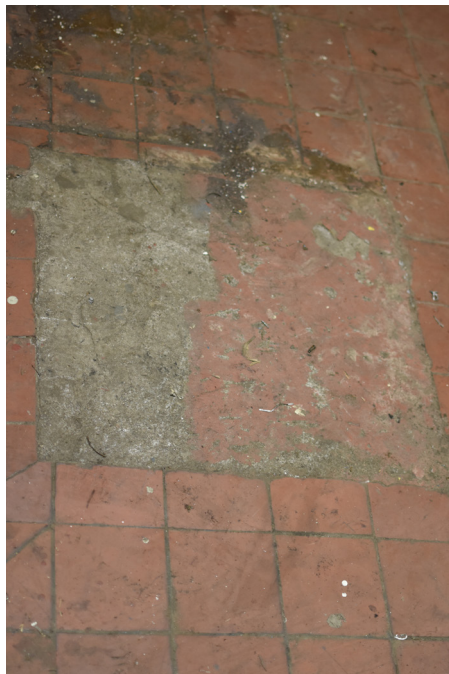
Room 05-04

Major: Broken window bricks. Hole in exterior wall for temporary (?) ventilation. Large hole in surface of wall from installation. Potential water damage in exterior walls (mainly around exterior door). Hole in wall to adjacent room for cable ladder. Moderate: Walls pierced by numbers of pipes and rods, damaging concrete and wall tiles. Hole in wall to adjacent room, patched up with concrete. Concrete beam cut to fit heavy duty crane (needs inspection to determine severity of impact on structure). Wall tiles broken. Minor: Floor tiles missing (concrete infill). Surface finish missing in places on all walls. Scrapings in ceiling from exterior door. I beams cut off over opening to adjacent room. Unused pipes in several areas. Construction of concrete foundation from adjacent room damaged wall tiles.

Reparations: Windows need to be changed, water damage and cut-off beam need inspection. Surface reparations depend on future use. Holes in walls need reparation. Broken tiles need to be replaced.

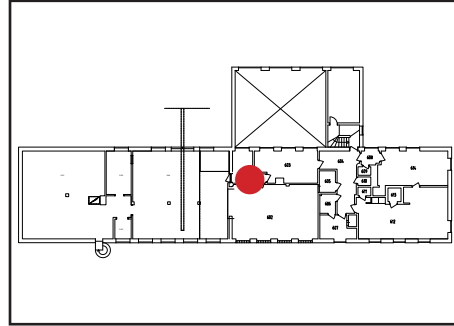
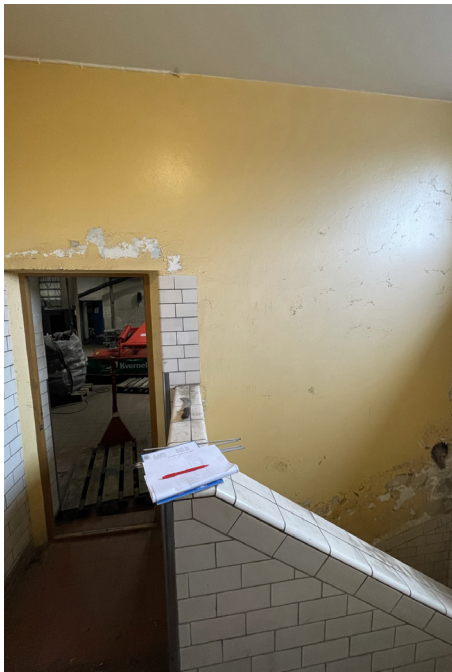
Major: holes in the exterior wall (in the stairs), broken wall plaster, minor: cracked paint, damaged window

Reperations: Walls, window

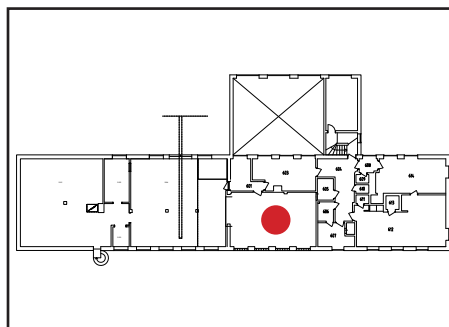
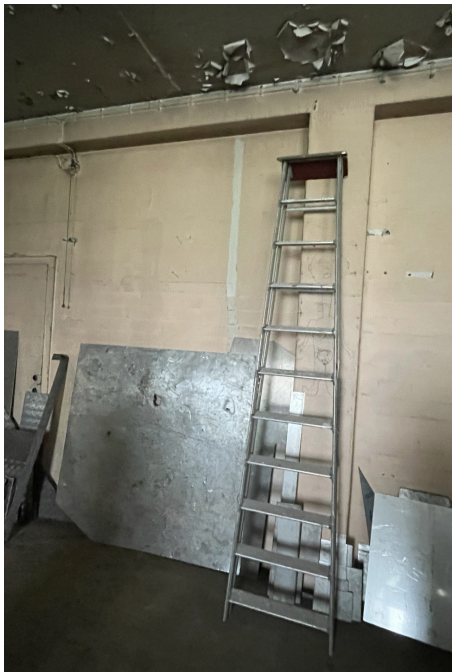
Room 06-02

Broken windows, metal residue on ceiling, broken wall plaster, cracked paint

Reperations: Walls, ceiling, windows

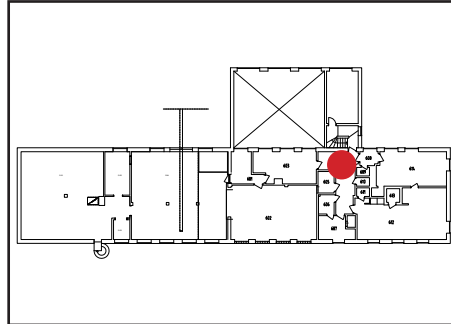
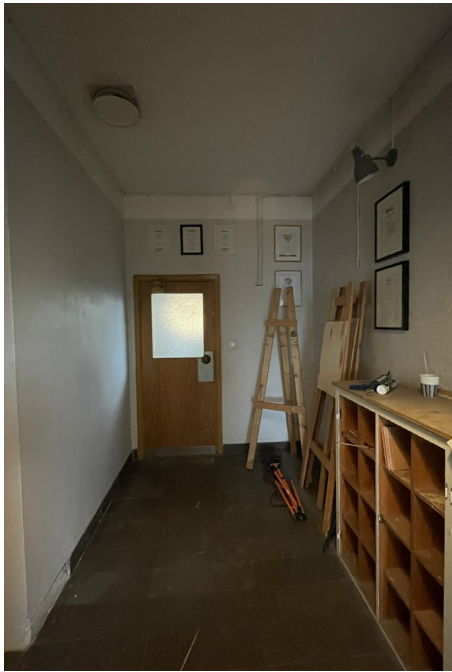
Room 06-04

Minor: Broken bases, doors

Reperations: Bases, doors, repaint

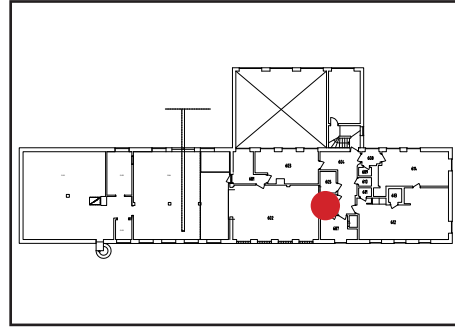
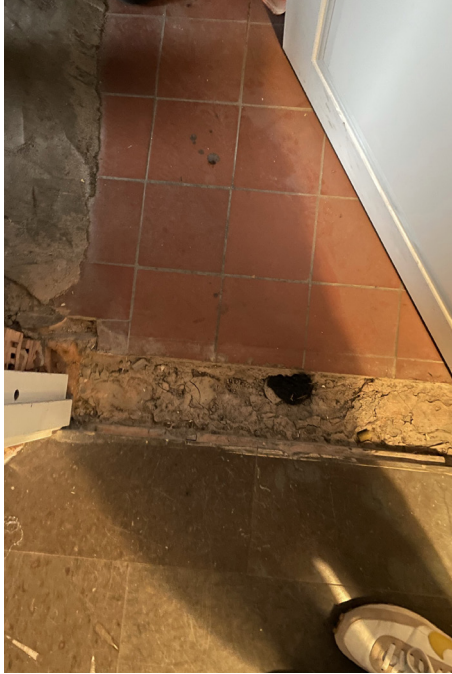
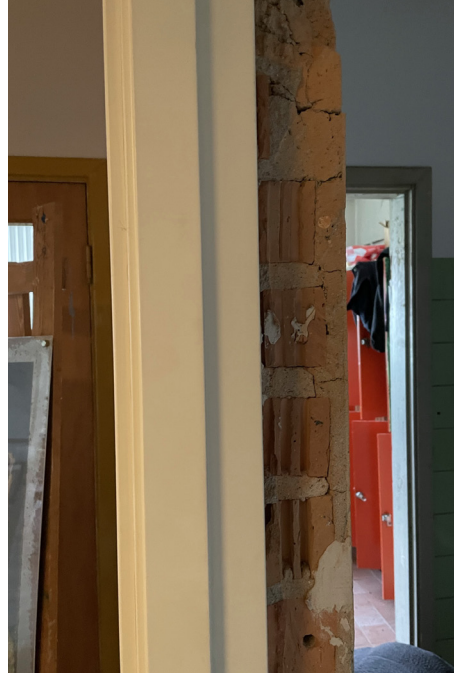
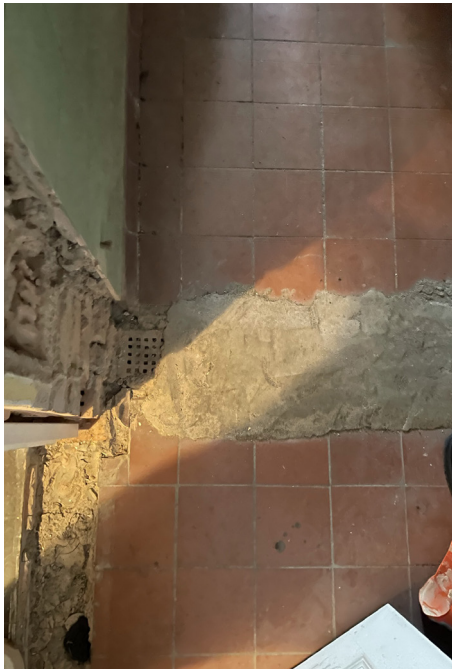
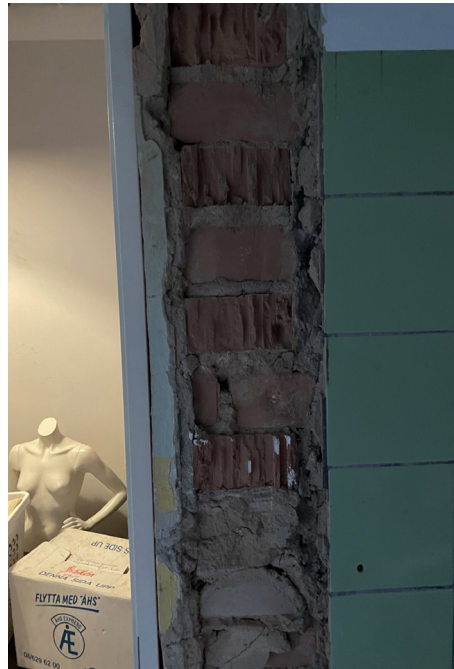
Exposed brick in wall that's been teared down, exposed concrete in floor

Reperations: Floor, walls

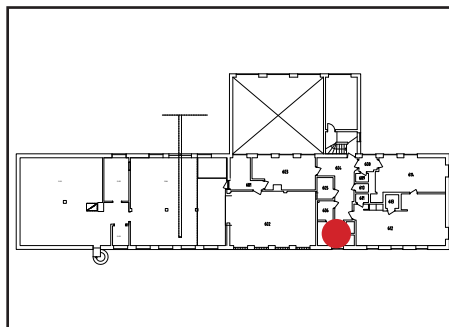
Room 06-07

Window, exposed concrete

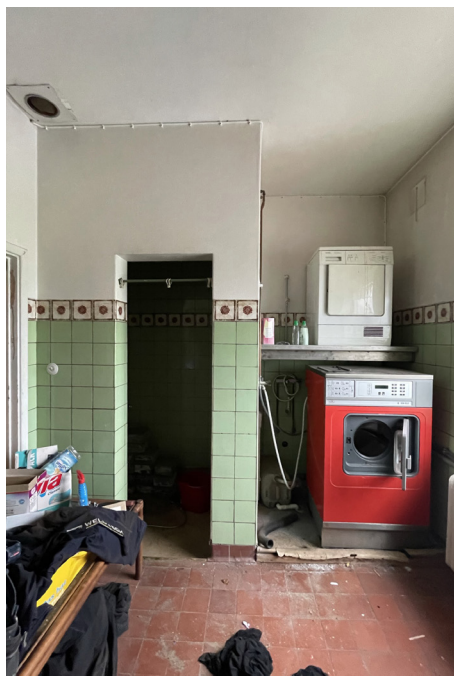
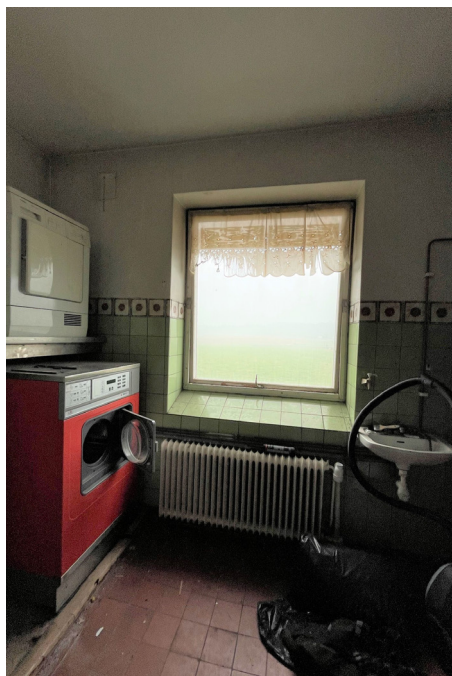
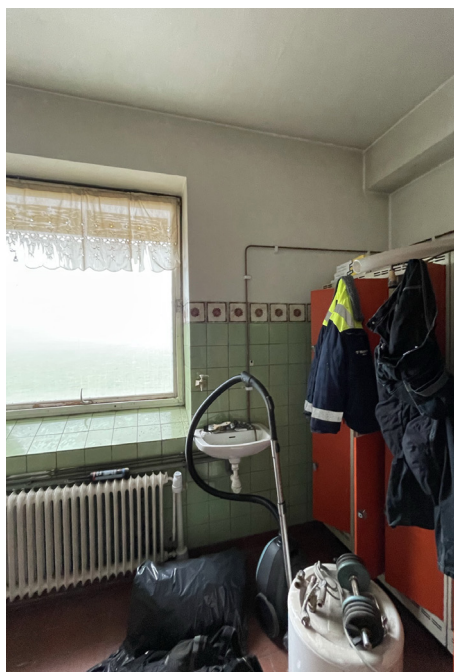
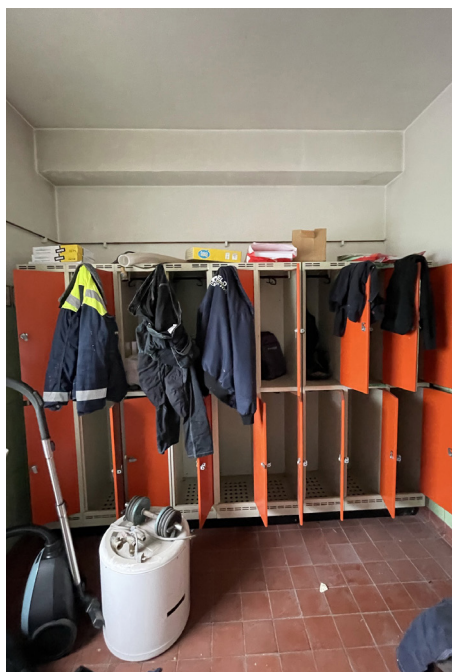
Damages:

Reperations: Floor, window

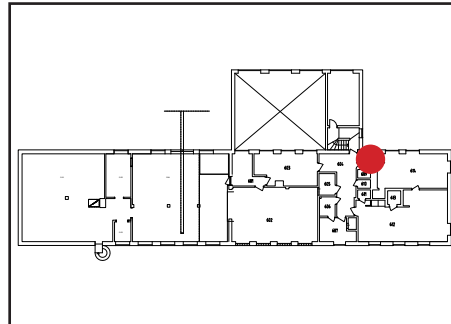
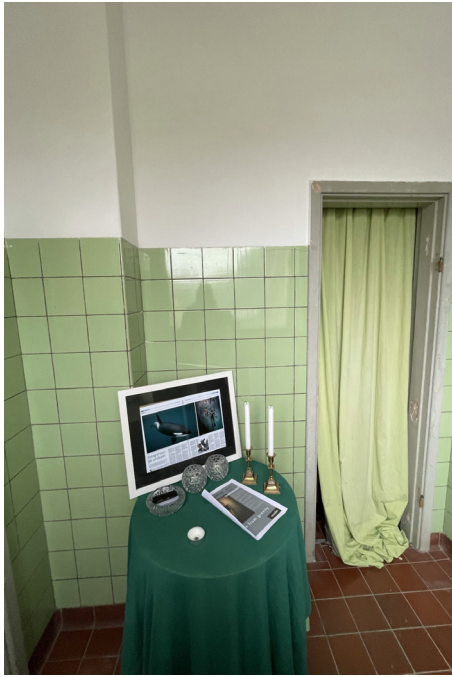
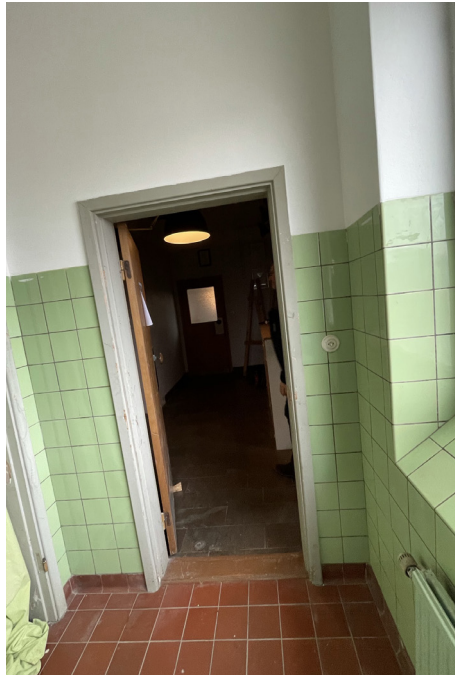
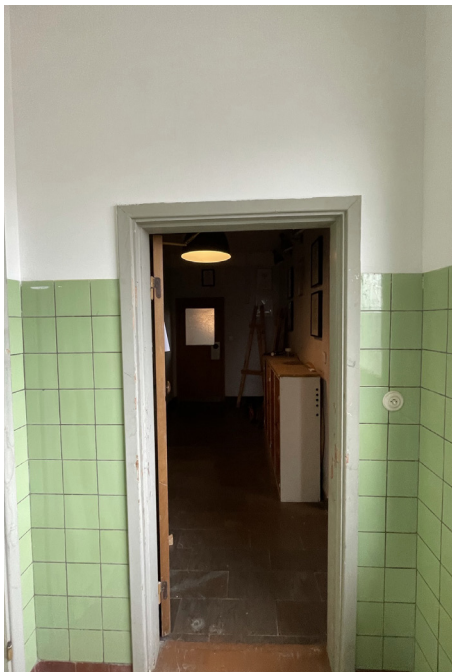
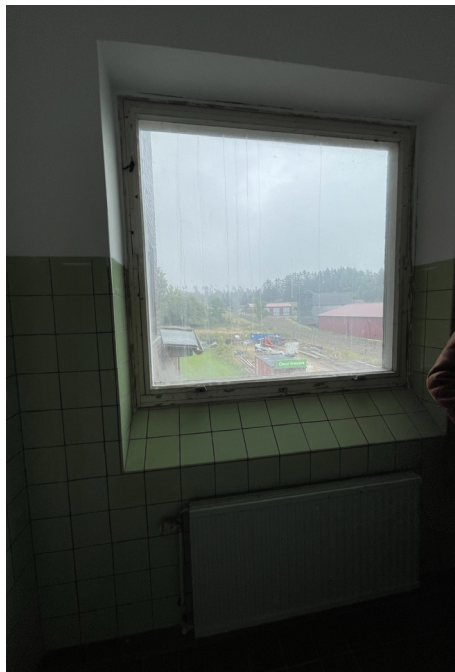
Room 06-08

Damages:

Doors

Reperations: Doors, window

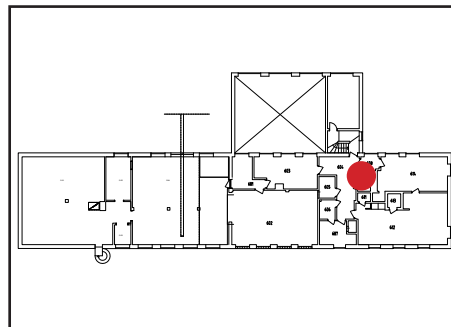
Room 06-09

Damages:

Minor: damaged doorframe, floor surface?

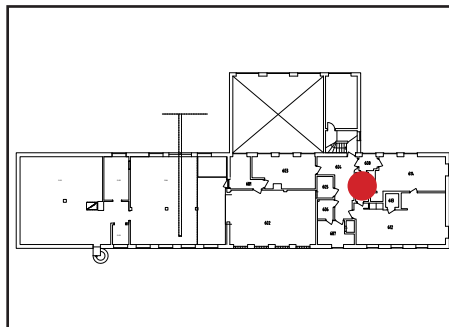
Damages:

Minor: door broken

Reperations: Change door

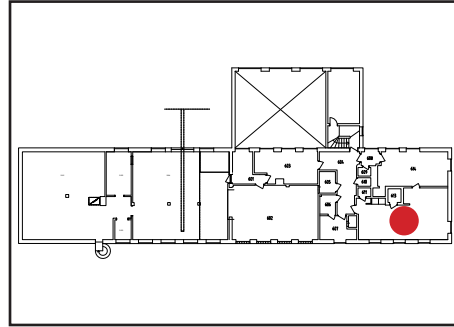
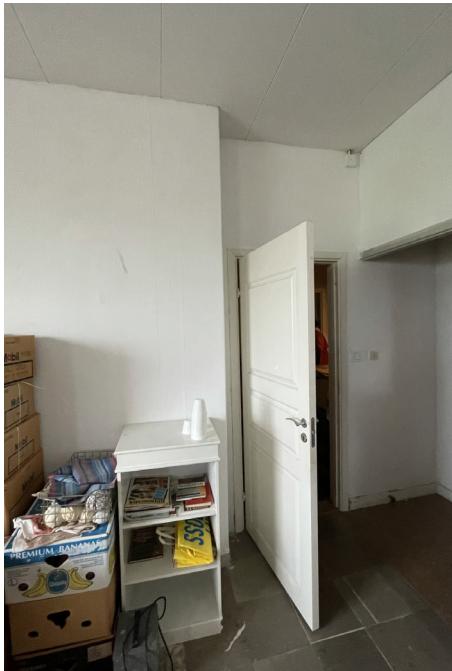
Room 06-12

Damages:

Minor: exposed concrete between different floor surfaces (where there's previously been walls) Damaged windows

Reperations: Change or repair floor surface, change windows

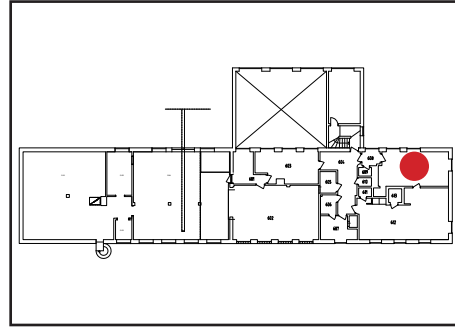
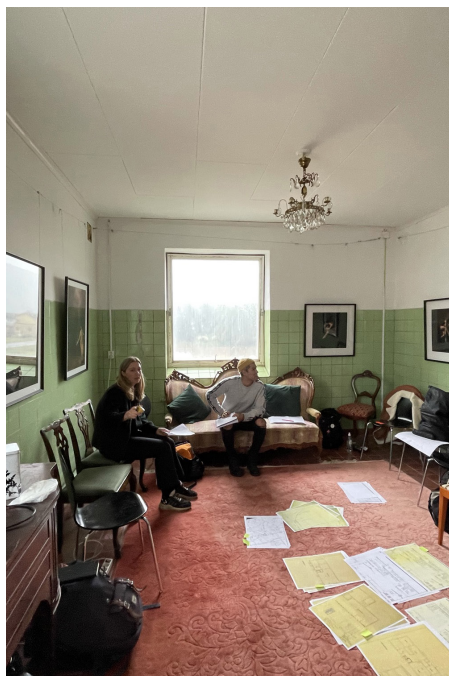
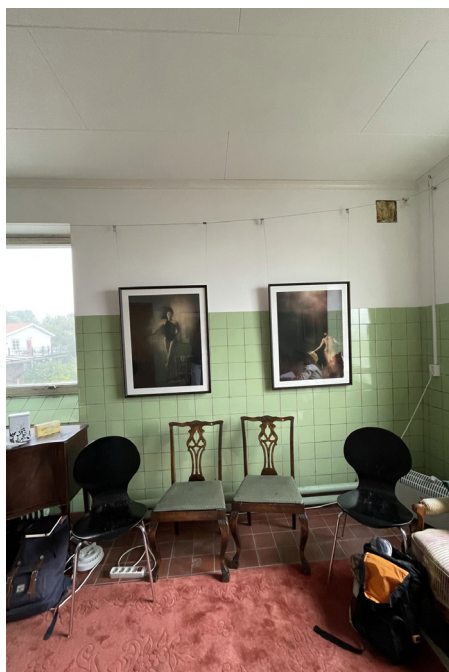
Damages:

Minor: damaged windows, damaged door, hole in the wall (ventilation?)

Reperations: Change or repair windows, change door

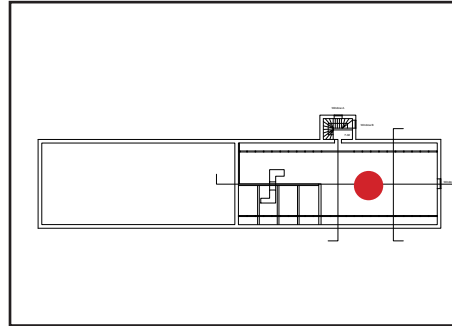
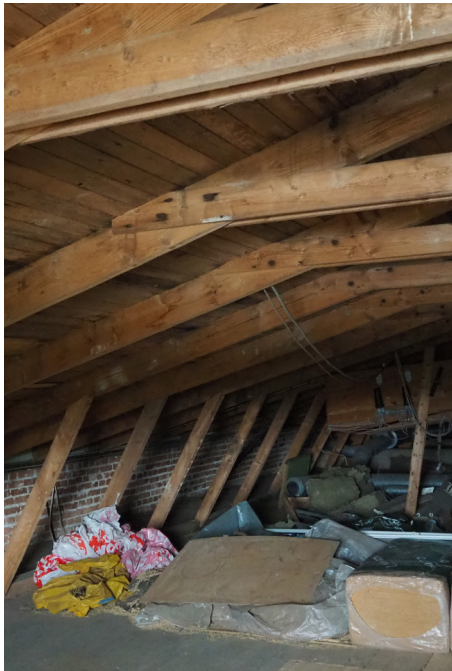
Room 07-01

Damages:

Minor : cracked paint and dirty space

Reperations: - windows need to be painted and wood to be treated

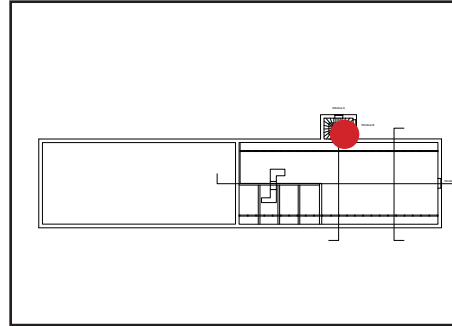
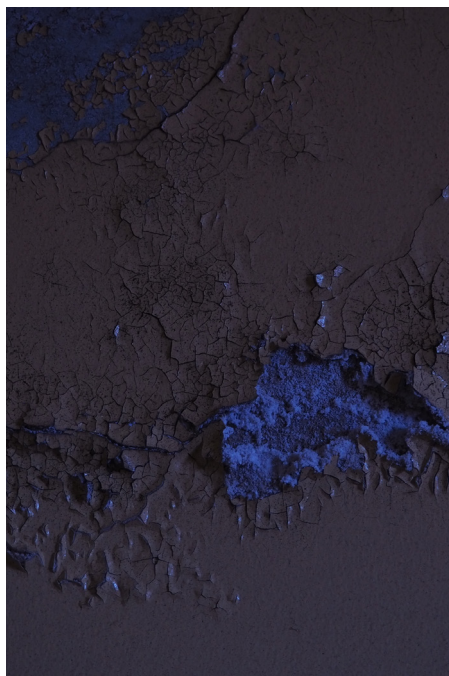
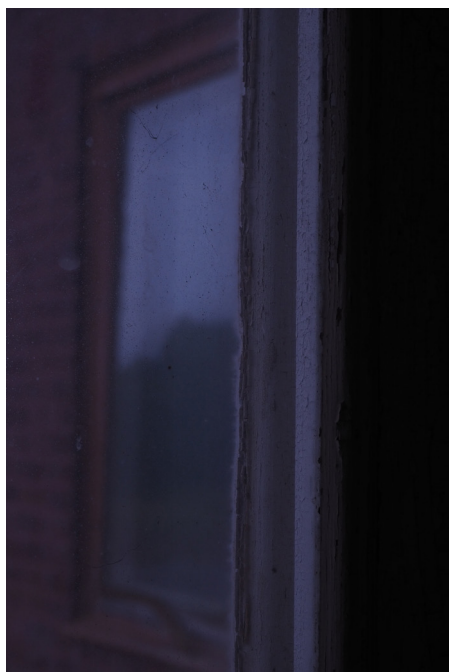
Room 07-02

Damages:

Major : - huge crack along the gable next to the window (the upper part of the wall is attached to the truss and the lower part is getting pulled down because of the sinking building)
- important water leakage through the roof

Moderate : - missing beams under a part of the floor

Reperations: strengthen the floor
fix the leak

short term actions for the wall/gable : - add mortar to the crack

long term actions for the wall/gable : - stabilise foundations

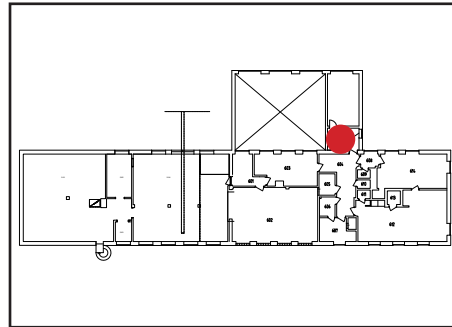
Room 08-01

Damages:

minor : inner doors + stairs and floor need cleaning

Moderate : cracked paint and dirty space + entrance door -> gap between the frame of the door and the wall : need a clean finish + repaint the windows frames.

Reperations: new surface layers (walls, ceilings and floor).
long term actions : replace windows (stairs cage isn't the most urgent)

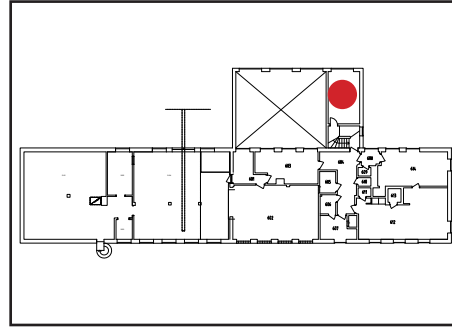
Damages:

minor: windows, doors, floor need to get cleaned

Reparations: new surface layers (walls, ceiling and floor). long term actions : replace windows/door, new insulation

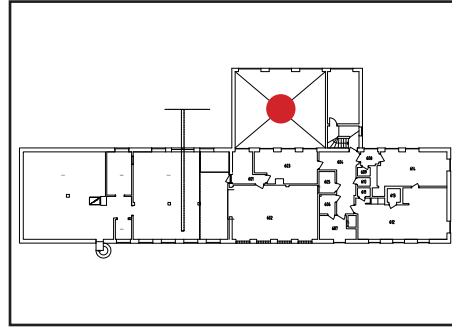
Damages:

minor: windows, doors, floor need to get cleaned

major: ventilation is partly gone - needs replacement, floor - tiles broken, big holes in floor, very uneven > replace tiles, fill holes, pipes are broken > new pipes

Reperations: new surface layers (walls, ceiling and floor) - new paint, new tiles, floor needs to get replaced > new, replace pipes
long term actions : replace windows/door, new insulation
