# TRANSFORM THE PAST TO LIVE IN A BETTER FUTURE

Renovation of a former centre of education in Brussels into a new social hub

Gothenburg, SWEDEN  
Master Thesis Spring semester 2021  
Chalmers University of Technology  
Department of Architecture and Civil Engineering  
Master Program of Architecture Planning Beyond Sustainability  
Direction of Building Design for Sustainability

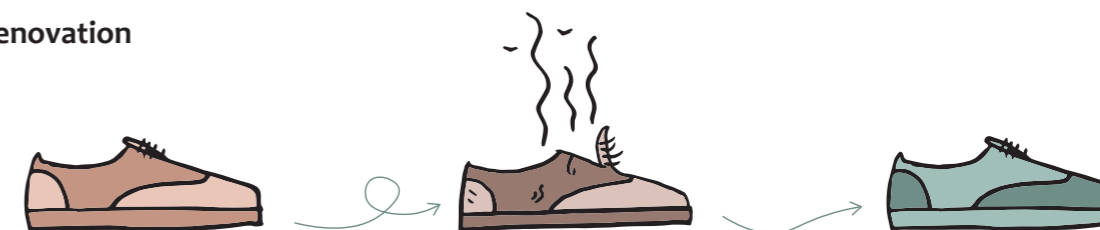
Figure 1. Drawing explaining the differences between Renovation/Restore/Refurbishment

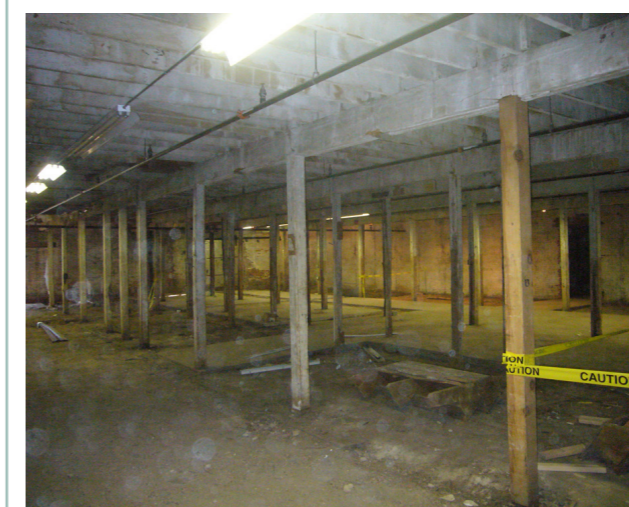
Figure 16. Horsebarn structure before (Frreehill B. & Moore M.)

The original building was in very poor condition, with challenges linked to the structure, and was saved from demolition. To assure safety without changing the whole skeletons of the building, careful additions to reinforce the structure were designed. To tackle down the energy efficiency aspect, insulation has been added and more efficient windows were placed. One of the focuses was to let the natural daylight penetrates the building as much as possible, increasing the well-being of the workers and decreasing the need for electricity.

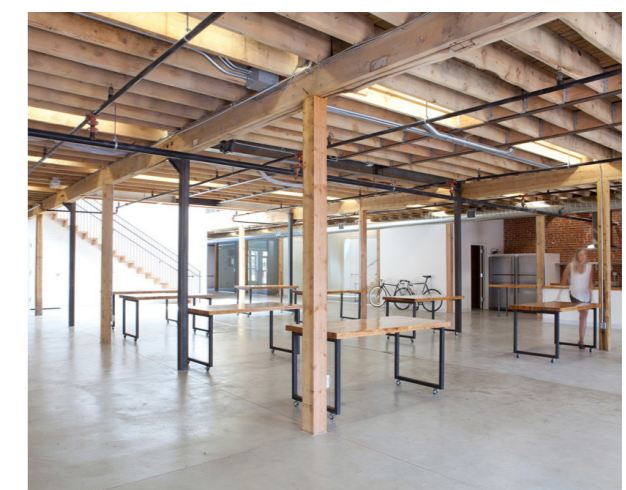
Figure 17. Horsebarn structure after (Frreehill B. & Moore M.)

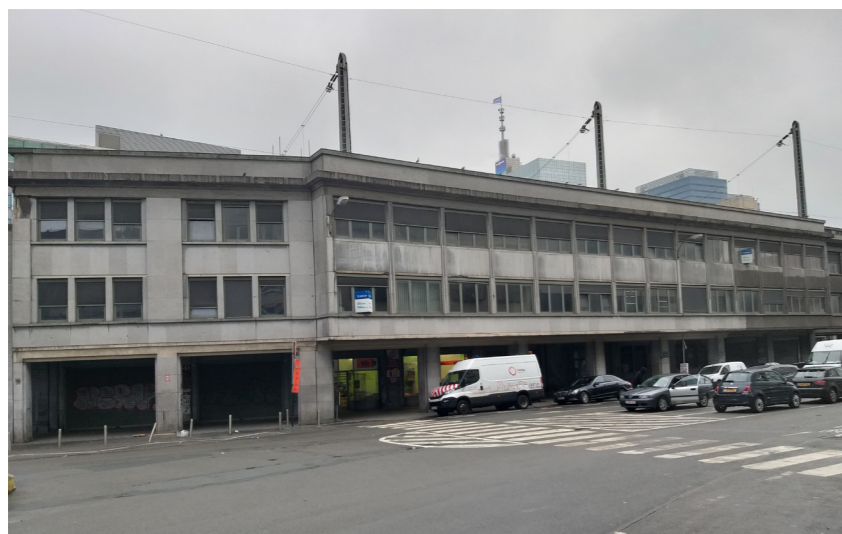
Figure 36. Building view from the South-East

The chosen building is located next to the railway, this one is raised above the ground to allow roads to pass under. Therefore, on both the ground floor and the first floor of the West side, there is no possibility to place windows. The building has been erected in 1958, it has always belonged to the Belgian railway company. It was used as an education centre until 2016, after it has been used as a “shelter” for the construction site next to it. It is left empty since 2018. The building structure is made of a concrete columns/ beams system allowing freedom in the plans. Thanks to its structure it is very resistant. It also provides the possibility to largely open up the East facade. By partially covering up the pavement, the building offers protection for pedestrians. In 2006, the windows have been replaced with double glazed ones, the radiators have also been changed and some work was done on the roof. According to the energy performance certificate, the current consumption is 499kWh/m<sup>2</sup>y (see Figure 37), as a reference, a passive building has to be under 15kWh/m<sup>2</sup>y, and now in Brussels, every renovation project has to be less than 100kWh/m<sup>2</sup>y primary energy (Bruxelles Environnement, 2019).

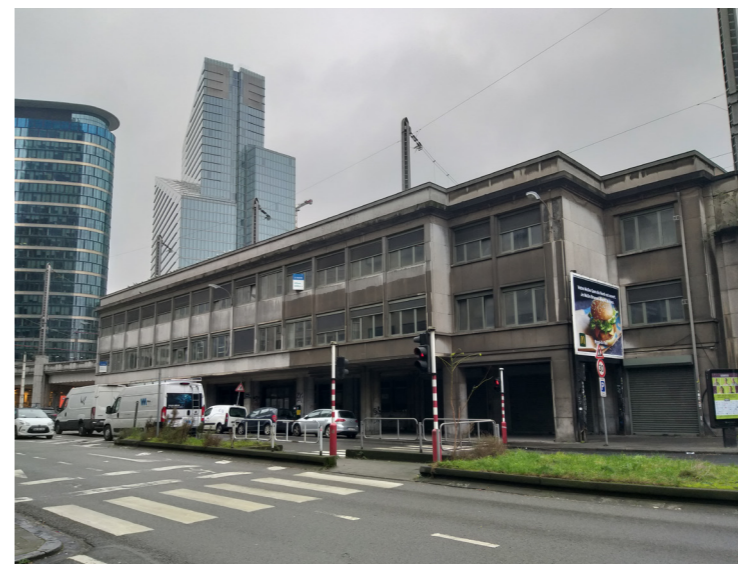
As can be seen in those pictures, the facade to the street is full of waste, the windows have bars to keep distance from the street. Inside, degradations can also be observed on the walls. The staircase has a pleasant design with plenty of daylight, especially on the last floor.

Figure 40. View from the North-East

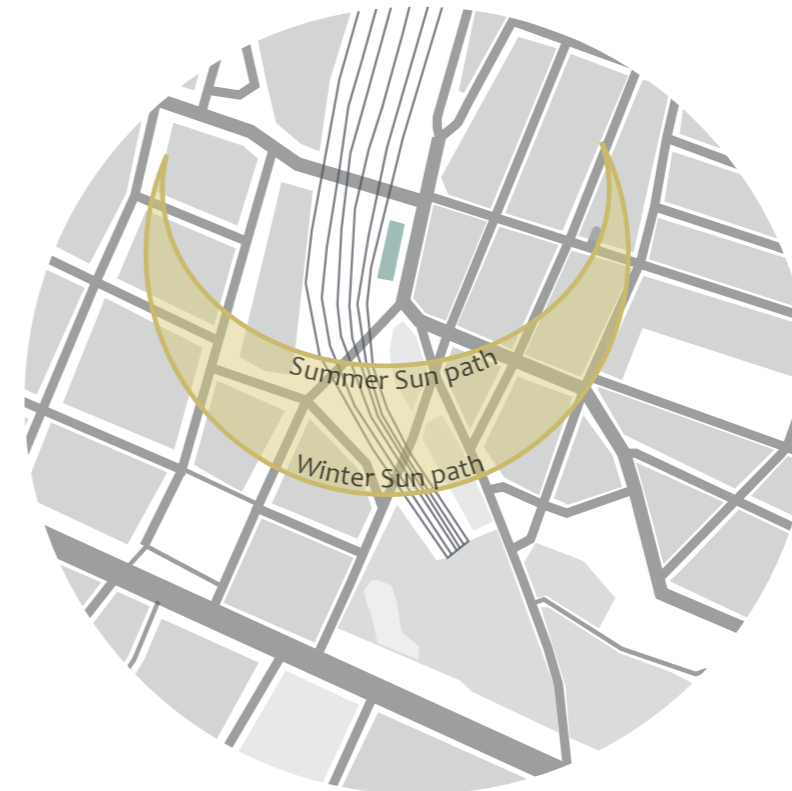
Figure 55. Sun path based on data retrieved from SunCalc

On the South, the sunlight is obstructed by some high-rises. On the West side thanks to the distance created by the railway of about 70m, natural light can penetrate the upper section building easier. As there are many windows, due to the function inside, on the Eastern and Western facade, a strategy to protect from overheating is designed. The windows will be equipped with shutters.

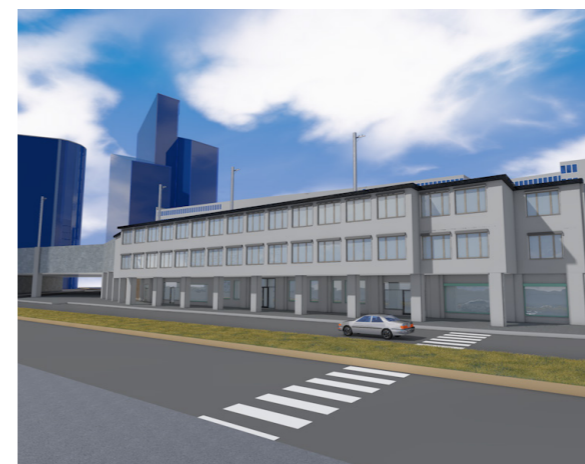
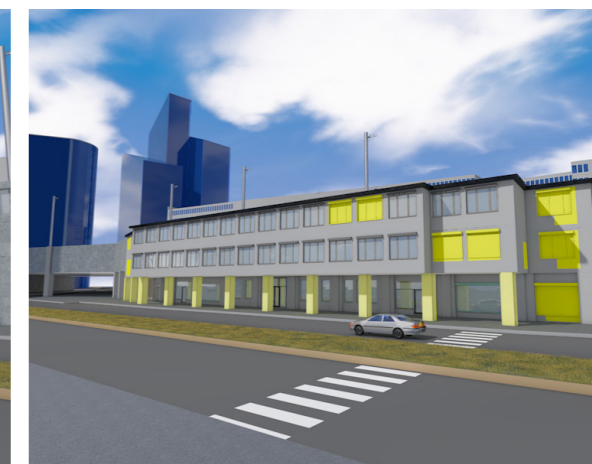
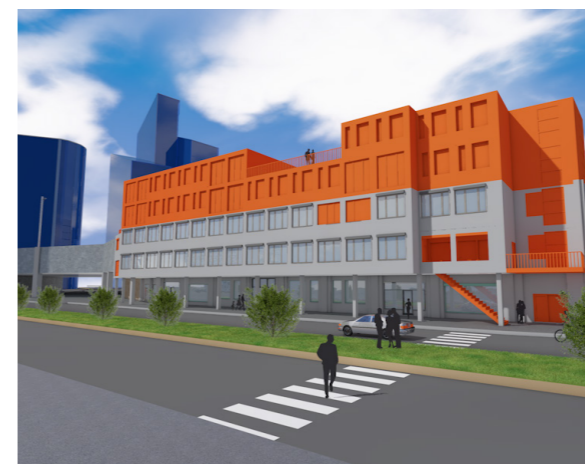
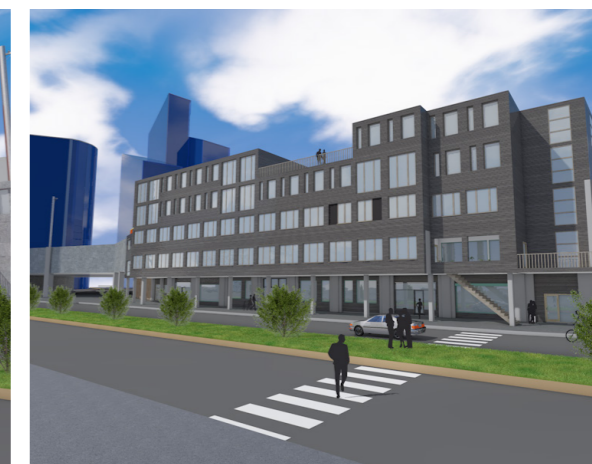
The yellow represents the part of the building that will be demolished, the red is for the parts that will be added.

The demolition plan shows that some windows have to be changed to adapt better to the new indoor design, the “coat” of the columns on the ground floor is also removed to let their inner structure appear.

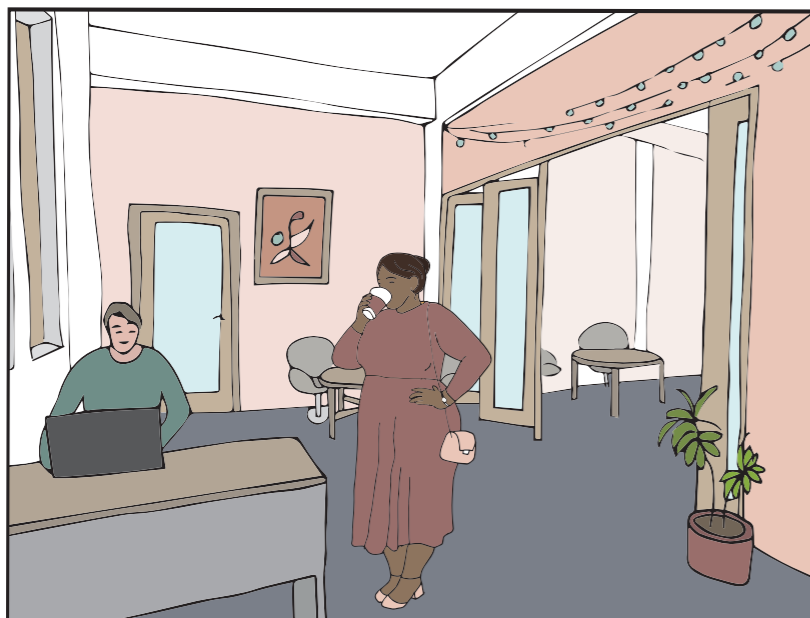
## PERSPECTIVE OF THE CO-WORKING

The co-working space can operate in collaboration with the restaurant. It is a comfortable place to work for people waiting for their train for instance. As it is on the ground floor, the atrium is used also for tables. The place offers different atmosphere, to work as group or alone. There are also printers and computers available.

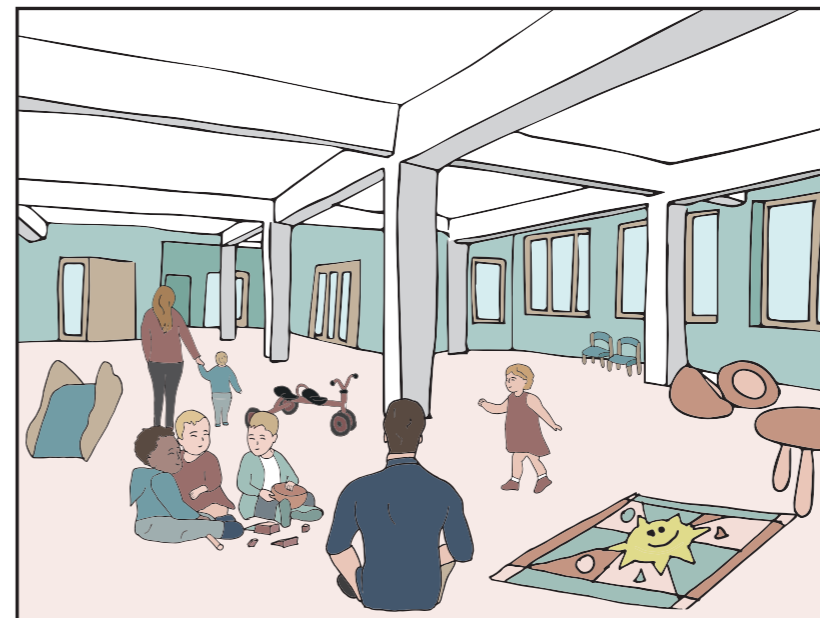
## PERSPECTIVE OF THE NURSERY

The nursery can be accessed from the street and from inside the building. As there is no possibility to have windows on the Eastern side of the nursery, the layout takes advantage of it by placing the nap room and the bathroom in the blind places.

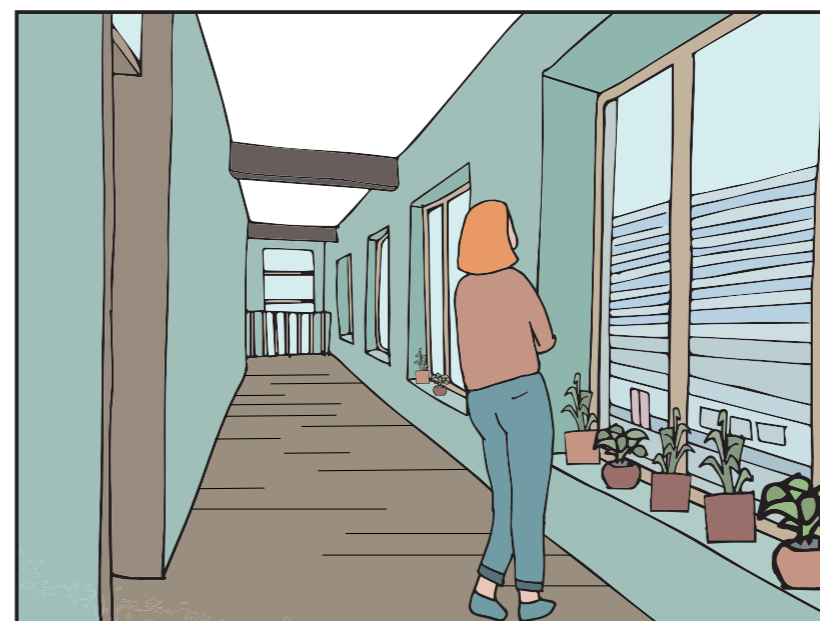
## PERSPECTIVE OF THE STUDENT HALLWAY

The student hallway is located alongside the railway to create a buffer zone to mitigate the noise. In order to make the circulation a pleasant experience, there are many windows opening up on the railway, showing the passage of the trains and lighting up the hall.

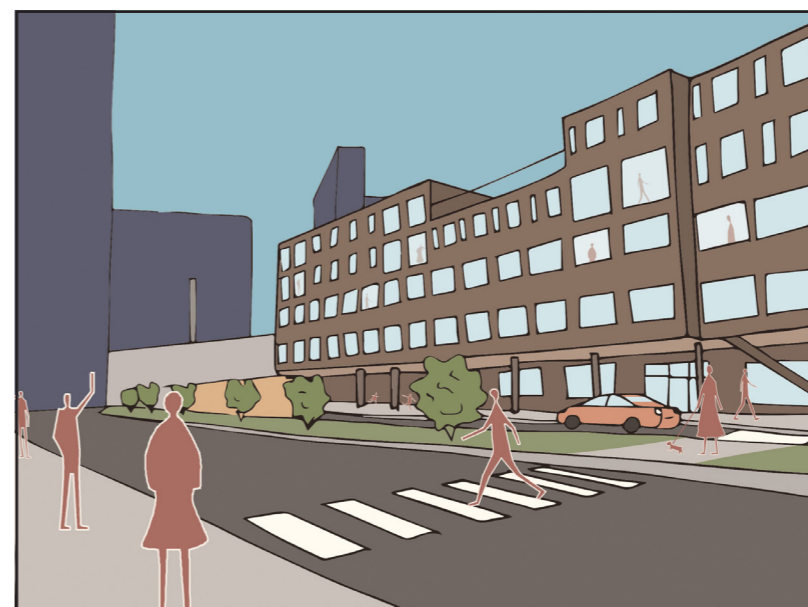
## PERSPECTIVE FROM THE NORTH EAST

Instead of the concrete panels, the new facade is covered up with a re-used wooden cladding, offering a more welcoming environment for the passengers.

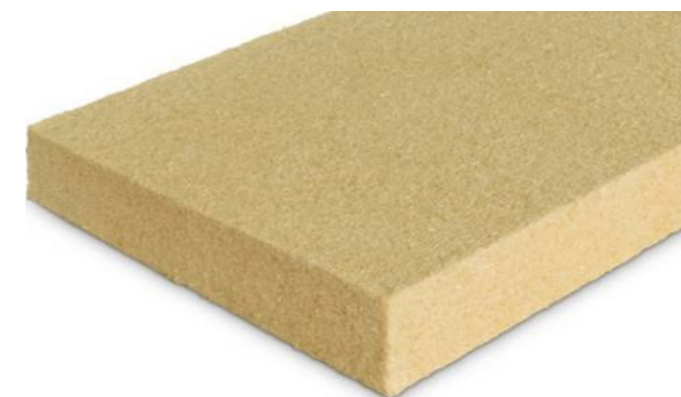
Figure 80. Steico flex F 036 (Steico)

Having compared the insulation materials, I decided to use mainly wood fibre for its better results. Therefore, I looked for suppliers in Belgium. A material, in particular, appeared as the best choice. It is a semi-rigid wood fibre panel called Steico flex F 036, there is one factory in France that produces it. It has a very low thermal conductivity (0,036 W/mK) which makes it efficient against heat and cold. It is made out of resinous wood from forests labelled PEFC & FSC. It does not contain any hazardous components, it does not irritate the skin. It is easy to install and can adapt to different shapes. It is also open to the diffusion of water vapour. (Steico, n.d.)

Thermal conductivity :  
0,036 W/mK  
Density :  
+ 55 kg/m<sup>3</sup>  
Components :  
Wood fibre, polyolefin fibre, ammonium sulphate  
Thickness :  
From 40 to 240mm  
(Steico, n.d.)

**Figure 80** Steico. (n.d.). *Steico flex F 036* [Photograph]. Steico. Retrieved April 20, 2021, from <http://www.steico.be/>
