Renovation for the future

An investigation of environmental impact and lifecycle costs from design choices during a renovation project

Johanna Olin
Chalmers School of Architecture
Department of Architecture and Civil Engineering

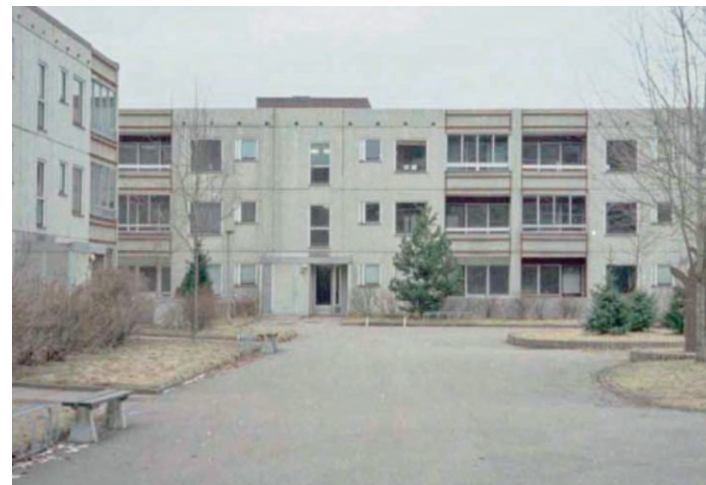
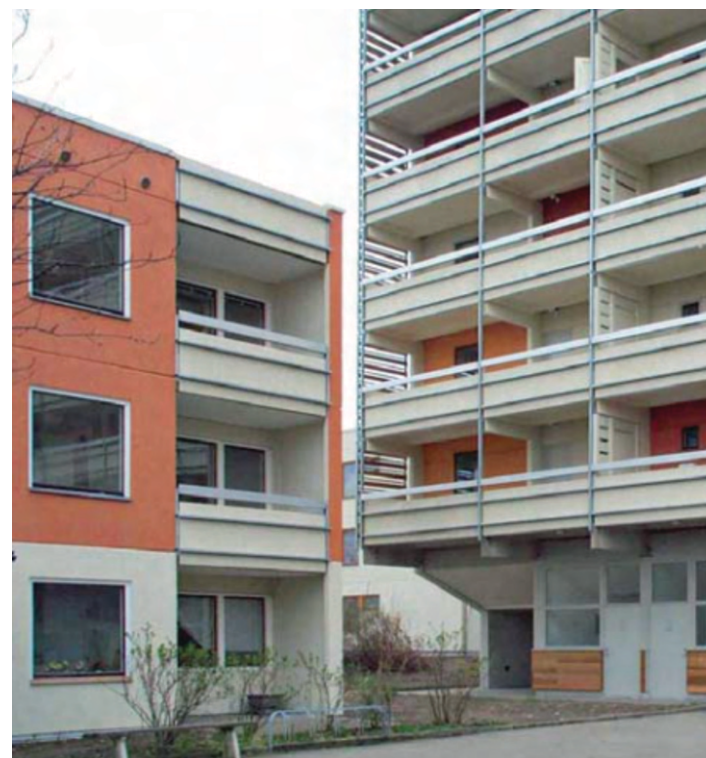
Figure 15 & 16: The building facades before and after the renovation

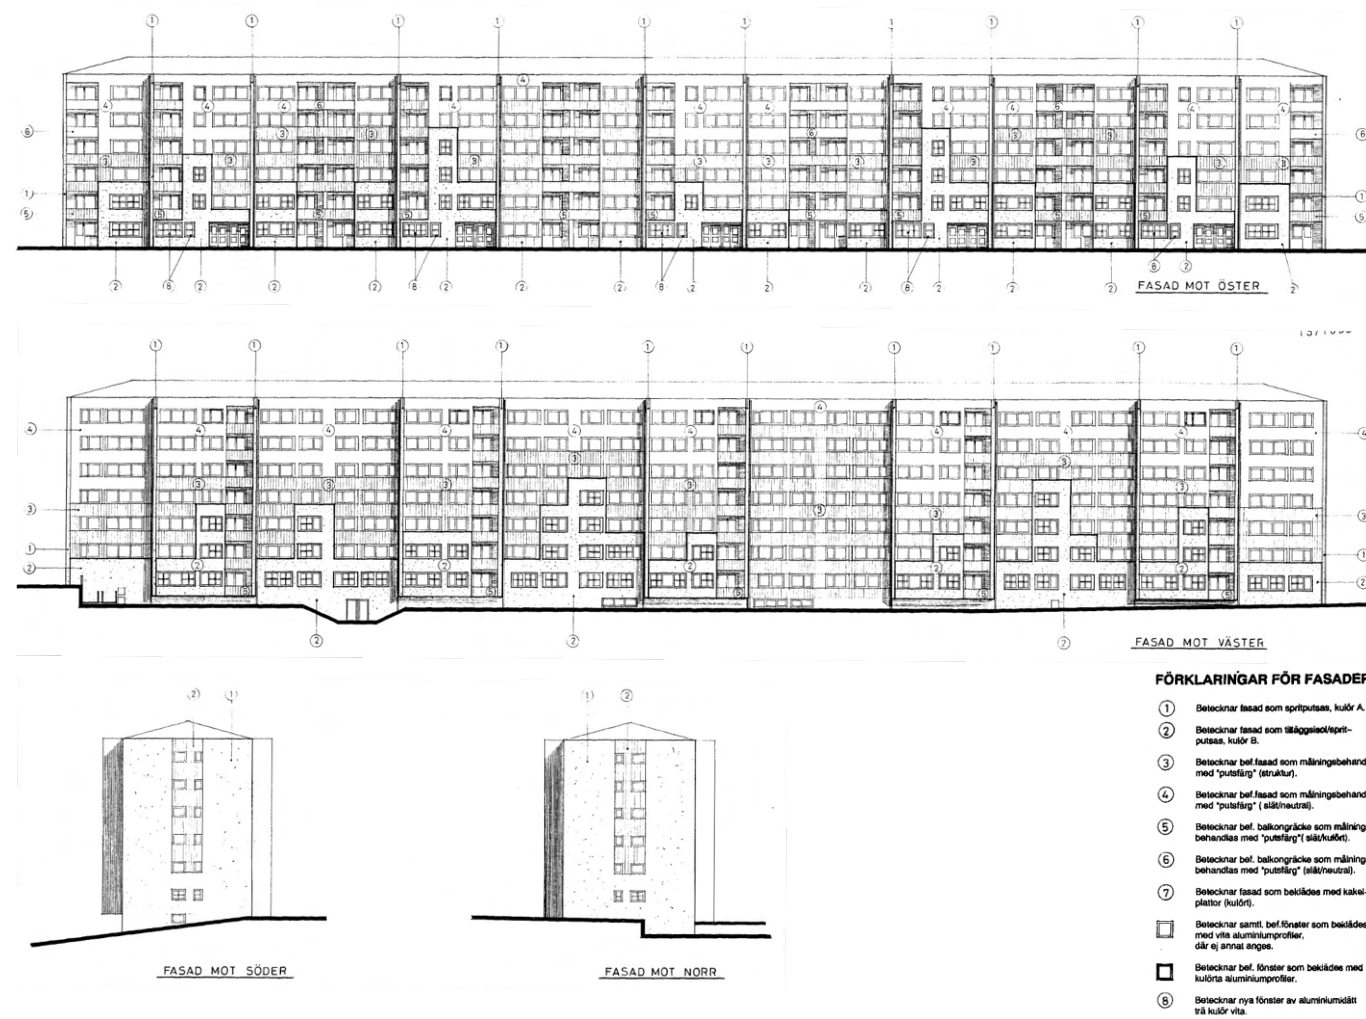
1993 New facade layers

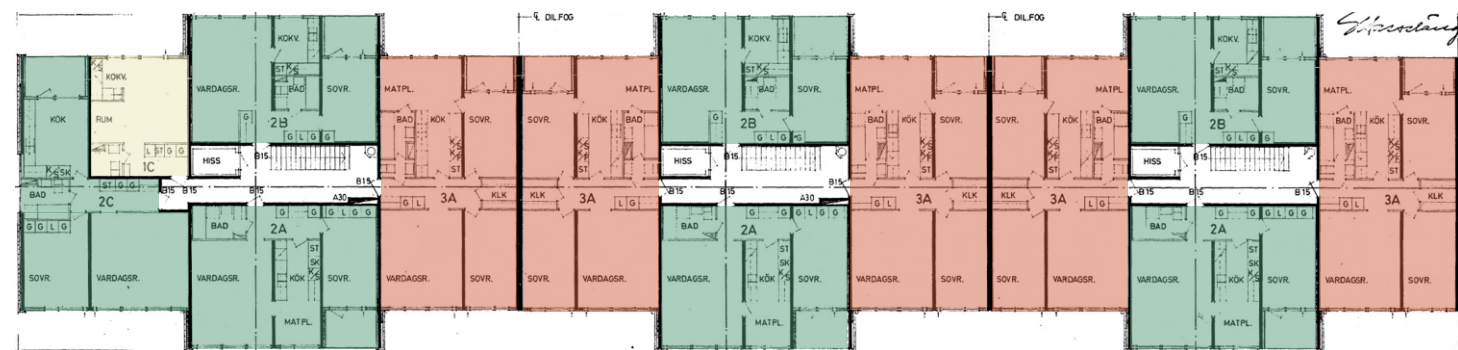
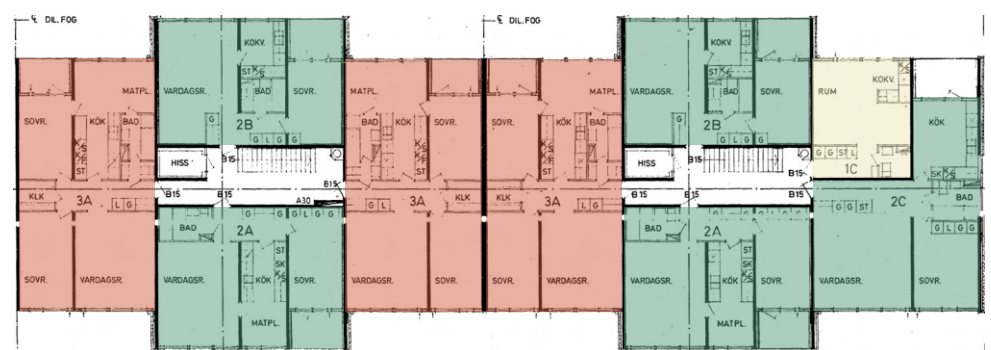
Floor 1-5

- 1-room apartments
- 2-room apartments
- 3-room apartments

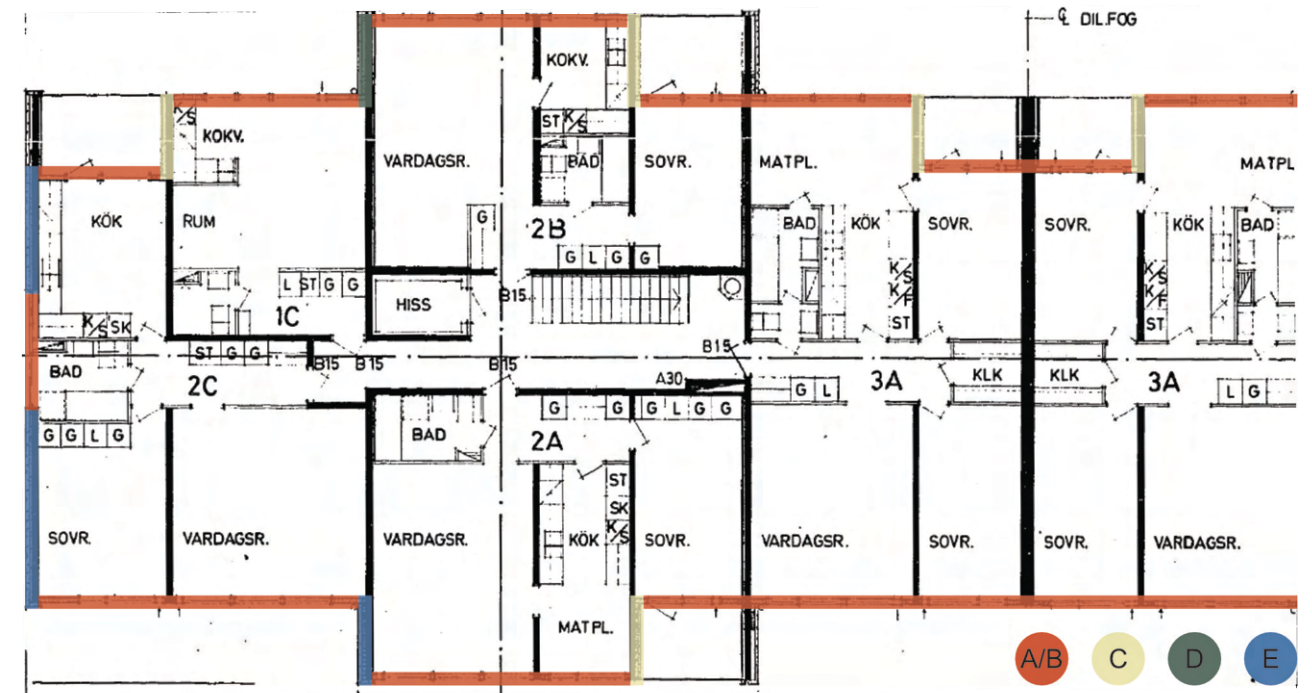
Walltypes changed in the renovation

Added material
Kept material

8mm cement fibreboard
55mm air gap + aluminium facade system
70mm stonewool insulation +
aluminium facade system
80mm concrete
100mm mineral wool
150mm concrete
50mm mineral wool

Removed: PCB removed from joists

The technical report from the investigation before the external renovation revealed that the buildings in the area had issues with large leakages of heat concentrated around the windows and by the connections between the façade and the concrete structure. The walls both had a low amount of initial insulation and the existing insulation had partially caved in, resulting in low insulating properties of the walls. In the renovation the building's joints were insulated, and new insulation replaced the old one. Since some of the wooden studs in the walls still were in good condition, they were kept in the façade. The changes to the walls have been adapted to the walls of the investigated building as illustrated in the drawings on the next page.

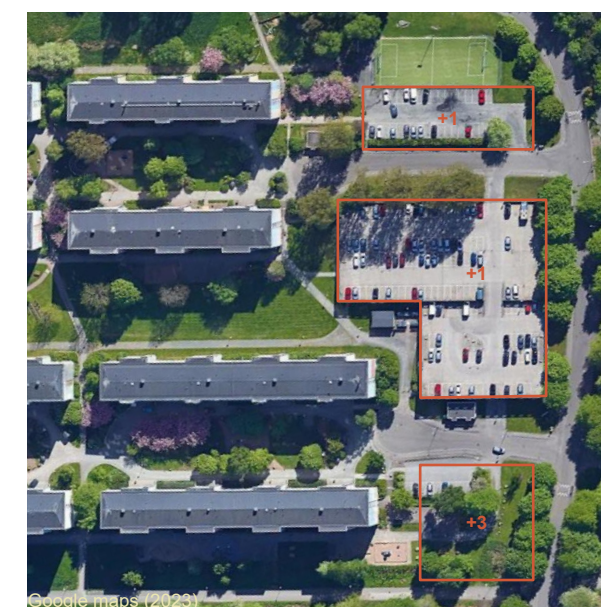
Potential placement of the new garage

It can be concluded from this test that the cost for building the new garage is slightly cheaper than the renovation and since it is also more interesting from an architectural perspective to investigate, that's the option which was chosen. Since these calculations all are based on estimated values and there is no developed plan for the new garage there could be other results from a more in-depth investigation.

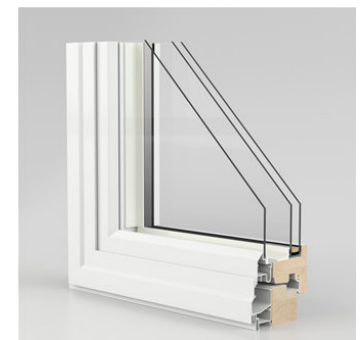
Figure 38: Window type used in the original renovation

In the original renovation the double-glazed windows from the 70s were exchanged due to issues with leakages. The replacing windows are triple glazed with a U-value varying from 0.9 to 1.2 W/m²K. In CAALA the U-value 0.9 has been used, which is one of the lowest U-values available. Using Wikells Sektionsfakta it can be assumed that the investment cost for a more energy efficient window would be ca 25% higher than the original cost, which in this case would not be profitable.

The windows have a wooden frame with an aluminium cover. While aluminium is a material with a high embodied carbon it in this case it lowers the need for maintenance of the wood since it doesn't need painting. A window with a wooden frame needs to be painted around every 10th year but has low environmental impact and a low investment cost. With a window fully in aluminium the need for maintenance is low but the embodied carbon is much higher. The aluminium covered wooden windows seem in this case to be a good compromise and the original window choice has been kept in this study.

Figure 38: LEIAB Fönster (n.d). *Produktblad Haga* (p.1). <https://www.leiab.se/produkter/p/haga/kipp-dreh-fonster/lkf1001ye--inatgaende-kipp-dreh-fonster-2-1-glas/>

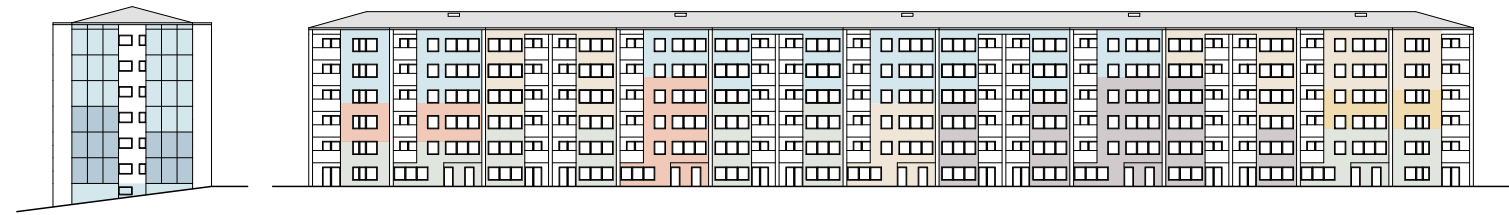
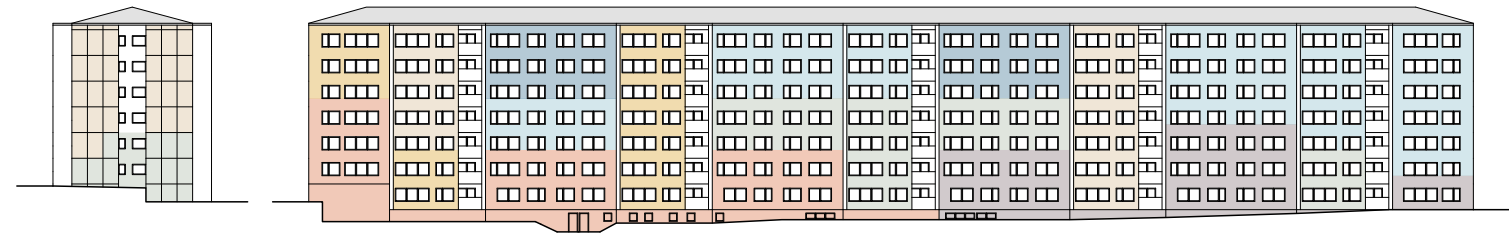
Old facades, 1:800

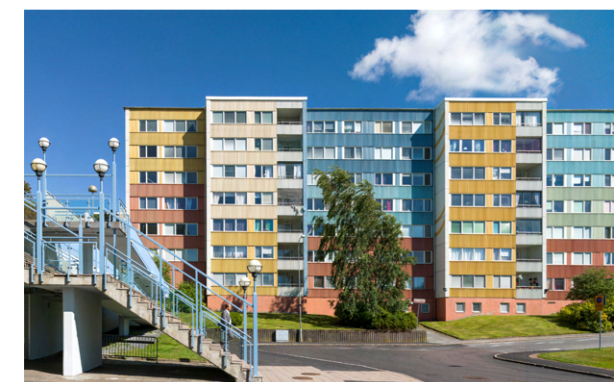
Figure 32

Figure 32: The original facade

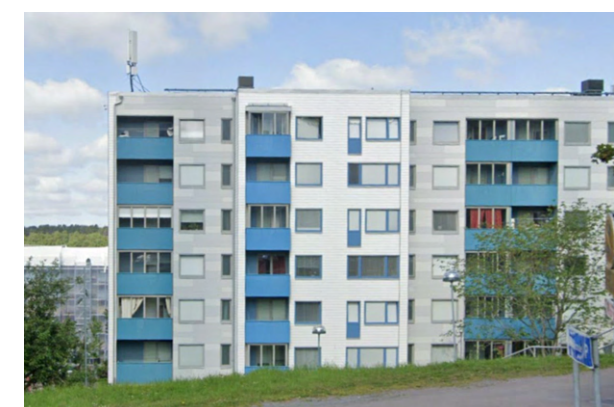
Figure 33

Figure 33: The current facade from the 90's
